ROOT CAUSE FAILURE ANALYSIS INVESTIGATION REPORT

# Weymouth Compressor Station September 11, 2020 Closure Seal Failure

**Algonquin Gas Transmission, LLC**  
**Subsidiary of Enbridge Inc.**

**Report No.:** 10263555-1, Rev. 0

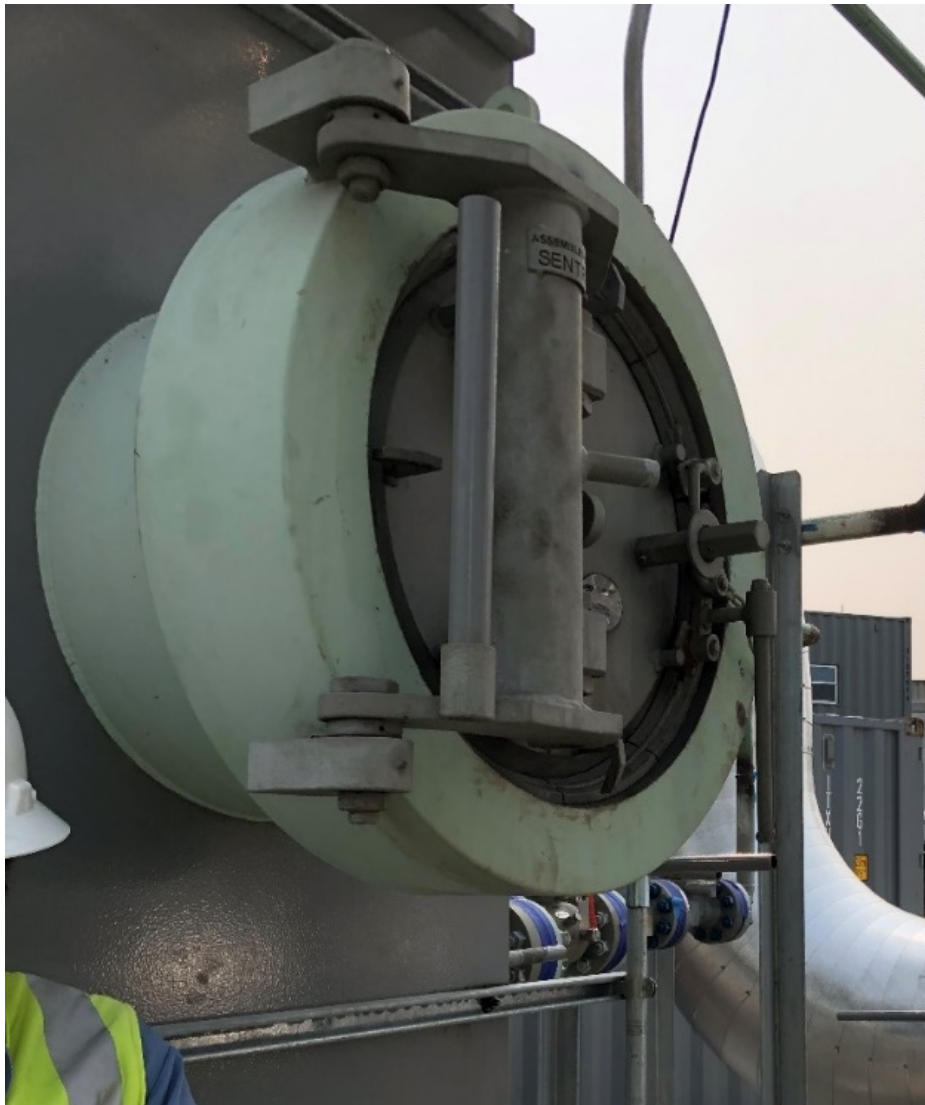
At 8:45 am, the seal for the sump closure door on filter separator FS-01 failed, releasing high pressure natural gas from a localized area between the filter separator closure hub and mating door. Figure 4 is a photograph taken by AGT showing the closure door that experienced the seal failure. A total volume of 169 MSCF of natural gas was released (13 MSCF released at ground level, 156 MSCF released through the source control silencer). Immediately after the seal failure, onsite personnel manually closed the filter separator inlet valve FSI-01 and outlet valve FSO-01 to isolate FS-01 and isolate the release location; however, valve closure could not be confirmed, because of the proximity of the release to the valve position indicators. Therefore, the release area was evacuated at 8:48 a.m. and by 8:50 a.m. it was determined that it was

**Figure 4. Photograph provided by AGT showing the closure on Filter Separator FS-01 that experienced a seal failure.**

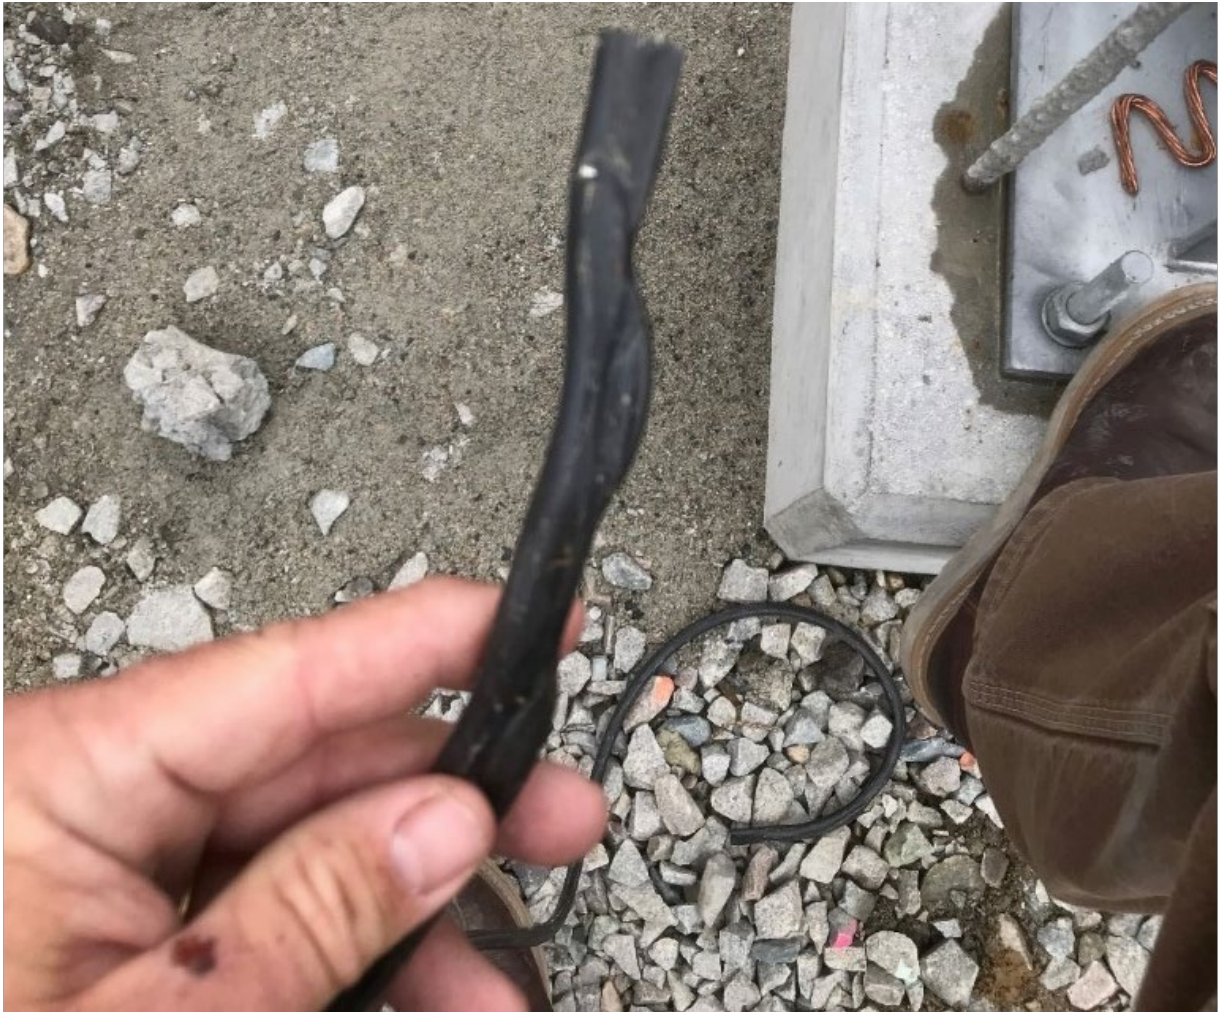
| Observations | Description | Verification |
|---|---|---|
| Direct Cause | The direct cause for the release was determined to be a failed seal on a closure door of a filter separator sump, which was later determined to have a temporary low-pressure O-ring in place, which was not intended for use at full operational pressure or service conditions. | Observations |

AGT initiated an investigation following the event to determine the cause of the loss of containment at the sump closure. The investigation determined that the seal (O-ring) that was in place during commissioning was not intended to experience operational pressure or in-service environments. The operational seal, intended for service, was shipped at the same time as the filter separator but was not installed. It was AGT's belief that the vessels were delivered with operational seals installed based on the experience of the AGT personnel onsite. As the unit was brought online, the O-ring experienced failure at a pressure of 579 psig. Figure 5 is a photograph showing the failed O-ring following opening of the closure door and removal of the O-ring. The O-ring exhibits a wavy pattern with areas that are flattened. Figure 6 is a photograph showing a similarly damaged O-ring on one of the sump closures of Filter Separator FS-02 following opening of the closure door. The O-ring exhibits the same characteristics as the failed O-ring on FS-01. Desiccant packs can also be seen inside the sump of FS-02.

The DNV GL investigation team reviewed photographs and other relevant information and verified the direct cause of the loss of containment was failure of the seal on the filter separator sump door closure. As part of DNV GL's investigation, interviews were conducted to identify the barriers in place at the time of the event, determine their effectiveness, establish root causes of any ineffective barriers, and suggest recommendations for continuous improvement.

**Figure 5. Photograph provided by AGT showing the failed O-ring.**

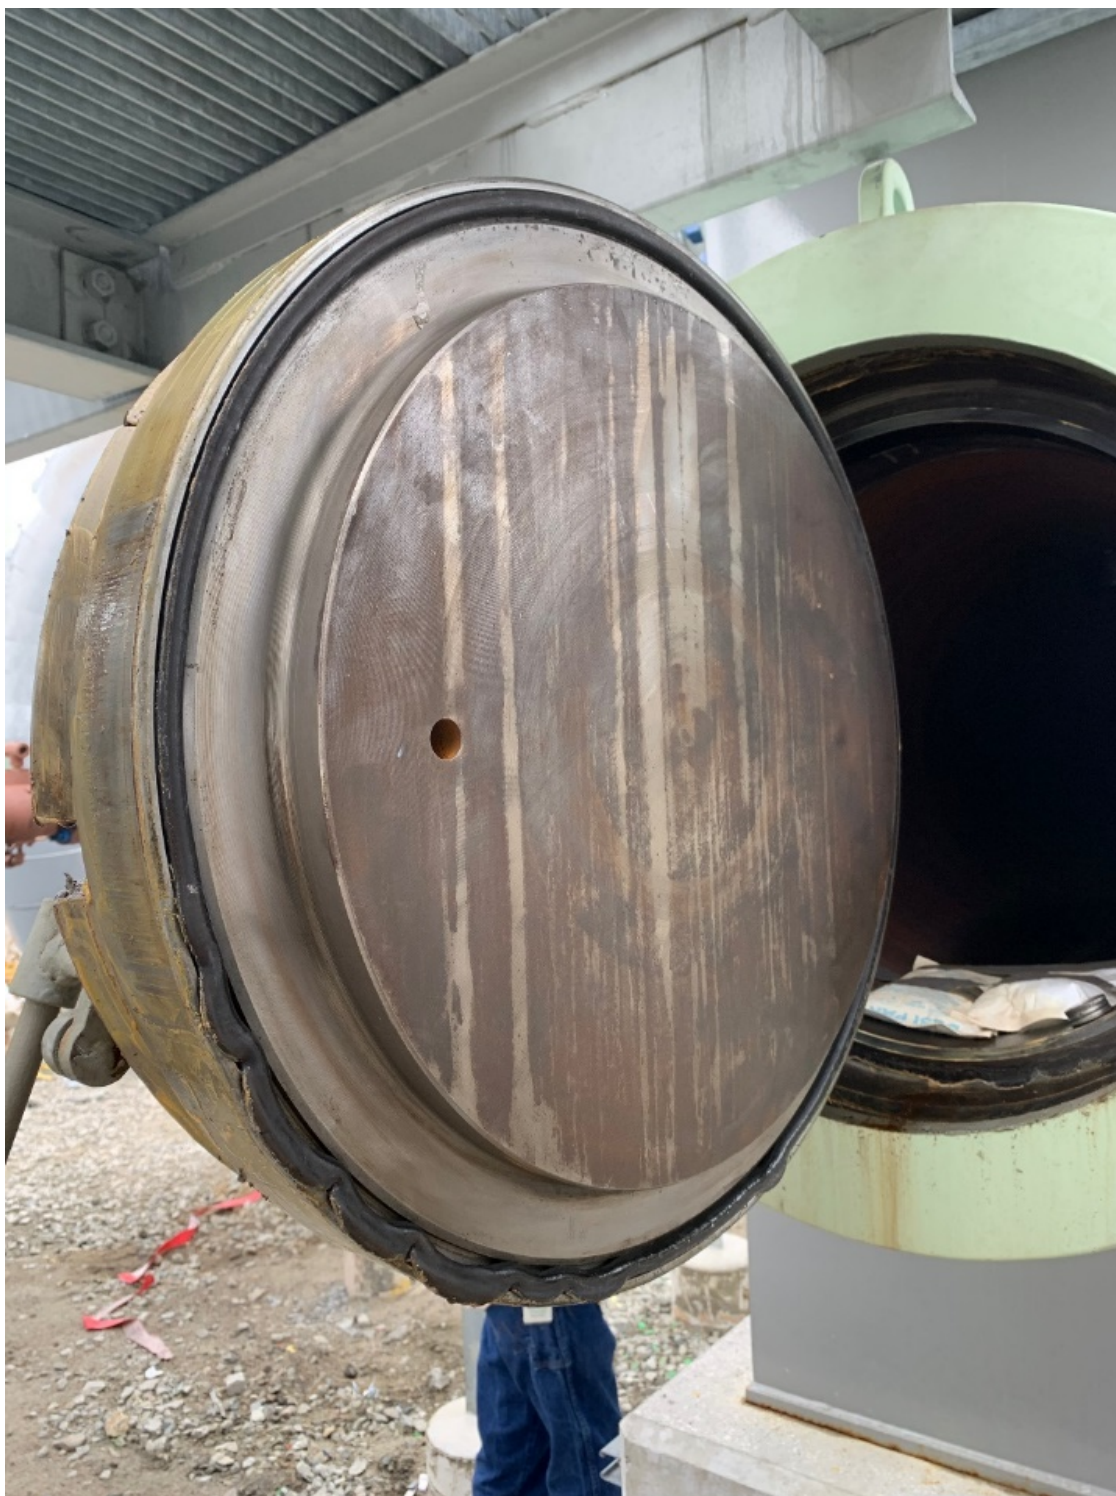
**Figure 6. Photograph provided by AGT showing a similarly damaged O-ring on a closure door of Filter Separator FS-02. Desiccant packs can also be seen inside the closure hub.**
