BRICK GRILL BASEMENT

MORANTE INSURANCE/BARBER SHOP BASEMENT

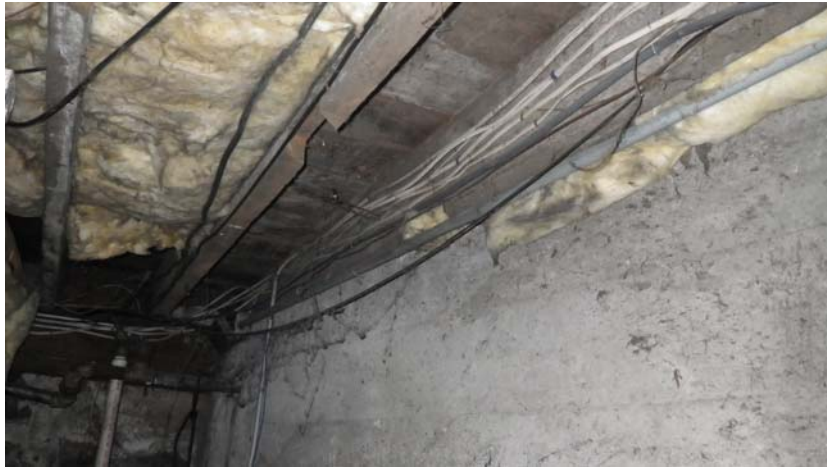
Brick Grill Basement B1 - looking along Smelt culvert wall.

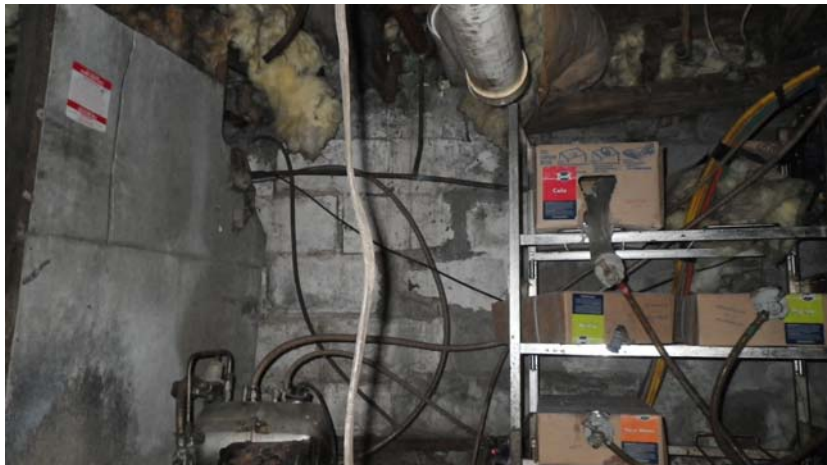
Brick Grill Basement B3 - looking at existing block foundation wall along culvert.

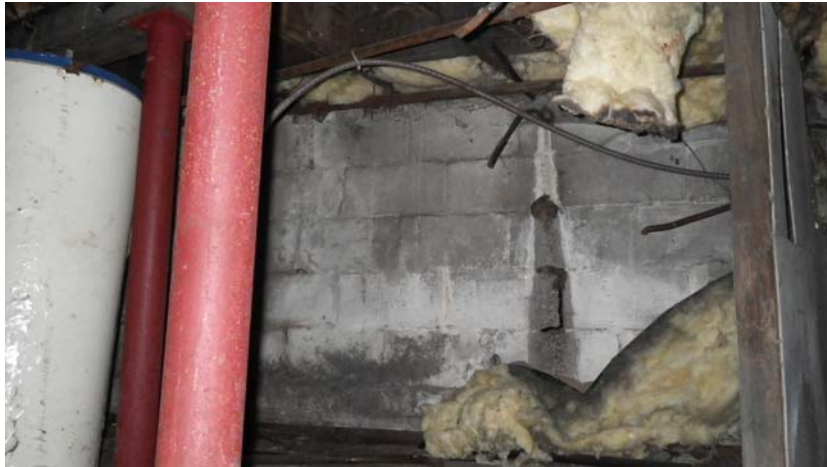
Brick Grill Basement B4 - looking along block foundation wall along culvert.

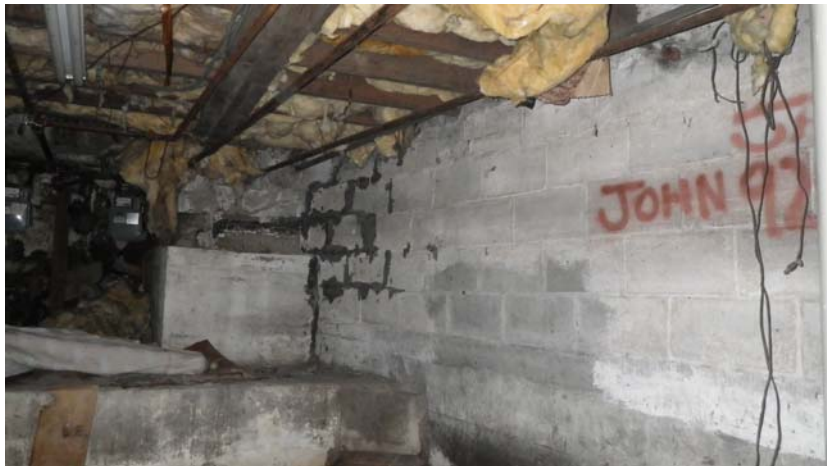
Brick Grill Basement B5 - looking towards Commercial Street along culvert wall.

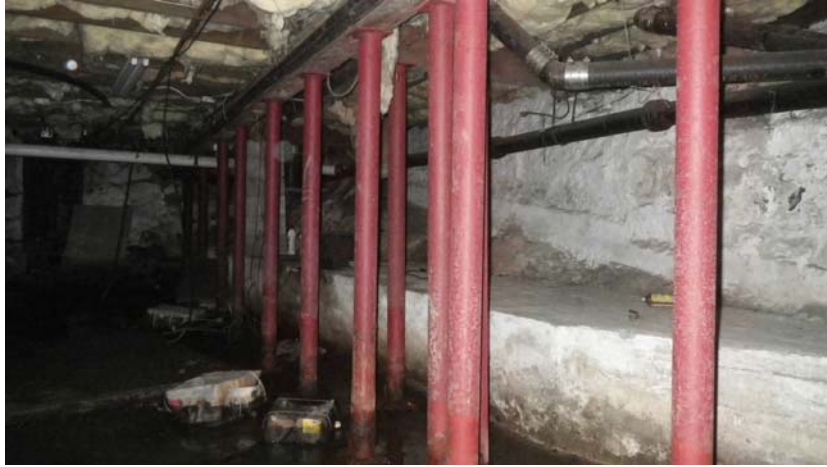
Brick Grill Basement B7 - looking east along foundation wall
between Chair Fair Building.

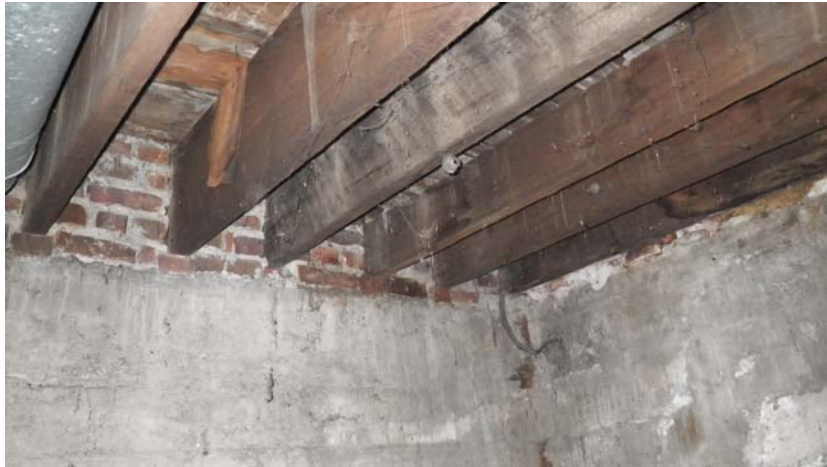
Morante Insurance/Barber Shop Basement M1 - looking in SW corner at culvert wall.

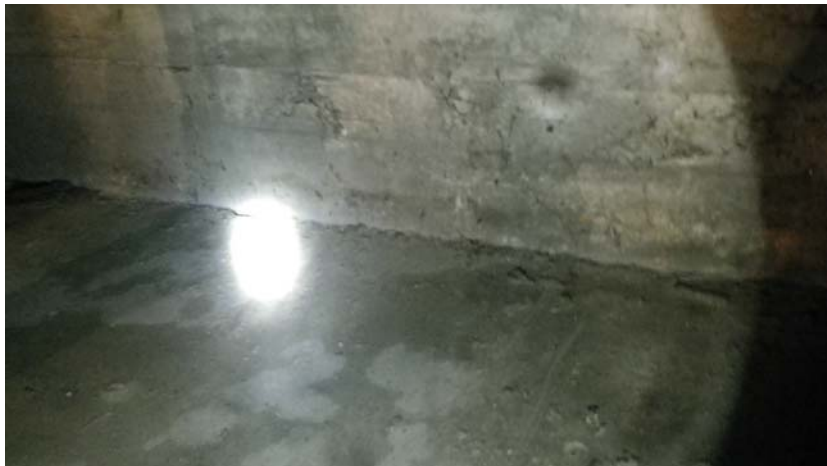
Morante Insurance/Barber Shop Basement M2 - looking at SW corner at slab wall interface.

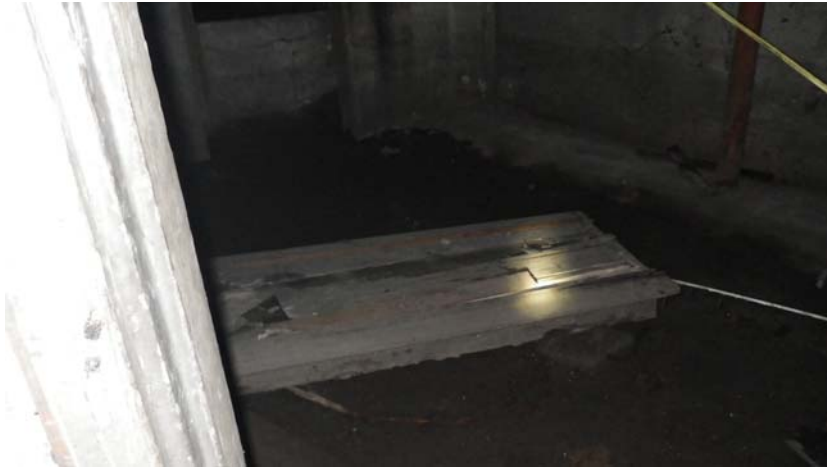
Morante Insurance/Barber Shop Basement M4 - looking at basement wall along culvert.

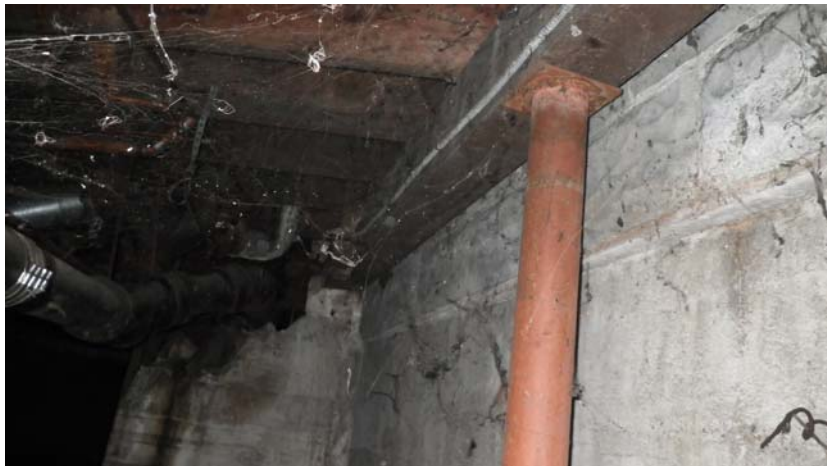
Morante Insurance/Barber Shop Basement M5 - another view at basement wall along culvert.

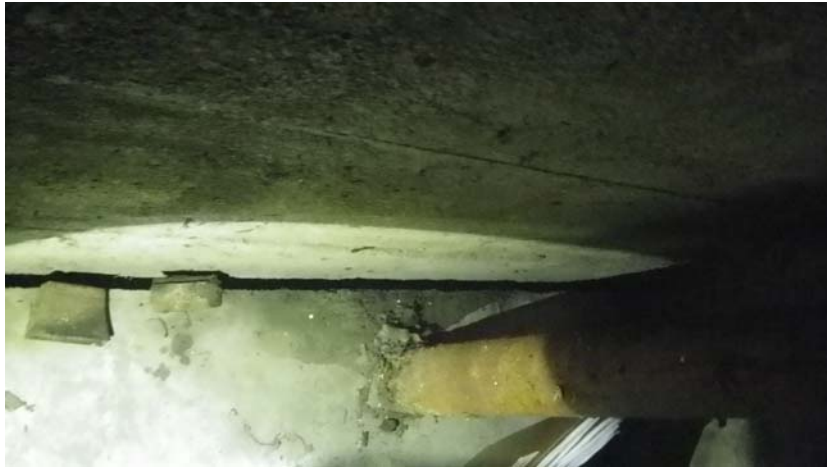
Morante Insurance/Barber Shop Basement M7 - view along culvert wall showing separation of slab and wall.

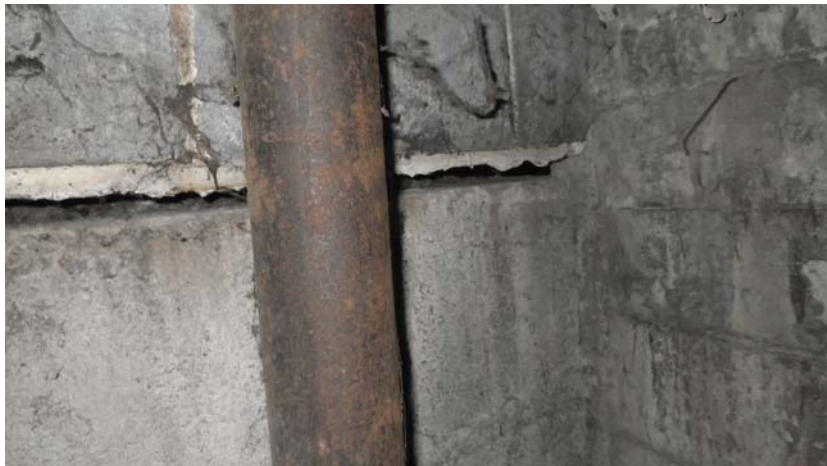
Morante Insurance/Barber Shop Basement M8 - another view showing settlement.

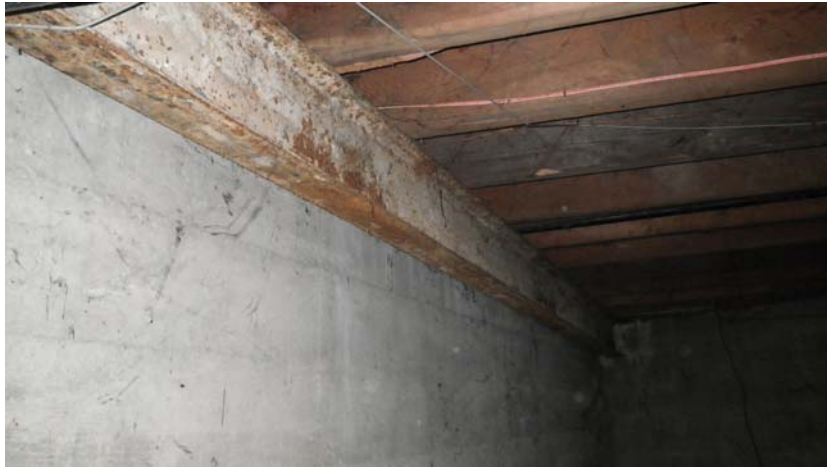
Morante Insurance/Barber Shop Basement M10 - view showing steel beam framing of floor above.

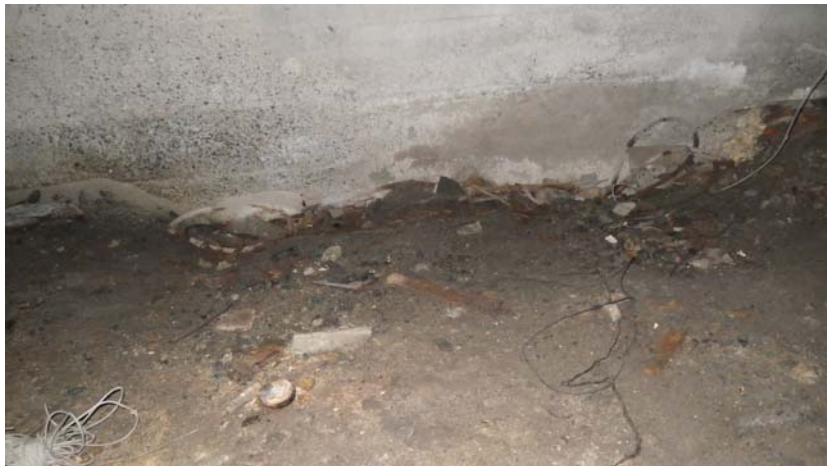
Morante Insurance/Barber Shop Basement M11 - view shows settlement of soil in basement.

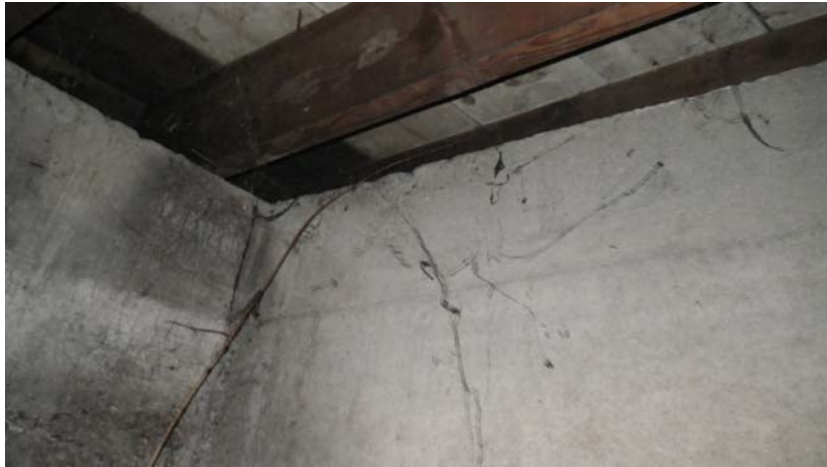
Morante Insurance/Barber Shop Basement M13 - framing in NE corner.

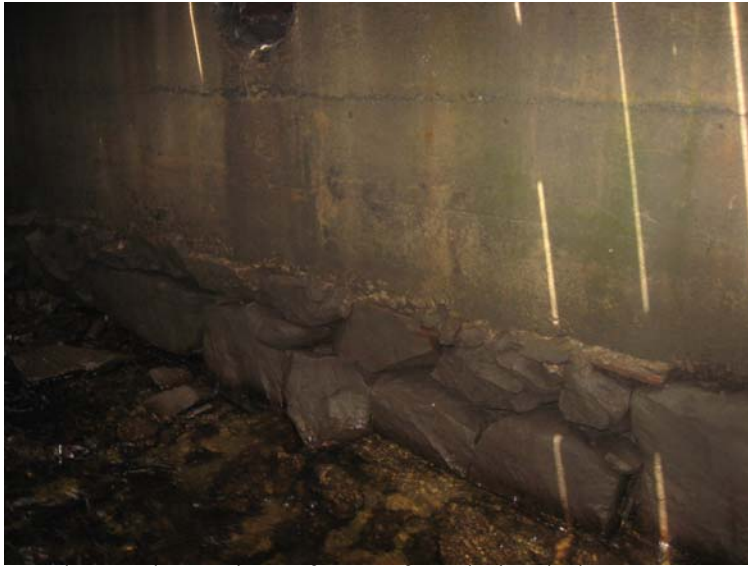
Smelt Brook 4 - view of stone foundation below concrete wall along north side of culvert.

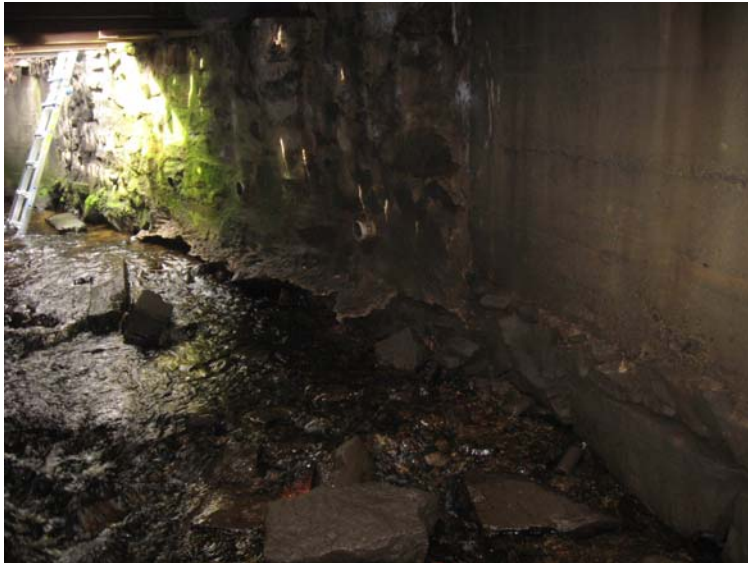
Smelt Brook 5 - view showing undermining along north culvert stone wall.

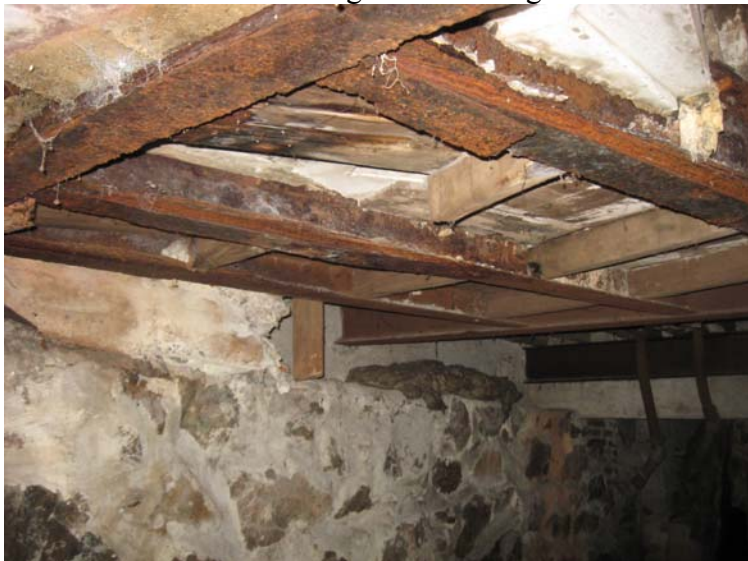
Smelt Brook 9 - view of deteriorated steel floor framing above culvert.

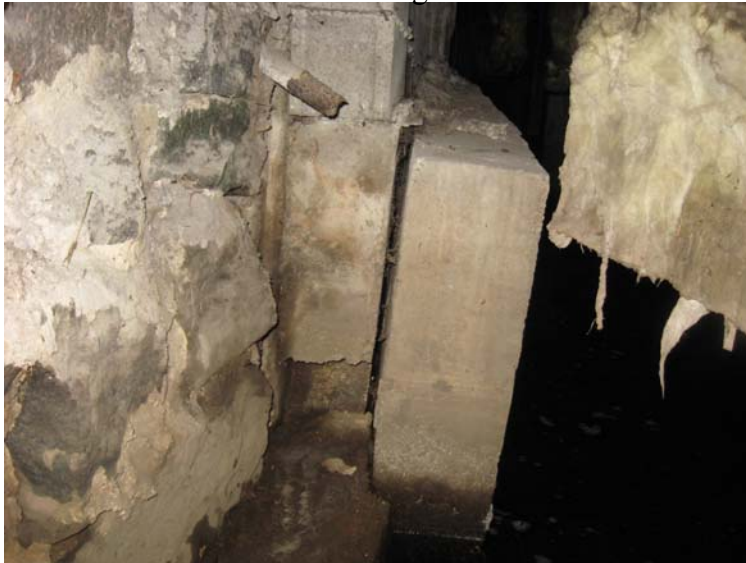
Smelt Brook 14 - view looking toward Commercial Street showing movement at culvert walls.

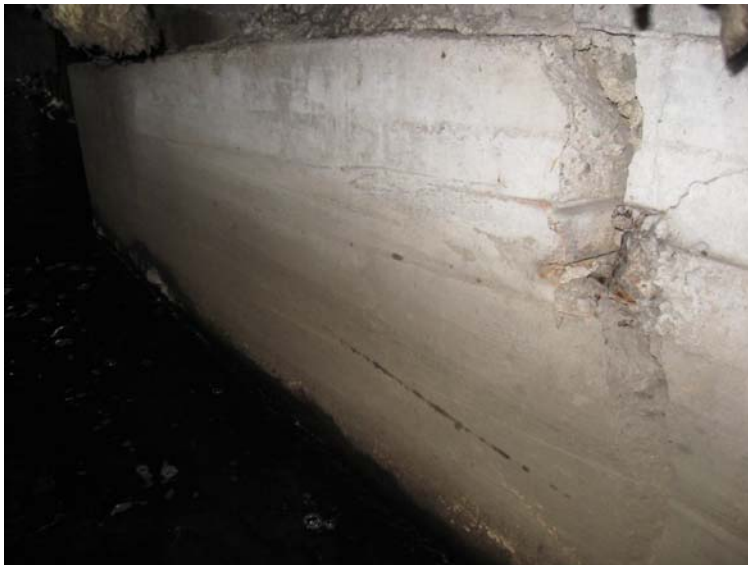
Smelt Brook 17 - view looking away from Commercial Street showing cracked and settled wall.

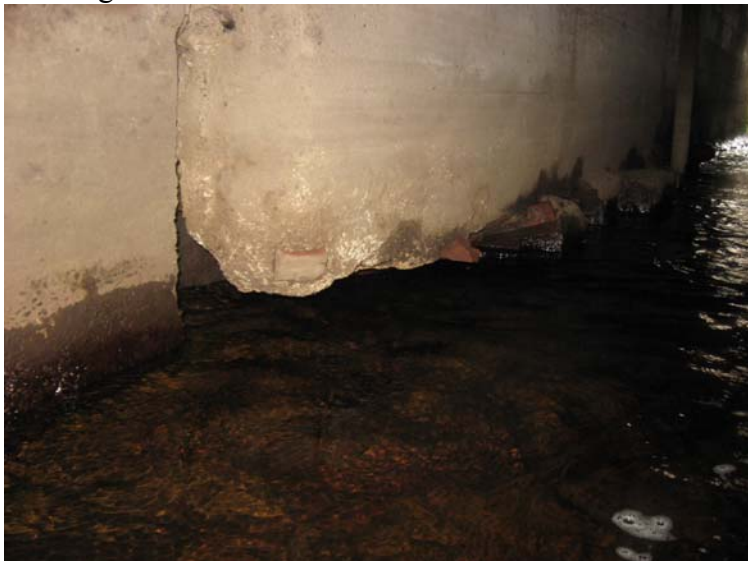
Smelt Brook 18 - view looking away from Commercial Street at undermined wall section below.

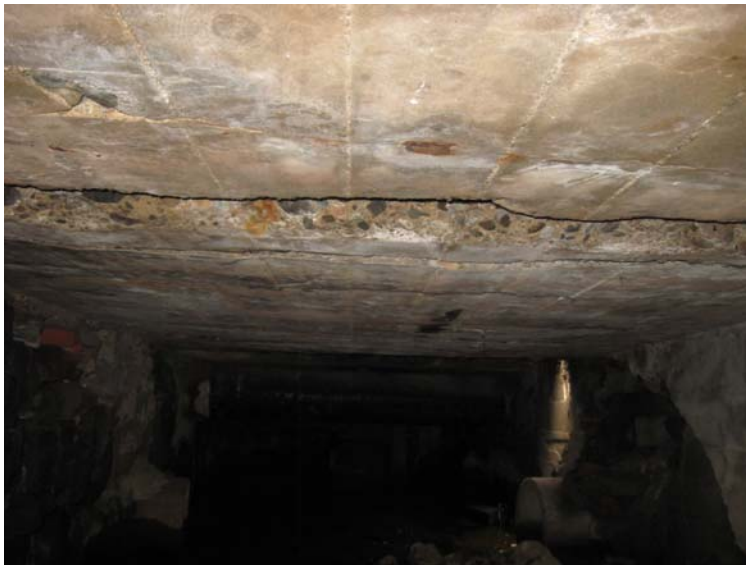
Smelt Brook 26 - view of reinforced concrete slab at Commercial Street sidewalk showing significant deterioration.

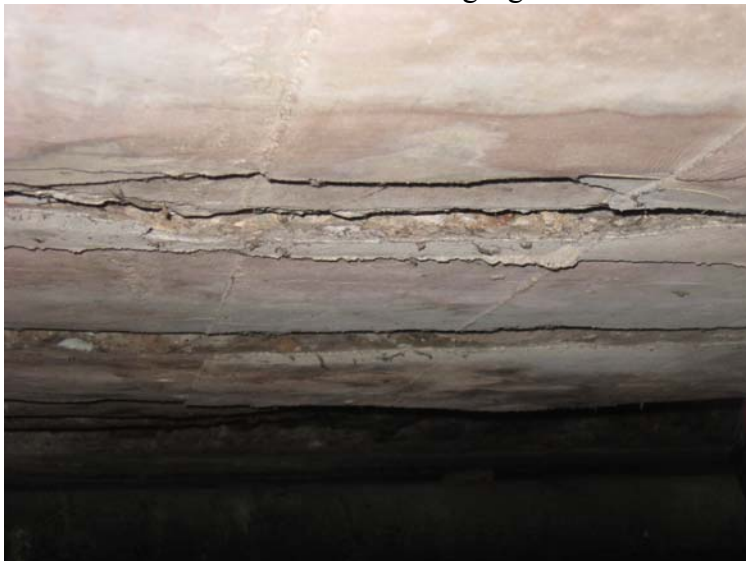
Smelt Brook 27 - view of reinforced concrete slab at Commercial Street sidewalk showing significant cracks.

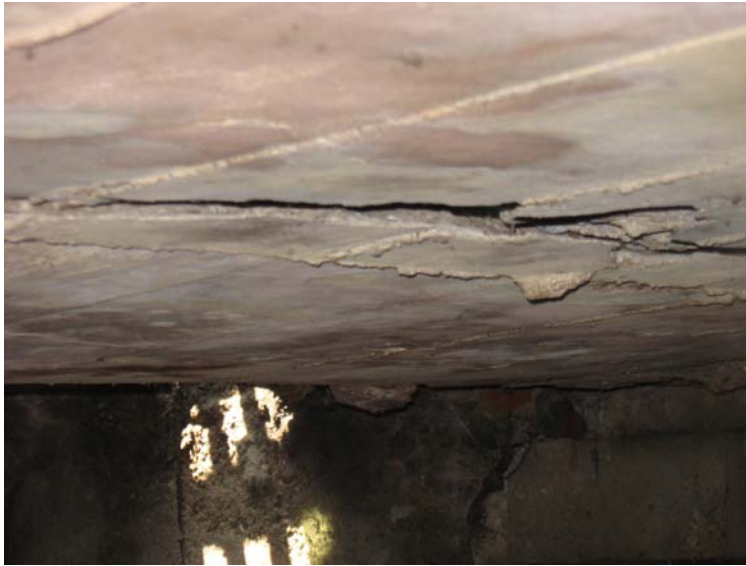
Smelt Brook 28 - view of reinforced concrete slab at Commercial Street sidewalk showing significant cracks.

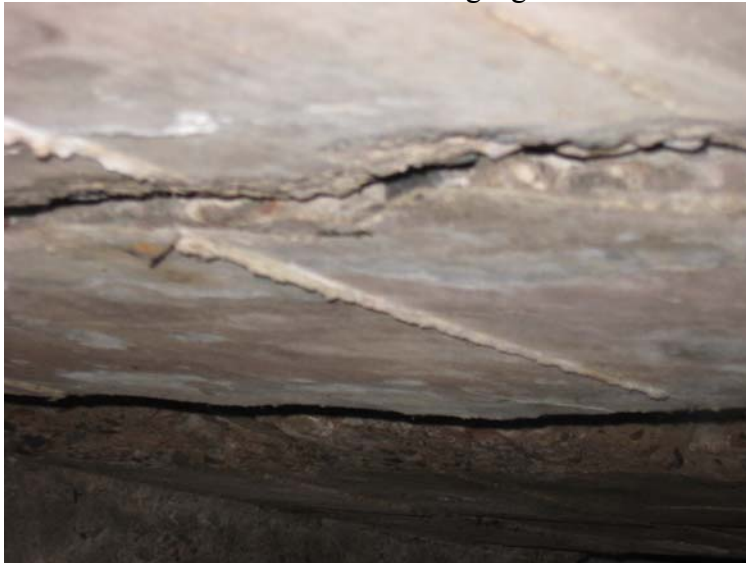
Smelt Brook 29 - view of reinforced concrete slab at Commercial Street sidewalk showing significant cracks.

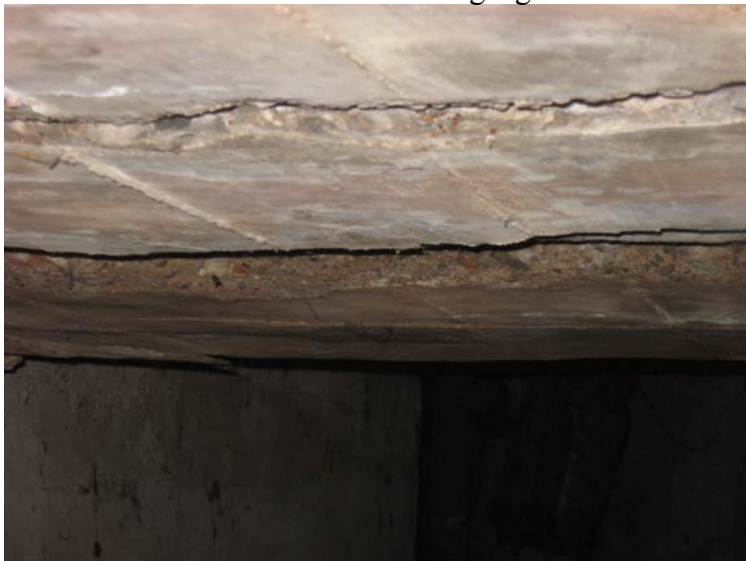
Smelt Brook 30 - view of reinforced concrete slab at Commercial Street sidewalk showing significant cracks.

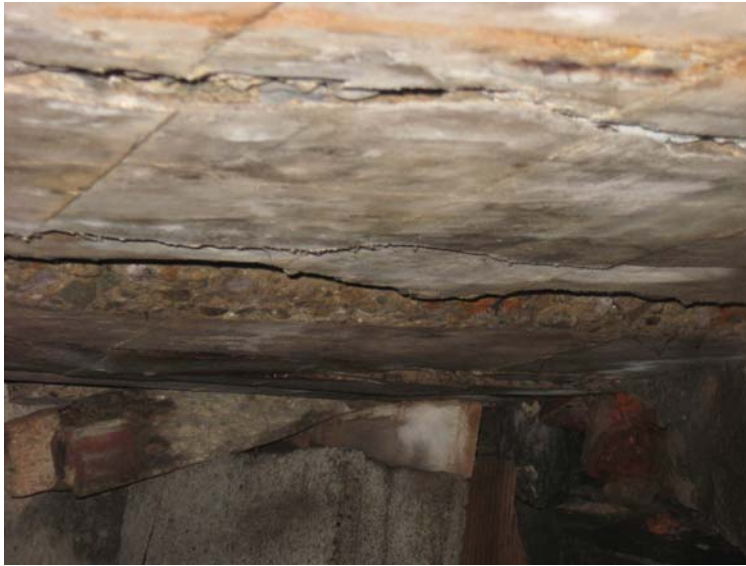
Smelt Brook 31 - view of reinforced concrete slab at Commercial Street sidewalk showing significant deterioration.

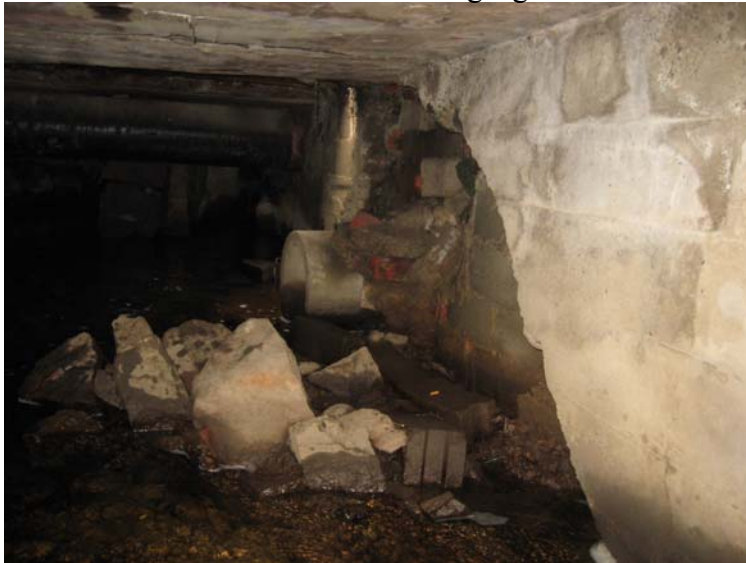
Smelt Brook 32- view below Commercial Street at pipe penetration at wall.
