RE: Fall 2021 Monitoring Report
Wetland and Buffer Zone Restoration
1400 Main Street, Weymouth, MA
MassDEP File #81-1216

PHOTOGRAPHIC DOCUMENTATION

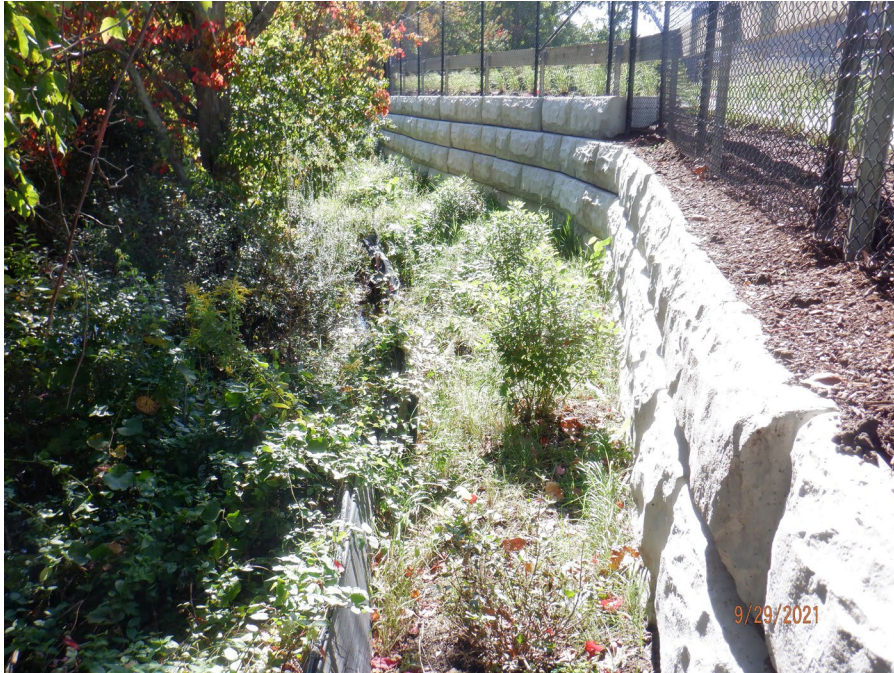
Photograph 1: Typical vegetation between the retaining wall and erosion control barrier, includes planted sweet pepperbush and a mix of herbaceous vegetation.

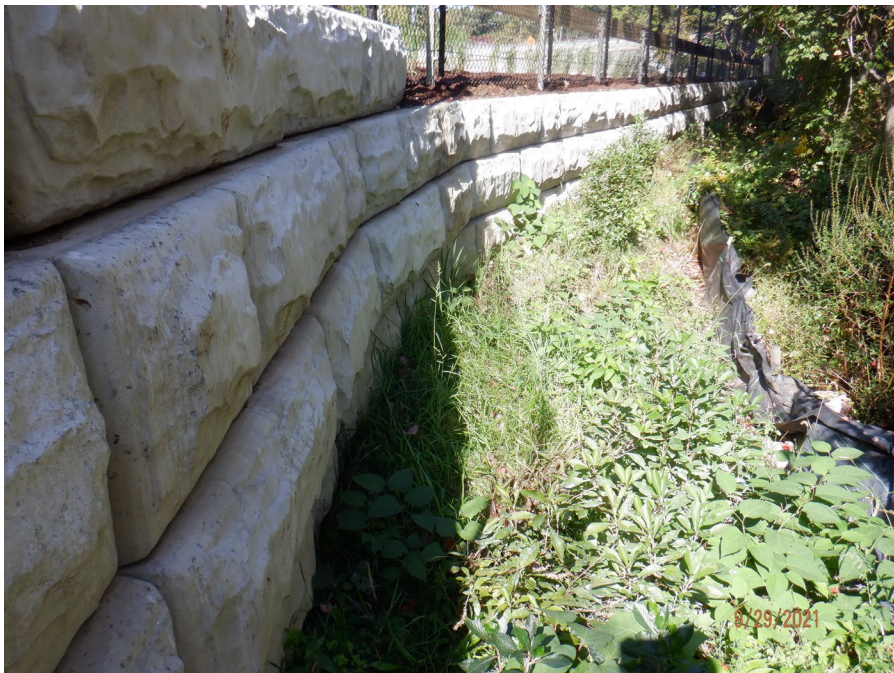
Photograph 2: Japanese knotweed re-sprouting below the retaining wall between outlets #2 and #3.

Invasive species have been significantly reduced within the restoration area. However, patches of invasive vegetation, including multiflora rose, glossy buckthorn, Japanese knotweed, purple loosestrife (*Lythrum salicaria*), and common reed (*Phragmites australis*), were observed beyond the limit of work erosion control barrier and within the wetland. Therefore, LE recommends continued management of invasive species at the site as detailed in the approved Vegetation Management Plan, dated September 26, 2019.

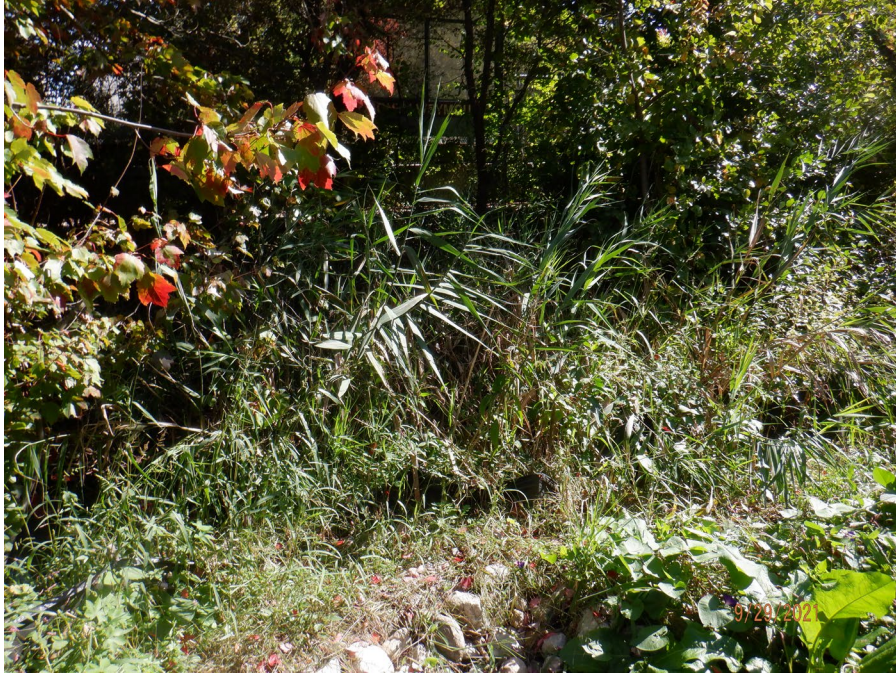
Photograph 3: Patch of common reed located at wetland edge below the retaining wall.

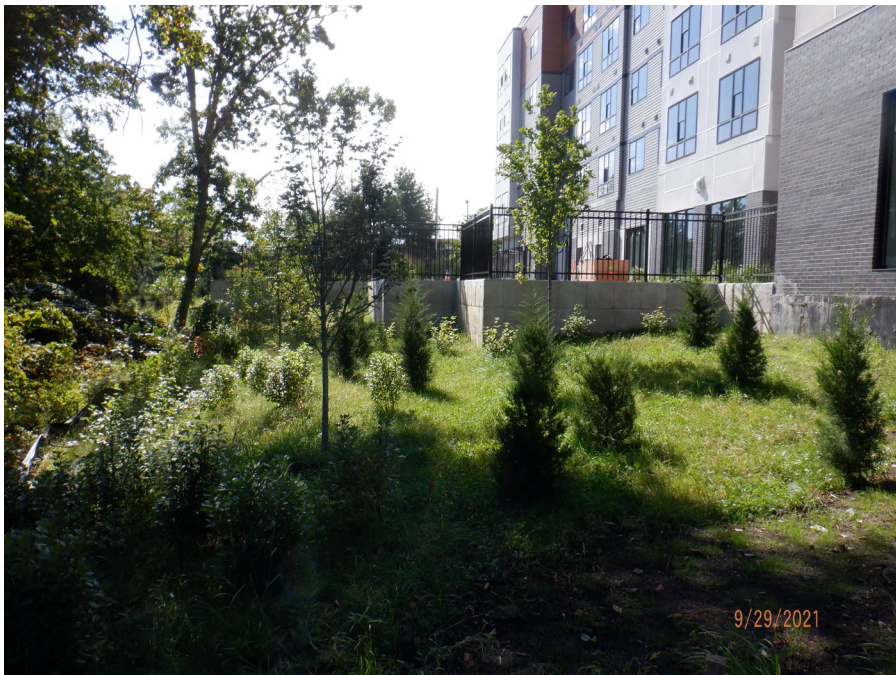
Photograph 4: Restoration area vegetation north of the pool/patio area.

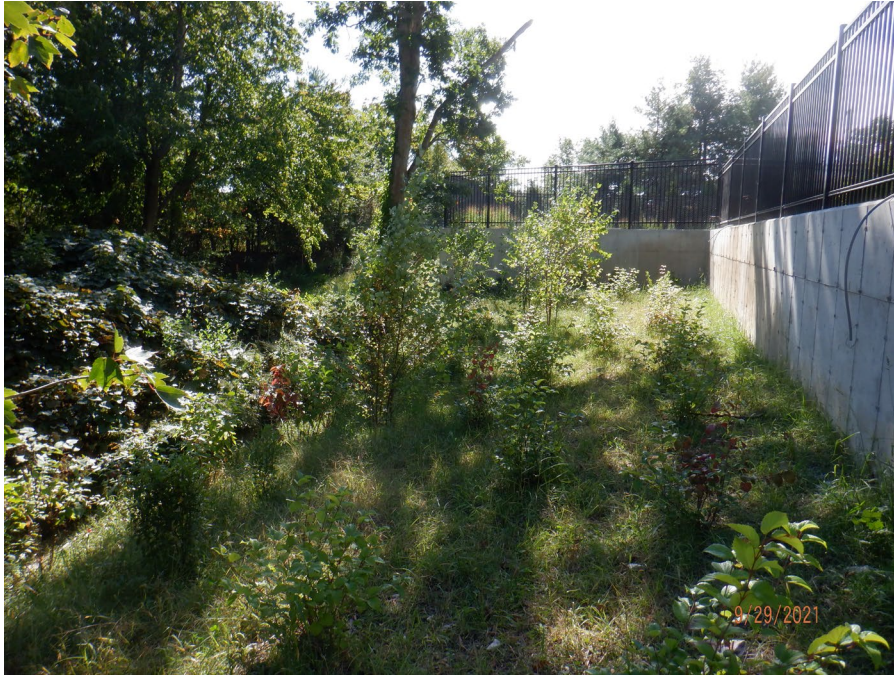
Photograph 5: Restoration area vegetation east of the pool patio area.

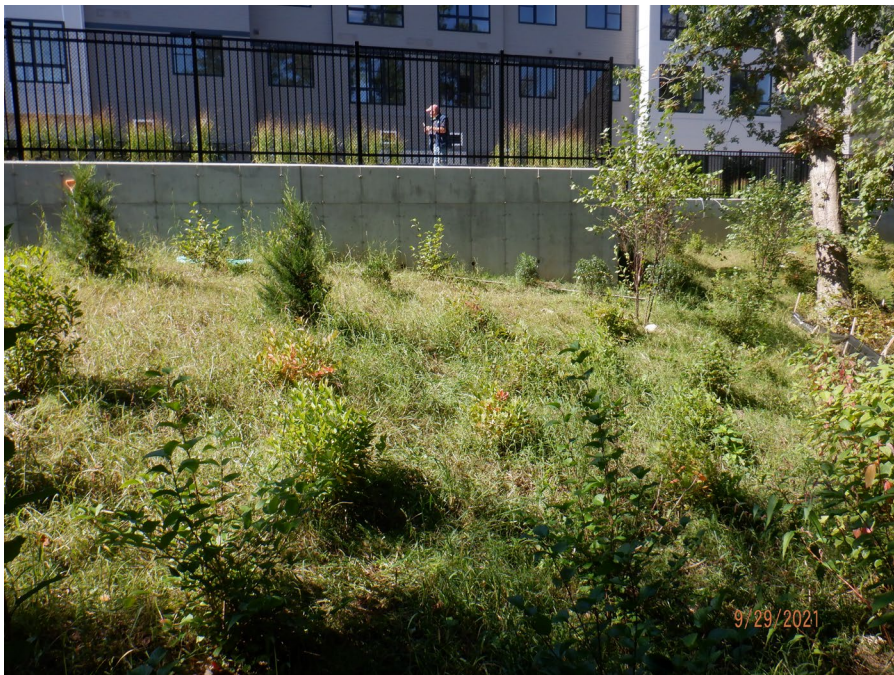
Photograph 6: Restoration area vegetation east of the pool area

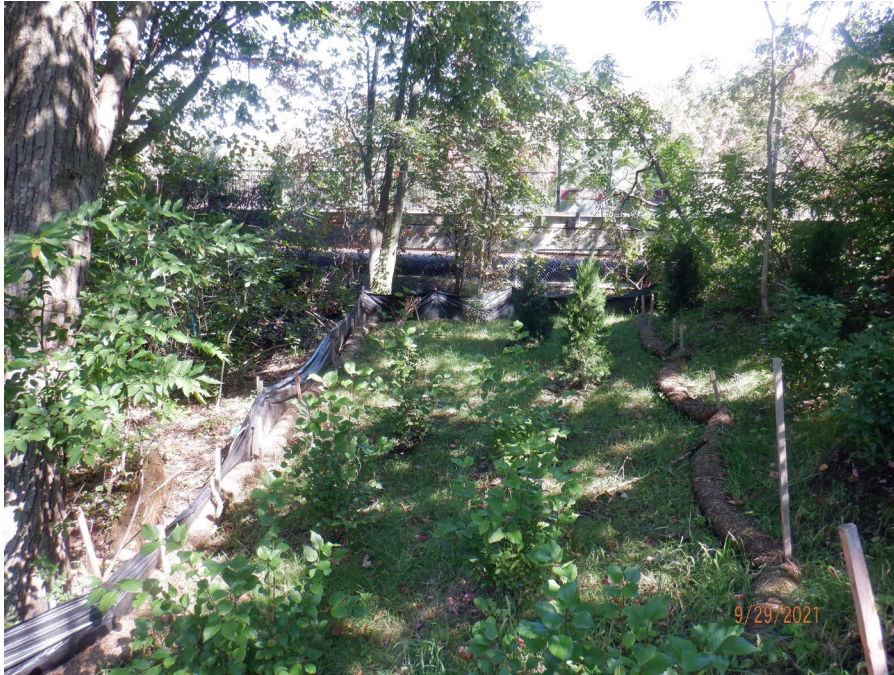
Photograph 7: Restoration area vegetation east of the pool area closer to the MBTA tracks.

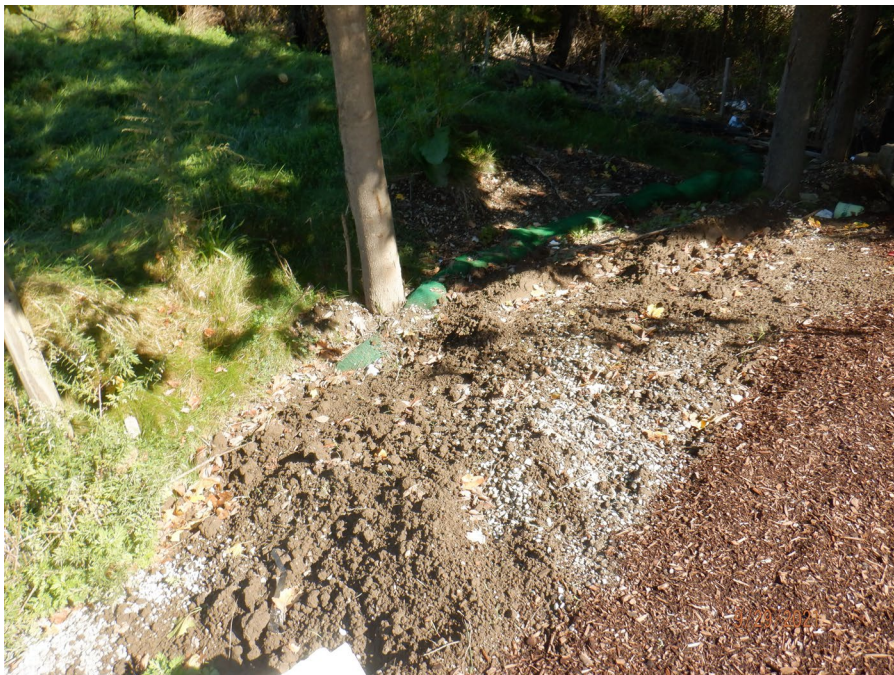
Photograph 8: Area of bare soil at northeast corner of property.

- A small area of bare soil remains at the northeast corner of the site adjacent to the northern property line (Photograph 8). This area should be stabilized by seeding/hydroseeding or by mulching as in adjacent areas. Soil accumulated along the erosion control barrier should be removed and the wattle should remain in place at this location until the soil is stabilized.

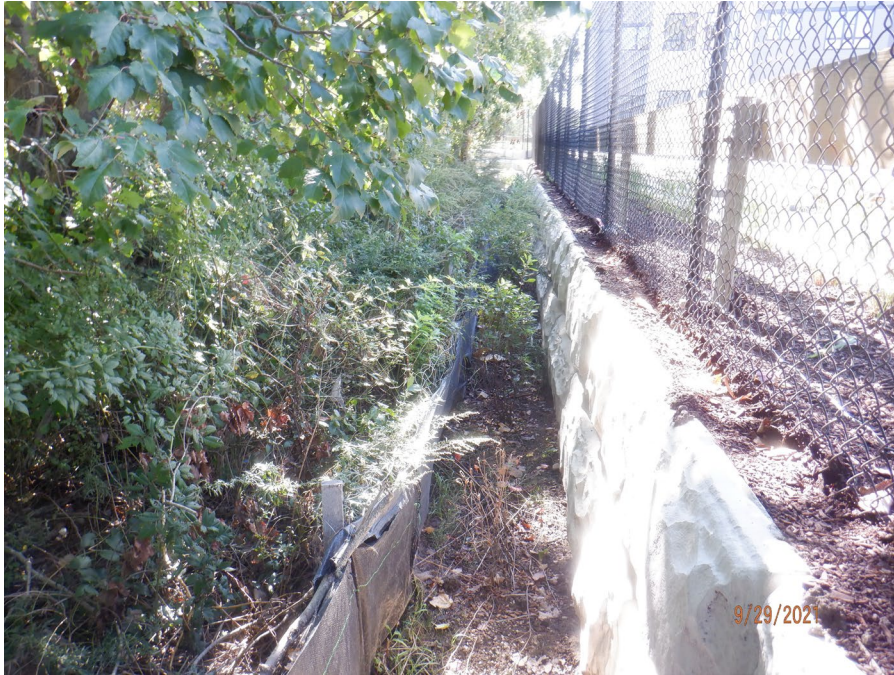
Photograph 9: Typical thin herbaceous cover below retaining wall in general area north of stormwater outlet #3.

- The area between the retaining wall and the wetland near the northeast corner of the site, where herbaceous cover is approximately 40 to 50 percent, likely due to shaded conditions (Photograph 9). This area should be re-seeded/hydroseeded. The erosion control barrier should remain in place at this location until the soil is stabilized.

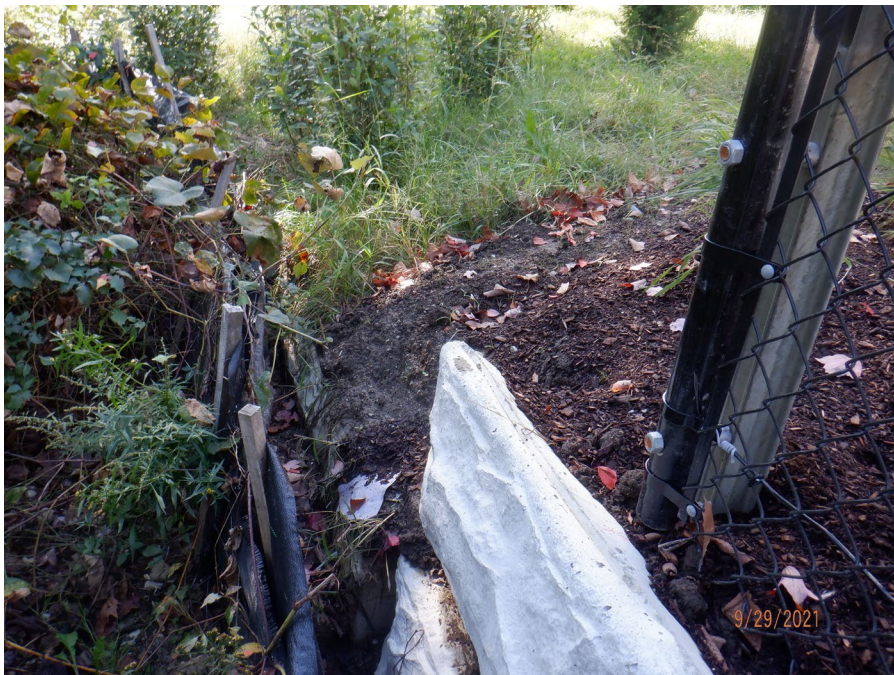
Photograph 10: Small area of bare soil at south end of retaining wall.

- A very small area of bare soil at the southeast corner of the retaining wall (Photograph 10). This area should be stabilized by seeding/hydroseeding or by mulching as in adjacent areas. Soil accumulated along the erosion control barrier should be removed and the barrier should remain in place at this location until the soil is stabilized.

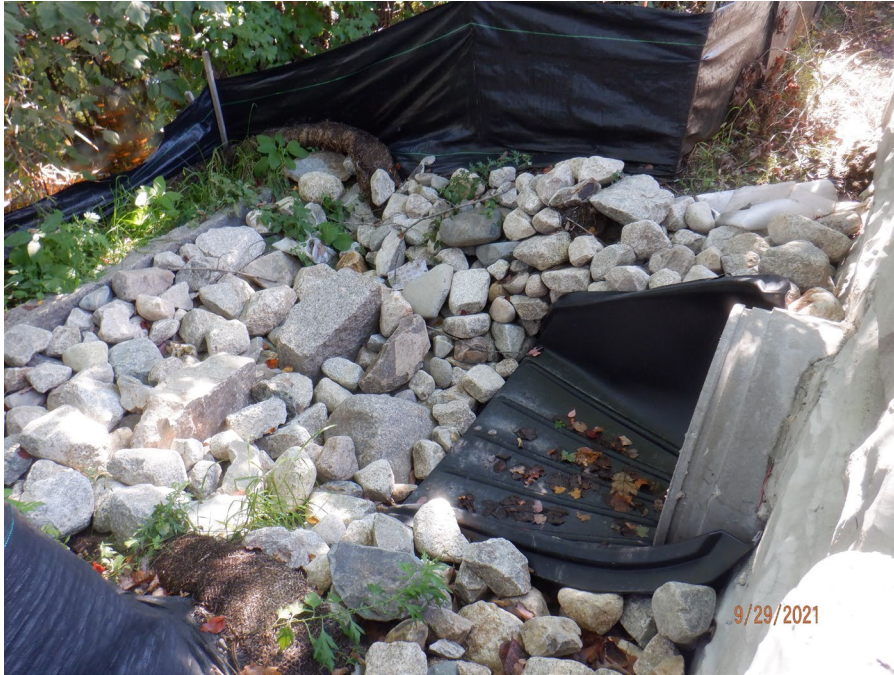
Photograph 11: Stormwater outlet #1 and erosion control barrier.

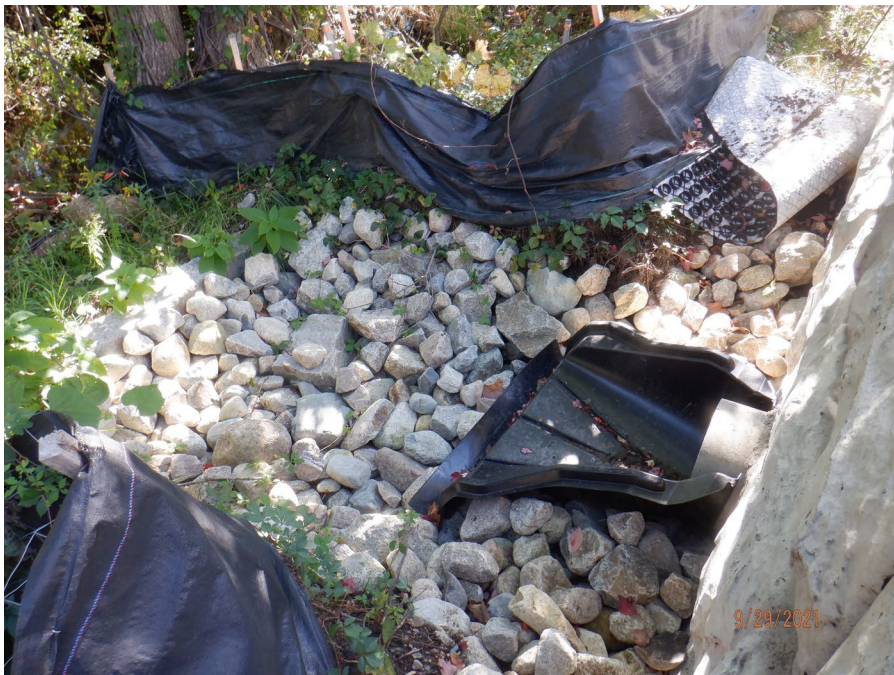
Photograph 12: Stormwater outlet #2, erosion control barrier, and construction debris.

Other than at the locations noted above, it is LE's opinion that the erosion control barriers can be removed at this time. Prior to removal of the erosion control barriers, LE recommends that any remaining construction debris (observed in several locations) be removed from the area along the base of the retaining wall and adjacent wetland.

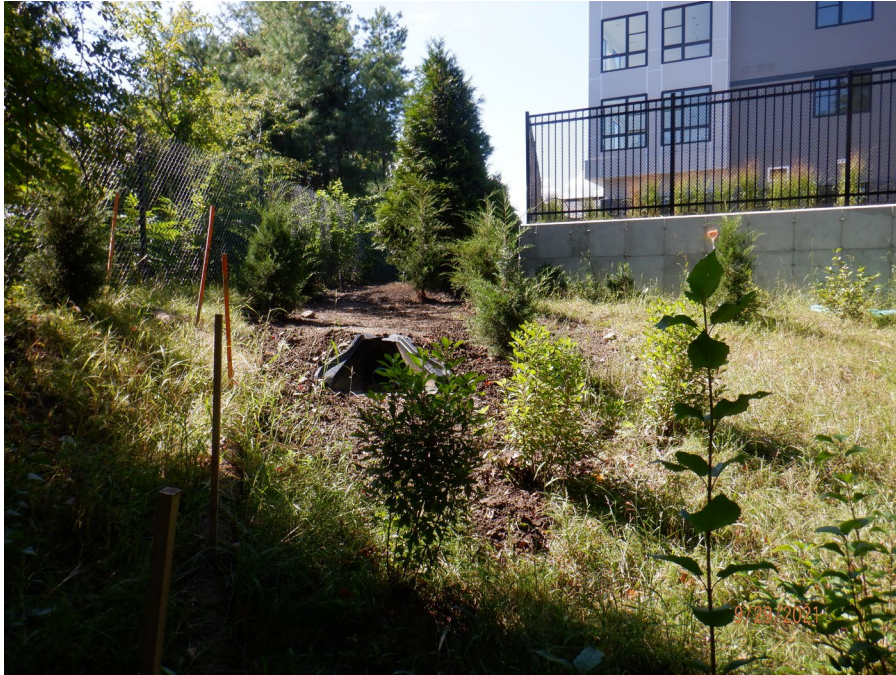
Photograph 13: Area of bare soil in general area between pool and southern property line.

- Between the southern property line and the pool area, a large area of bare soil had not yet been seeded (Photograph 13). This area should be stabilized by seeding/hydroseeding. The erosion control wattle that is located along the toe of the nearby slope could be moved to the edge of the disturbed soil around this area if it is movable. If it is not, a new wattle should be placed along the edge of disturbed soil at this location. An erosion control barrier should remain in place at this location until soils are stabilized.
