**INTERIM REPORT
FOR RESTORATION OF THE WEST COVE
OF WHITMAN'S POND
1999-2000**

WEYMOUTH, MASSACHUSETTS

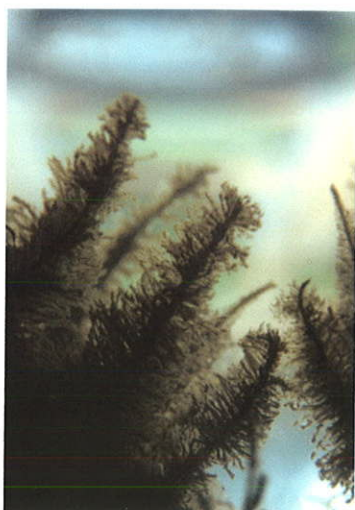
Aquatic Weed.

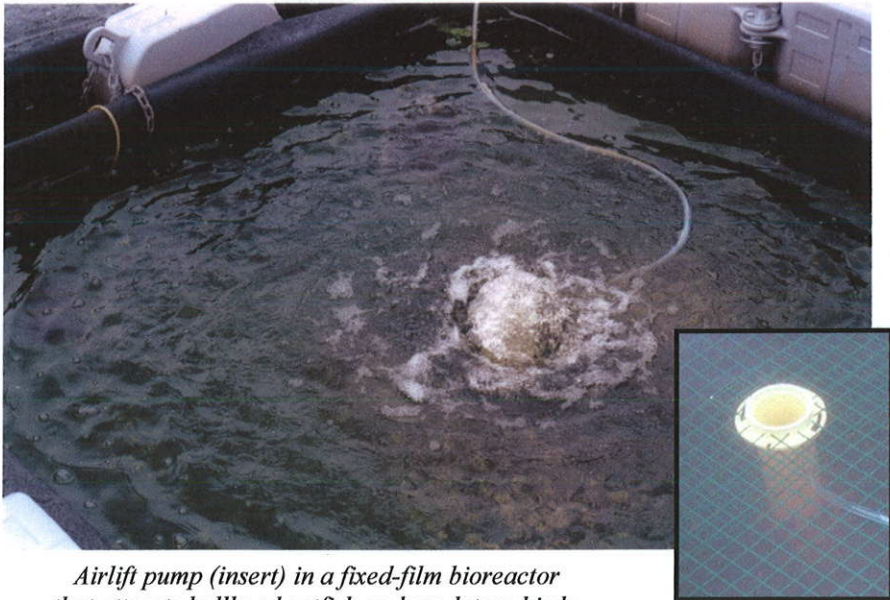
Airlift pump (insert) in a fixed-film bioreactor that attracts bullhead catfish and predatory birds

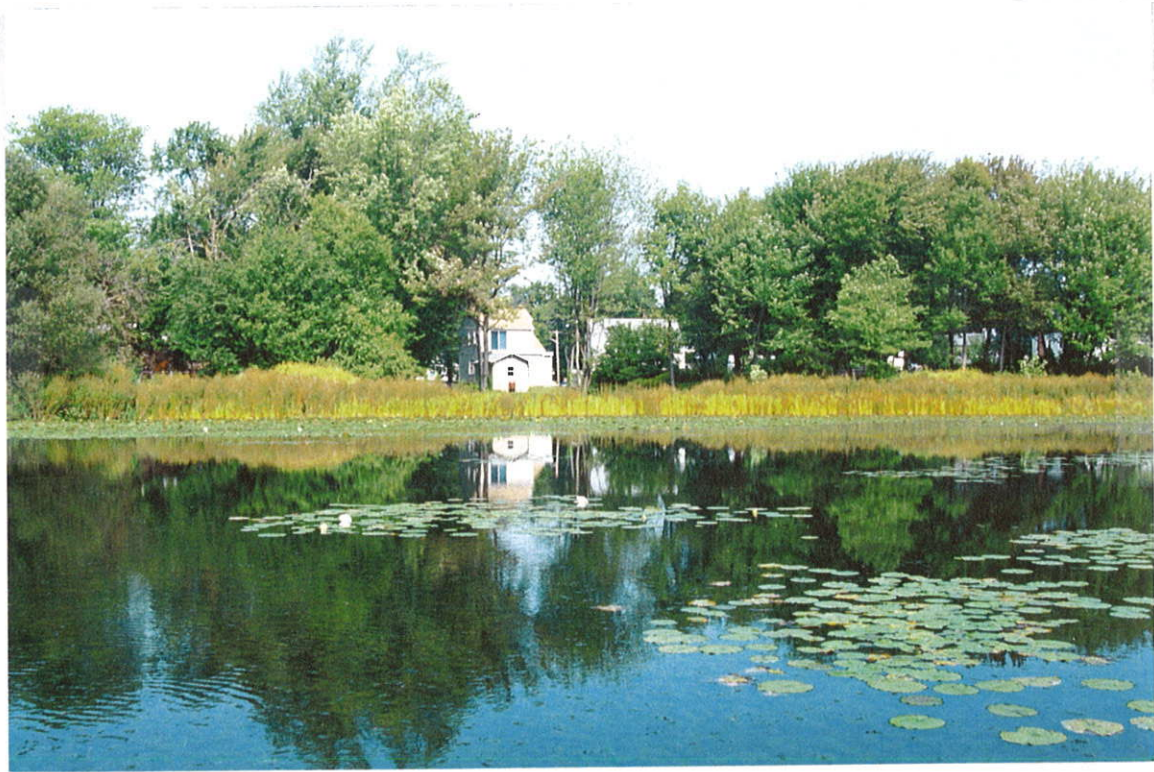
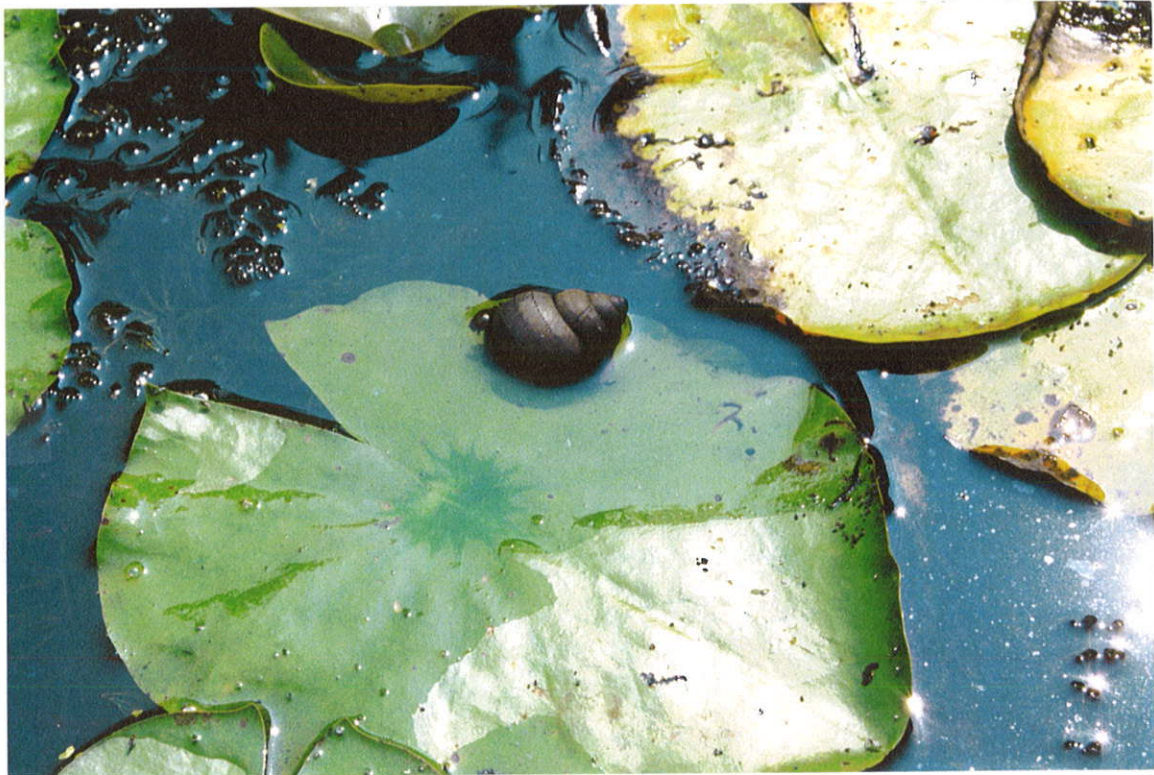
Despite heavy growth of nuisance aquatic plant species, the pond still supports the microbial life required for the Restorer to digest the sediments and clean the water. Above a large snail suns itself on a lily pad during Ocean Arks' recent sampling inspection.

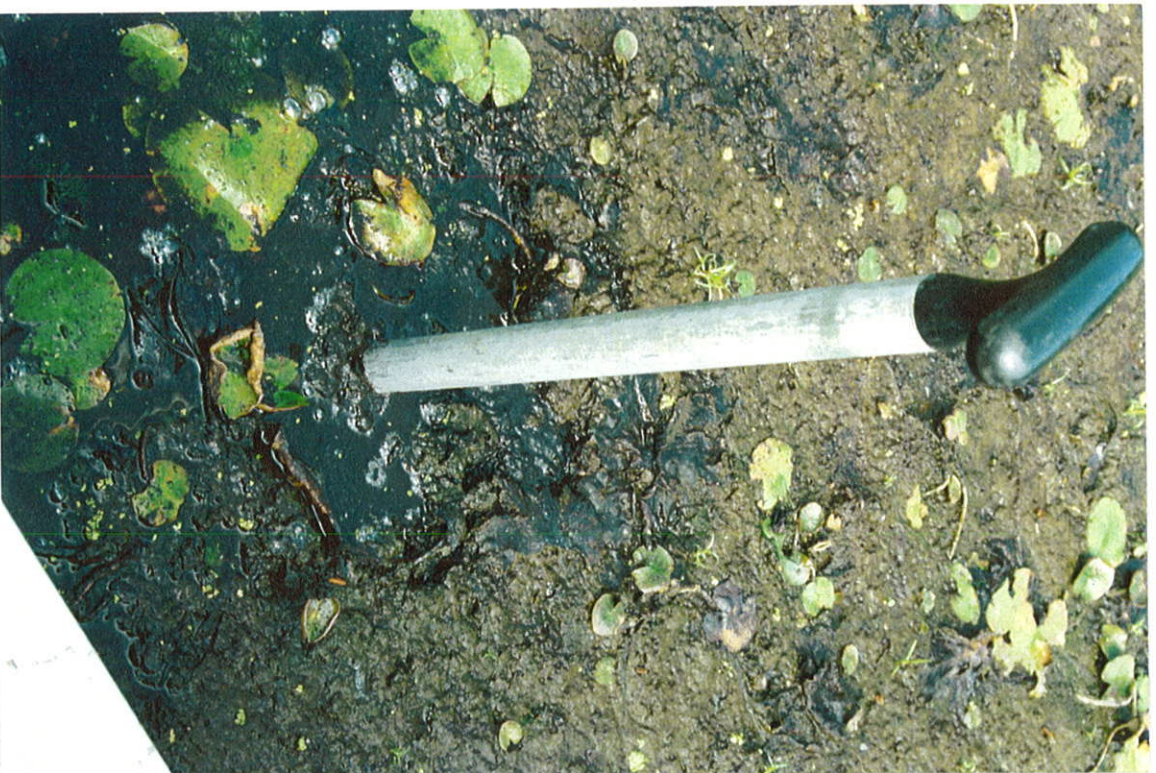
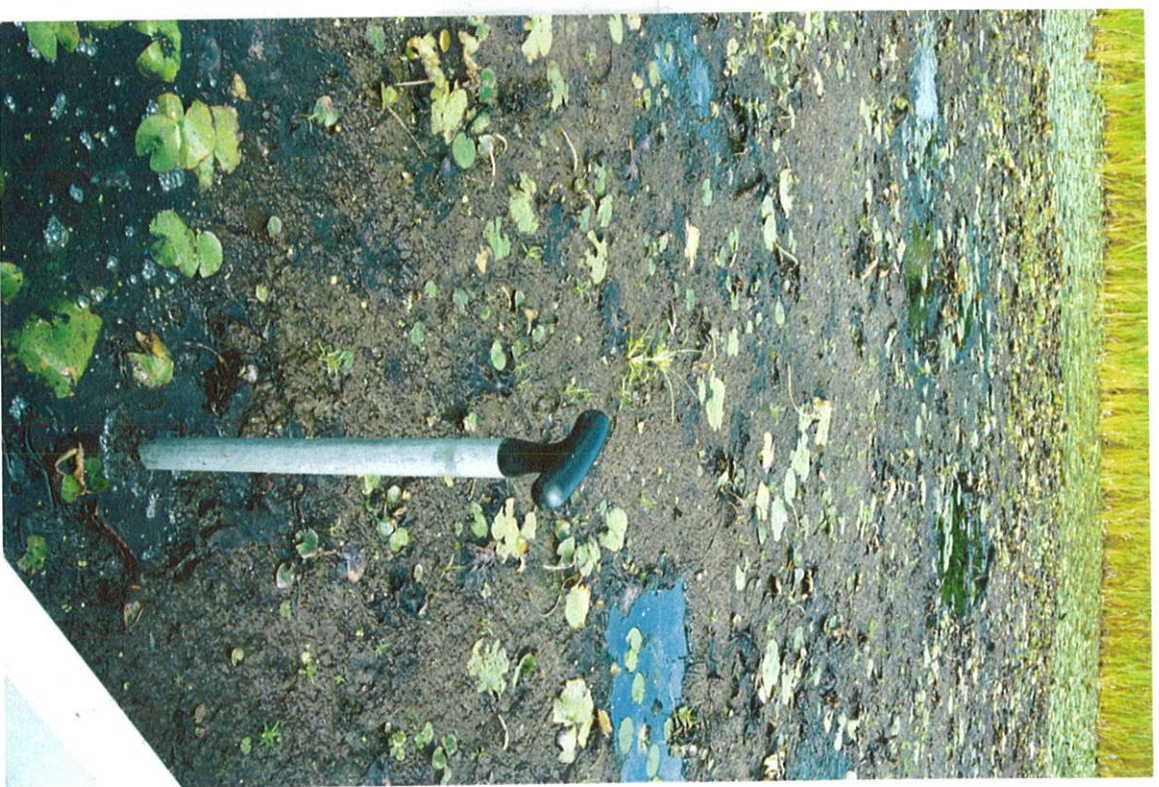
Floating sludge clogs the water column at the northern end of the West Cove. With a texture of chocolate mayonnaise on a hot day, these late summer mats of “bio-solids” are a primary target of the Restorer. Due to the shallow depths and hydrodynamics of the pond, elimination via bio-digestion will probably occur in the summer of 2001.
