Risk Assessment Study for Battery Energy Storage System at Fore River Energy Center

Calpine Corporation and Weymouth Fire Department

October 21, 2021

**Risk Assessment Study for
Battery Energy Storage System at
Fore River Energy Center
North Weymouth, MA**

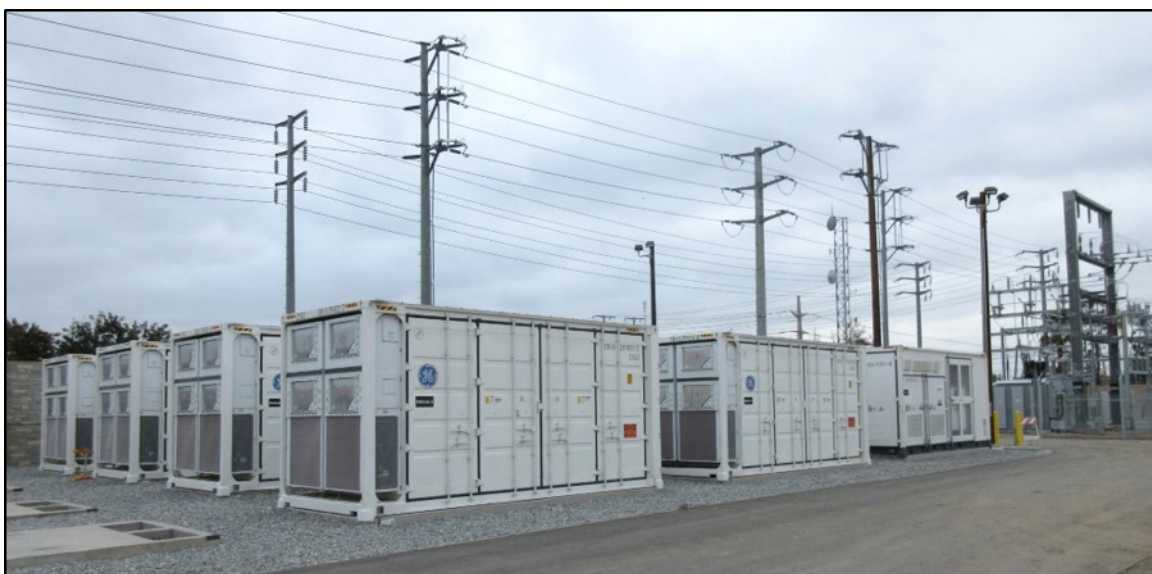
Exhibit 4 **Johanna Energy Center in Santa Ana, California**

technology. The system, now in commercial operation, is supported by a 20-year Resource Adequacy Power Purchase Agreement. The JEC project will be able to provide energy to up to 12,000 households during peak events, and/or 24,000 households during normal load conditions. **Exhibit 4** shows the JEC project in the SASP.

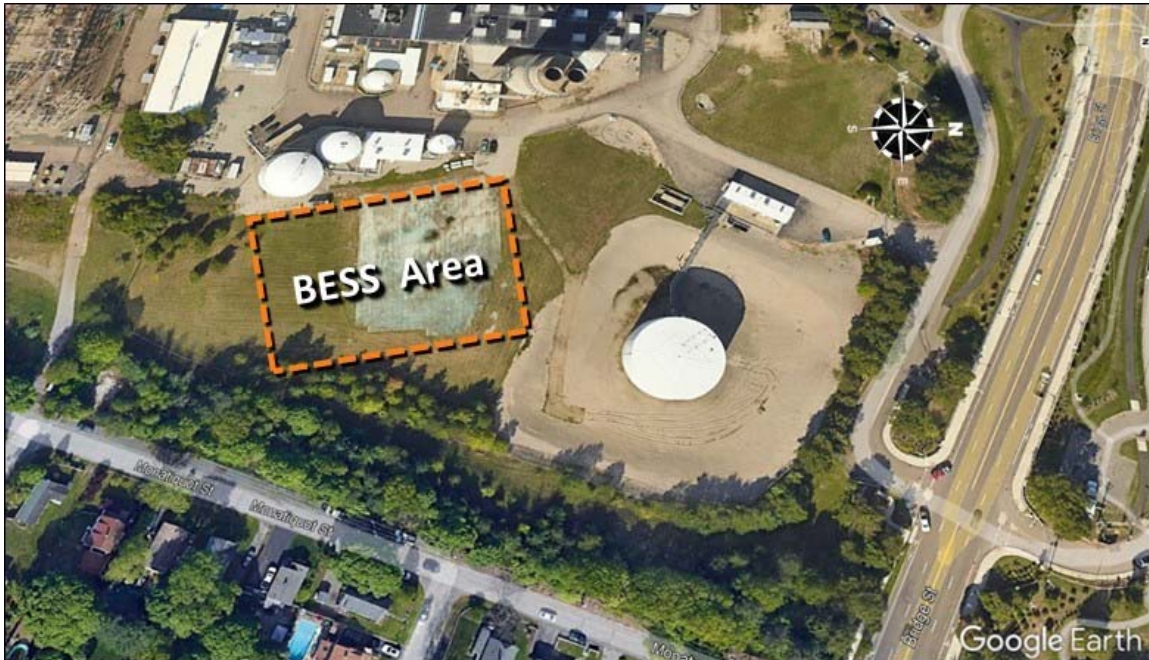
Exhibit 6 Aerial View of Proposed Area for BESS Facility

On October 8, 2021, the Lummus Consultants representative, Mr. John Senner and Mr. Jay Peterson, participated in a site visit at FREC. During the site visit, Mr. Senner and Mr. Peterson met with WFD Deputy Chief Justin Myers and Mr. Charlie Parnell, the FREC General Plant Manager. A general tour of the site included the proposed BESS area. Following that briefing, Mr. Peterson requested copies of selected documents for further review. **Exhibit 6** shows the proposed area for the BESS containers.

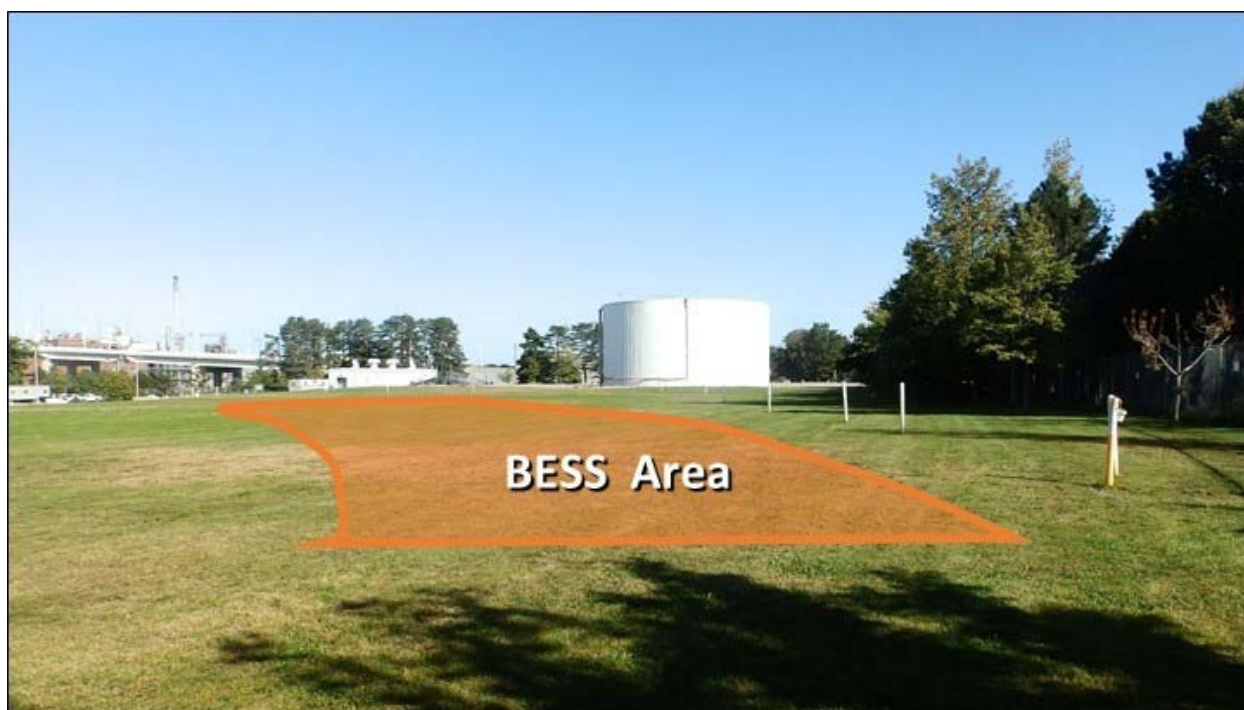
Exhibit 9 Proposed BESS Area at FREC

Lummus Consultants expects the low profile of the new BESS equipment will not impose any additional adverse visual impact on the community.

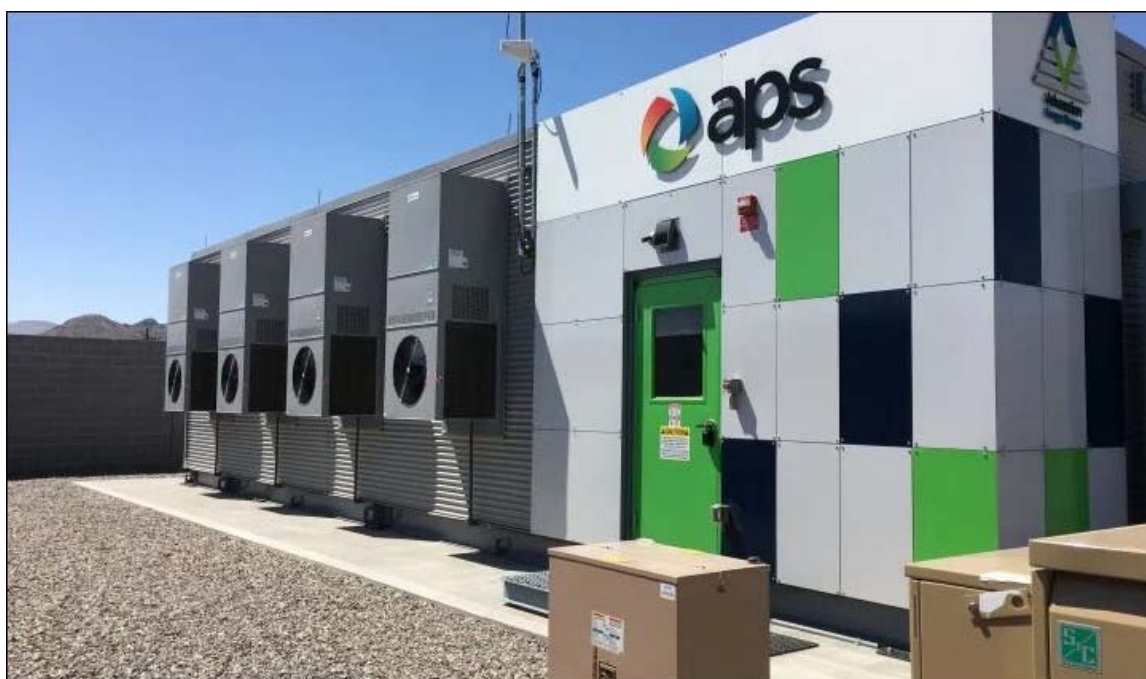
Exhibit 11 Arizona Public Service — McMicken BESS Facility

The facility was put into service in March 2017 and was equipped with an HVAC system to control the temperature in the BESS container and an automatic fire suppression system using a gaseous suppression agent (Novec 1230). **Exhibit 11** shows the McMicken BESS Facility.

Several cell thermal runaways occurred within one rack. The cause of the thermal runaway event is disputed with one study assigning the root cause to an internal short circuit due to abnormal dendritic growth within a single cell. A separate study conducted for the battery manufacturer concluded the initial thermal runaways were caused by external arcing near the cells.

Although the cause of the initial thermal runaway is in dispute, there is no dispute about the cause of the explosion. The investigation verified that the Novec 1230 suppression agent had discharged as designed, but the system was inherently unable to curtail the progression of cell thermal runaways in the rack.

The Novec 1230 design concentration of 10 v% should have been sufficient to prevent ignition of the flammable gas generated from the initial cell runaways, but the agent concentration decreased as leakage occurred. In fact, the room integrity tests conducted upon commissioning of the Novec 1230 system indicated that the leakage rate was too large to retain the design concentration for 10 min, as required by NFPA 2001, 2015.

When the APS BESS door was opened, a significant amount of Novec 1230 and other gases flowed out and were replaced with air. The resulting decreased residual Novec 1230 concentration and suddenly increased oxygen concentration, combined with runaway generated gases, formed a flammable mixture in a portion of the enclosure. The UL investigation report states that the flammable mixture producing the deflagration was ignited either by the still hot battery surfaces, by arcing, or by molten material generated and ejected in ongoing thermal runaways.

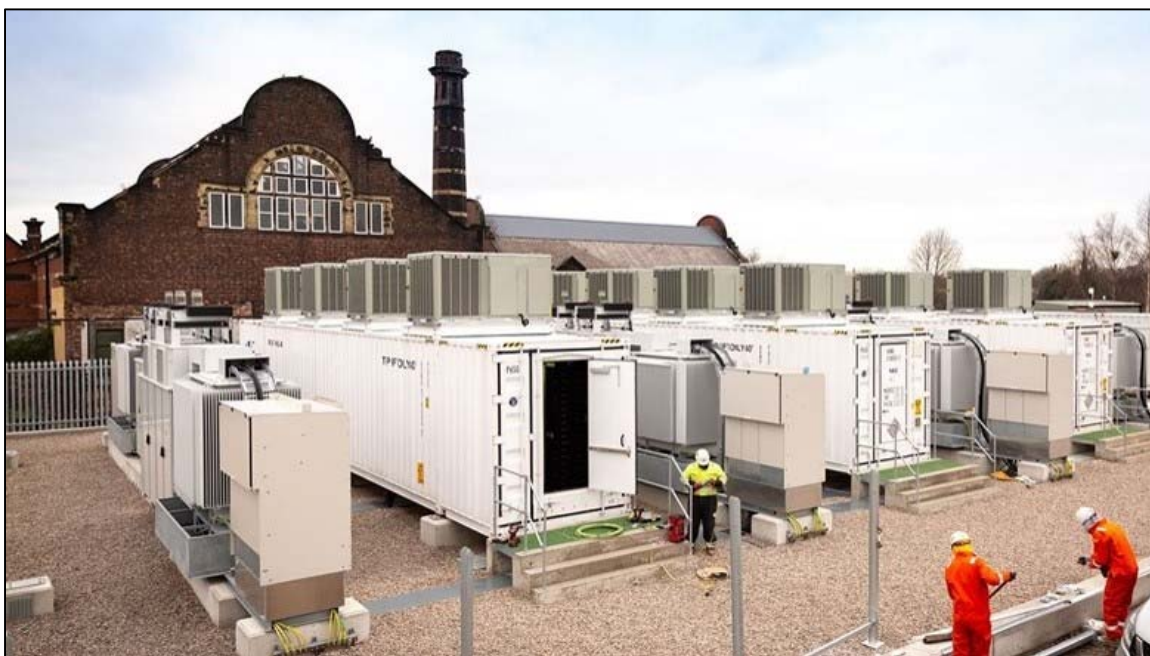
Exhibit 12 ØRSTED Carnegie Road BESS in Liverpool, England

Danish power company, Ørsted, installed a 20 MW Li-ion BESS facility at Carnegie Road Station in Liverpool, England that went commercial in early 2019. The BESS shown in **Exhibit 12** consisted of three battery containers, as well as the associated PCS, all supplied by NEC.

In September 2020, a fire occurred at this BESS facility. The fire occurred in one of the battery containers on September 15, 2020. The local fire department responded at 1 a.m. and used water sprays to tackle the fire, asking residents nearby to keep their windows and doors closed due to smoke from the incident. The blaze went on for several hours. It was noted that by 7:30 a.m. the fire response at the site had been scaled down. A further update at 11:45 a.m. stated one fire engine was still at the scene, with firefighting still continuing, although by that stage only one hand-held pump was in use. News articles indicated that the incident was being investigated, but no root cause report has been issued to our knowledge.

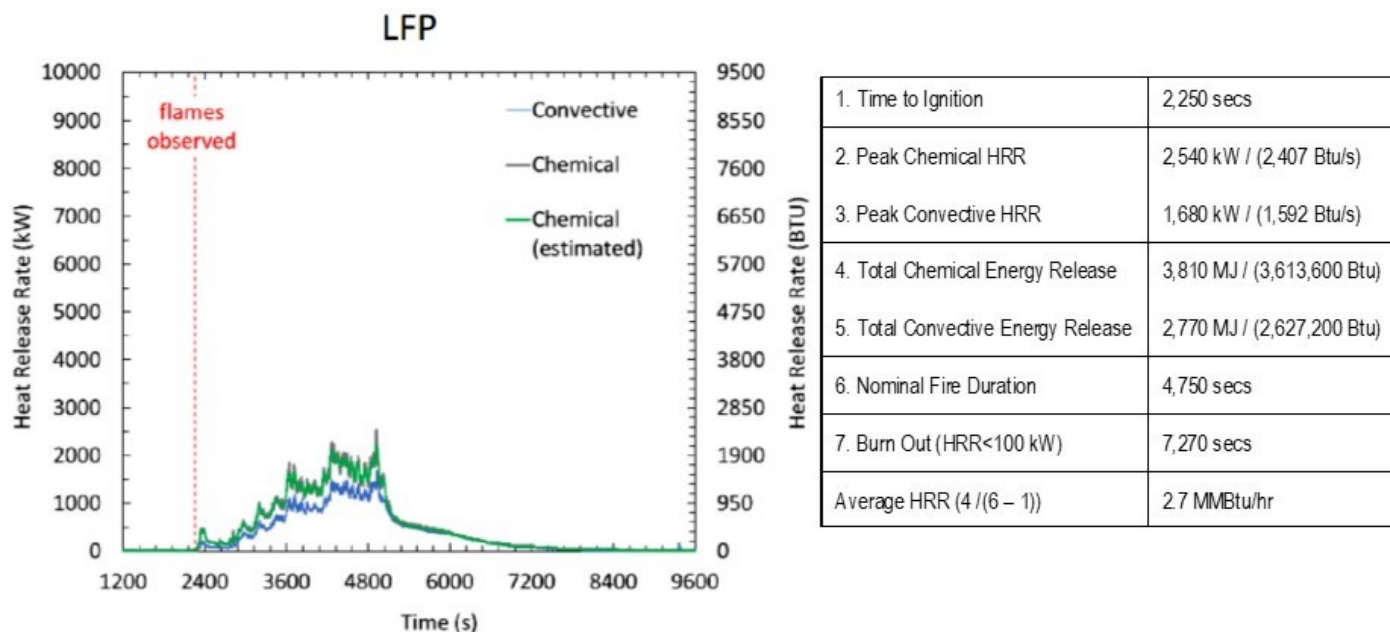
Exhibit 13 LFP Heat Release Rate Diagram

The LFP modules burned at between 400 to 600 °C until the fire self-extinguished. **Exhibit 13** shows the LFP heat release rate diagram along with key test results. The total chemical energy released over the fire duration was approximately 2.7 MMBtu/hr for an 83 kWh rack of LFP modules. This is equivalent to 32.5 Btu/Wh (34.3 kJ/Wh) of battery capacity.

Two different Li-ion battery chemistries were tested – Lithium Iron Phosphate (LFP) and Lithium Nickel Oxide/Lithium Manganese Oxide (LNO/LMO). The large-scale free burn tests were conducted with the LFP and LNO/LMO equipment to evaluate the overall fire hazard and performance of sprinkler protection. The two large-scale free burn tests were conducted with full ESS racks located in an indoor open-air environment under a 20-MW fire products collector. This approach allowed for real-time measurement of the chemical and convective heat release rate from the fire and magnitude of radiant exposure to surrounding objects, which was used to compare the relative hazard of the LFP and LNO/LMO systems.

The free burns were conducted on a full rack of each type of battery. The LFP rack had an energy capacity of 83 kWh and included 16 modules, each with 78 batteries. The LNO/LMO rack had an energy capacity of 125 kWh and included 16 modules, each with 64 batteries.

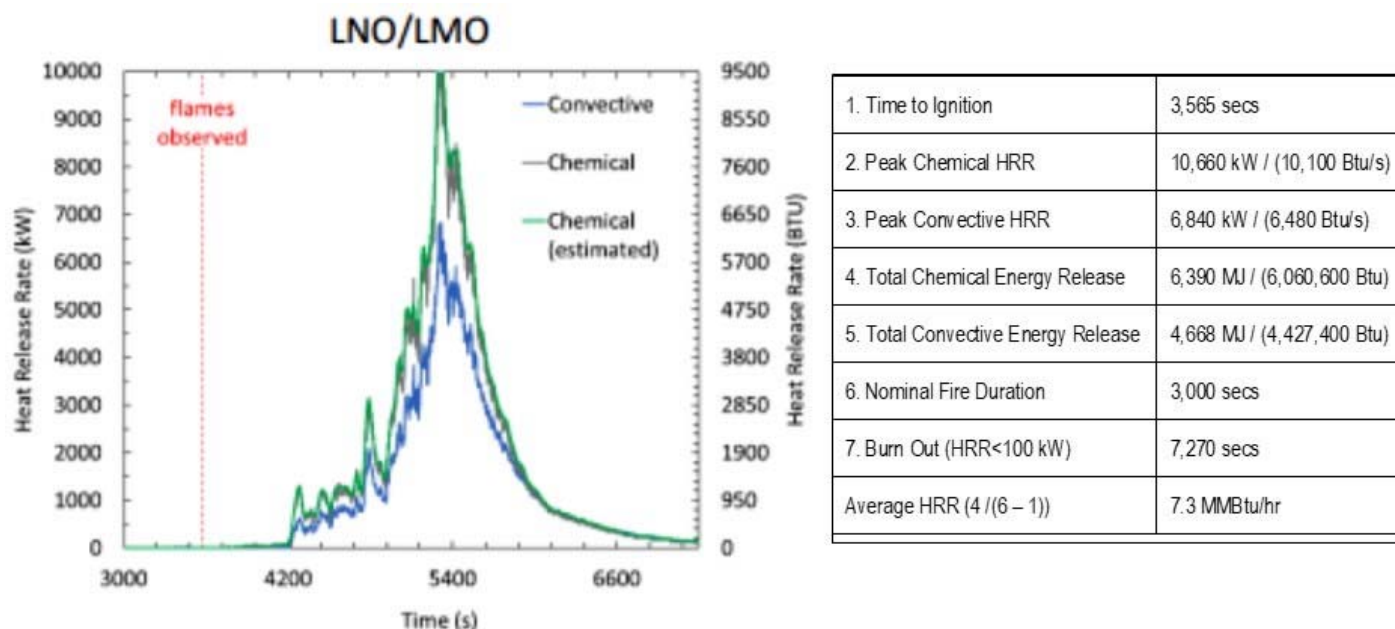
Exhibit 14 LNO/LMO Heat Release Rate Diagram

Initially, the LNO/LMO modules followed a similar heat release as the LFP modules but at around 5,000 seconds into the free burn, the heat release and temperature spiked up with the combustion temperature then rapidly increased to over 1,000 °C. **Exhibit 14** shows the LNO/LMO heat release rate diagram along with key test results. The total chemical energy released over the fire duration was approximately 7.3 MMBtu/hr for a 125 kWh rack of LNO/LMO modules. This is equivalent to 58.4 Btu/Wh (61.6 kJ/Wh) of battery capacity.

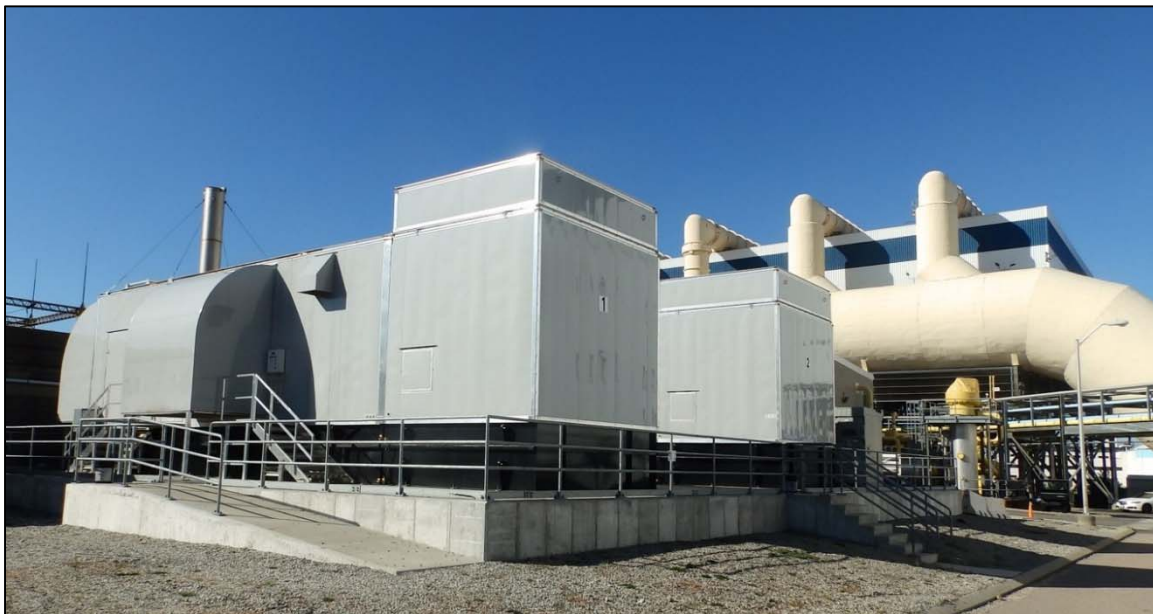
Exhibit 19 **FREC Black Start Diesel Generators**

Lummus Consultants reviewed a recent noise study related to the addition of new equipment at FREC. The noise study prepared by Hessler Associates, Inc. dated July 28, 2017 evaluated the potential community noise impact associated with the installation of two black start diesel generator packages at FREC, shown in **Exhibit 19**. As part of this noise study, ambient noise levels were measured over a one-week period from July 22 to 29, 2017 at a location near the boundary with the residential area on Monatiquot Street. FREC went into an outage on July 28, 2017 allowing the measurement of sound levels both with and without FREC in operation. There was no meaningful difference in the sound levels measured during the outage period and prior to the outage when FREC was operating at full or partial load.
