Town of Weymouth, Massachusetts

**Whitman's Pond
Comprehensive Investigation, Evaluation,
And Hydrological Study**

February 2004

B E T A **BETA Group, Inc.**
Engineers • Scientists • Planners
315 Norwood Park South, Norwood, MA 02062 781.255.1982 fax: 781.255.1974
6 Blackstone Valley Place, Lincoln, RI 02865 401.333.2382 fax: 401.333.9225
email: BETA@BETA-eng.com

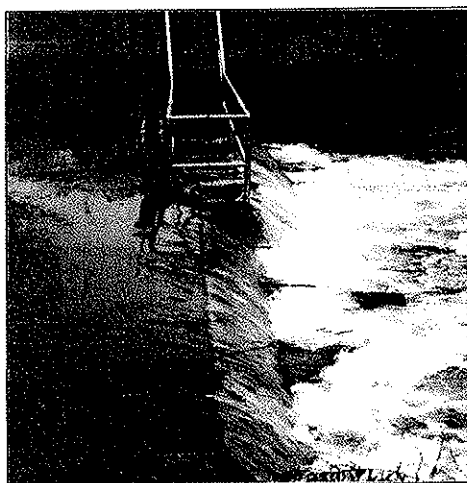
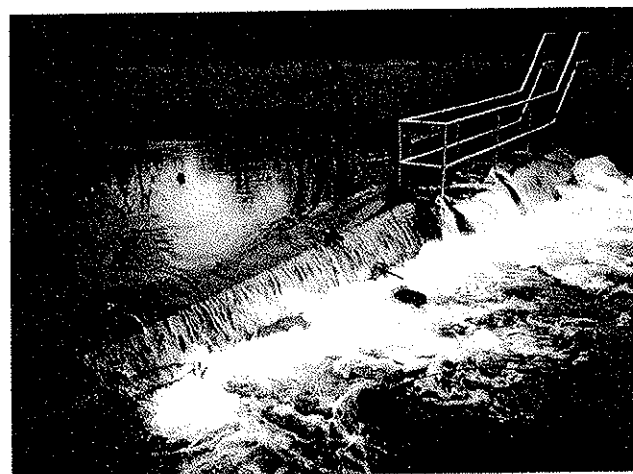
Figure 5: Storm Flows Over-top Control Structure When Sluice Gate is Not Opened

Original engineering plans for the SNUP were rejected by the U.S. Environmental Protection Agency (EPA) on the basis that too much existing natural wetland area would be disturbed. The SNUP was redesigned, and the final construction of the SNUP was allegedly only one half the size of the original. According to the designers, this significantly reduced the efficiency of the SNUP, however, there is little documentation as to the effectiveness of the SNUP since its construction. Upon review of the construction plans, however, the effective area of the constructed SNUP is similar to the area of the original design, as detailed below.

Recommended improvements to the design, operation and maintenance of the SNUP are discussed in Section 7 of this report. These improvements will improve the efficiency and reduce the maintenance needs for the SNUP.

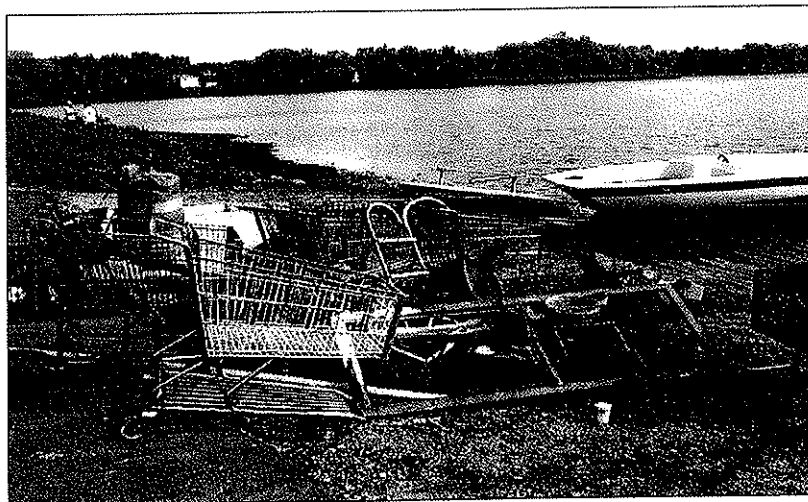
Each year, the Whitman's Pond Association, volunteers, and DPW staff engage in a cleanup effort to clean the shores and remove debris from sections of the Pond. Vegetation, muck and debris, such as shopping carts, automobiles and an occasional boat are removed and hauled away for disposal. Literally tons of debris are collected annually by these individuals. In 2003, the cleanup day was held on September 13th. The picture below shows some of the debris removed this year.

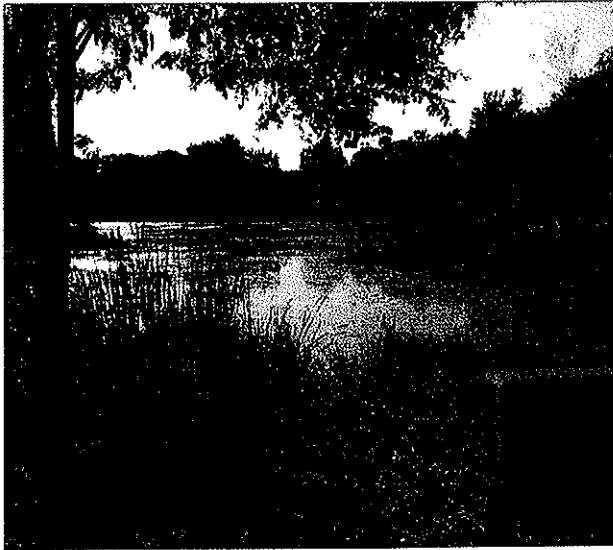
West Cove Prior to Hydro-raking/Fluridone West Cove After Hydro-Raking/Fluridone

BETA feels that the most effective mechanical management tools for Whitman's Pond are weed harvesting and hydro-raking. Physical management of invasive aquatic species ranks high with respect to environmental benefit, value to the Whitman's Pond watershed, and public support. However, project costs to the Town are a somewhat of a factor, since annual appropriations are needed.

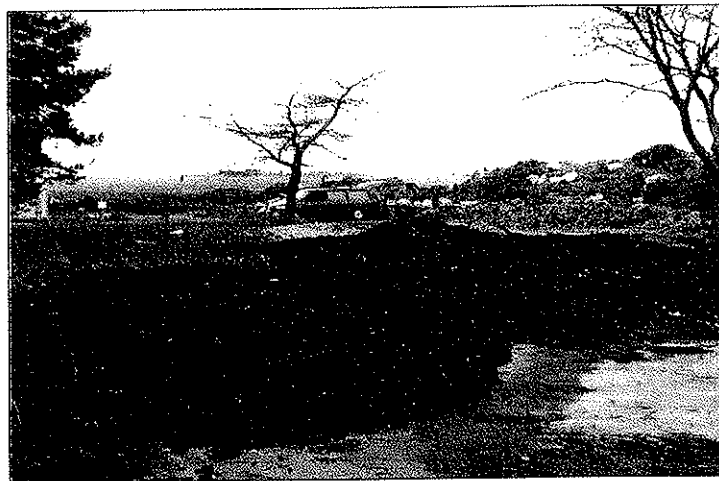
Some of the Material Removed During Hydro-Raking West Cove
