COASTAL engineering co. 260 Cranberry Hwy, Orleans, MA 02653 508.255.6511 P 508.255.6700 F		BY
		REVISION
		DATE
		NO.
PROJECT	TOWN OF WEYMOUTH	WEYMOUTH, MA
	WESSAGUSETT ROAD, REGATTA ROAD AND RIVER STREET	
SHEET TITLE	EXISTING CONDITIONS -	
	SITE ASSESSMENT	
SCALE AS NOTED		
DRAWING FILE C18729-NOI 05-2017.dwg		
DATE 06-09-17		
DRAWN BY BED		
CHECKED BY KZ		
C3.1.1		
1 OF 2 SHEETS		
PROJECT NO. C18729.00

PROJECT	TOWN OF WEYMOUTH	WEYMOUTH, MA
	REGATTA ROAD	
	SHEET TITLE	
	EXISTING CONDITIONS -	
	VEGETATION ASSESSMENT

EXISTING CONDITIONS - VEGETATION ASSESSMENT

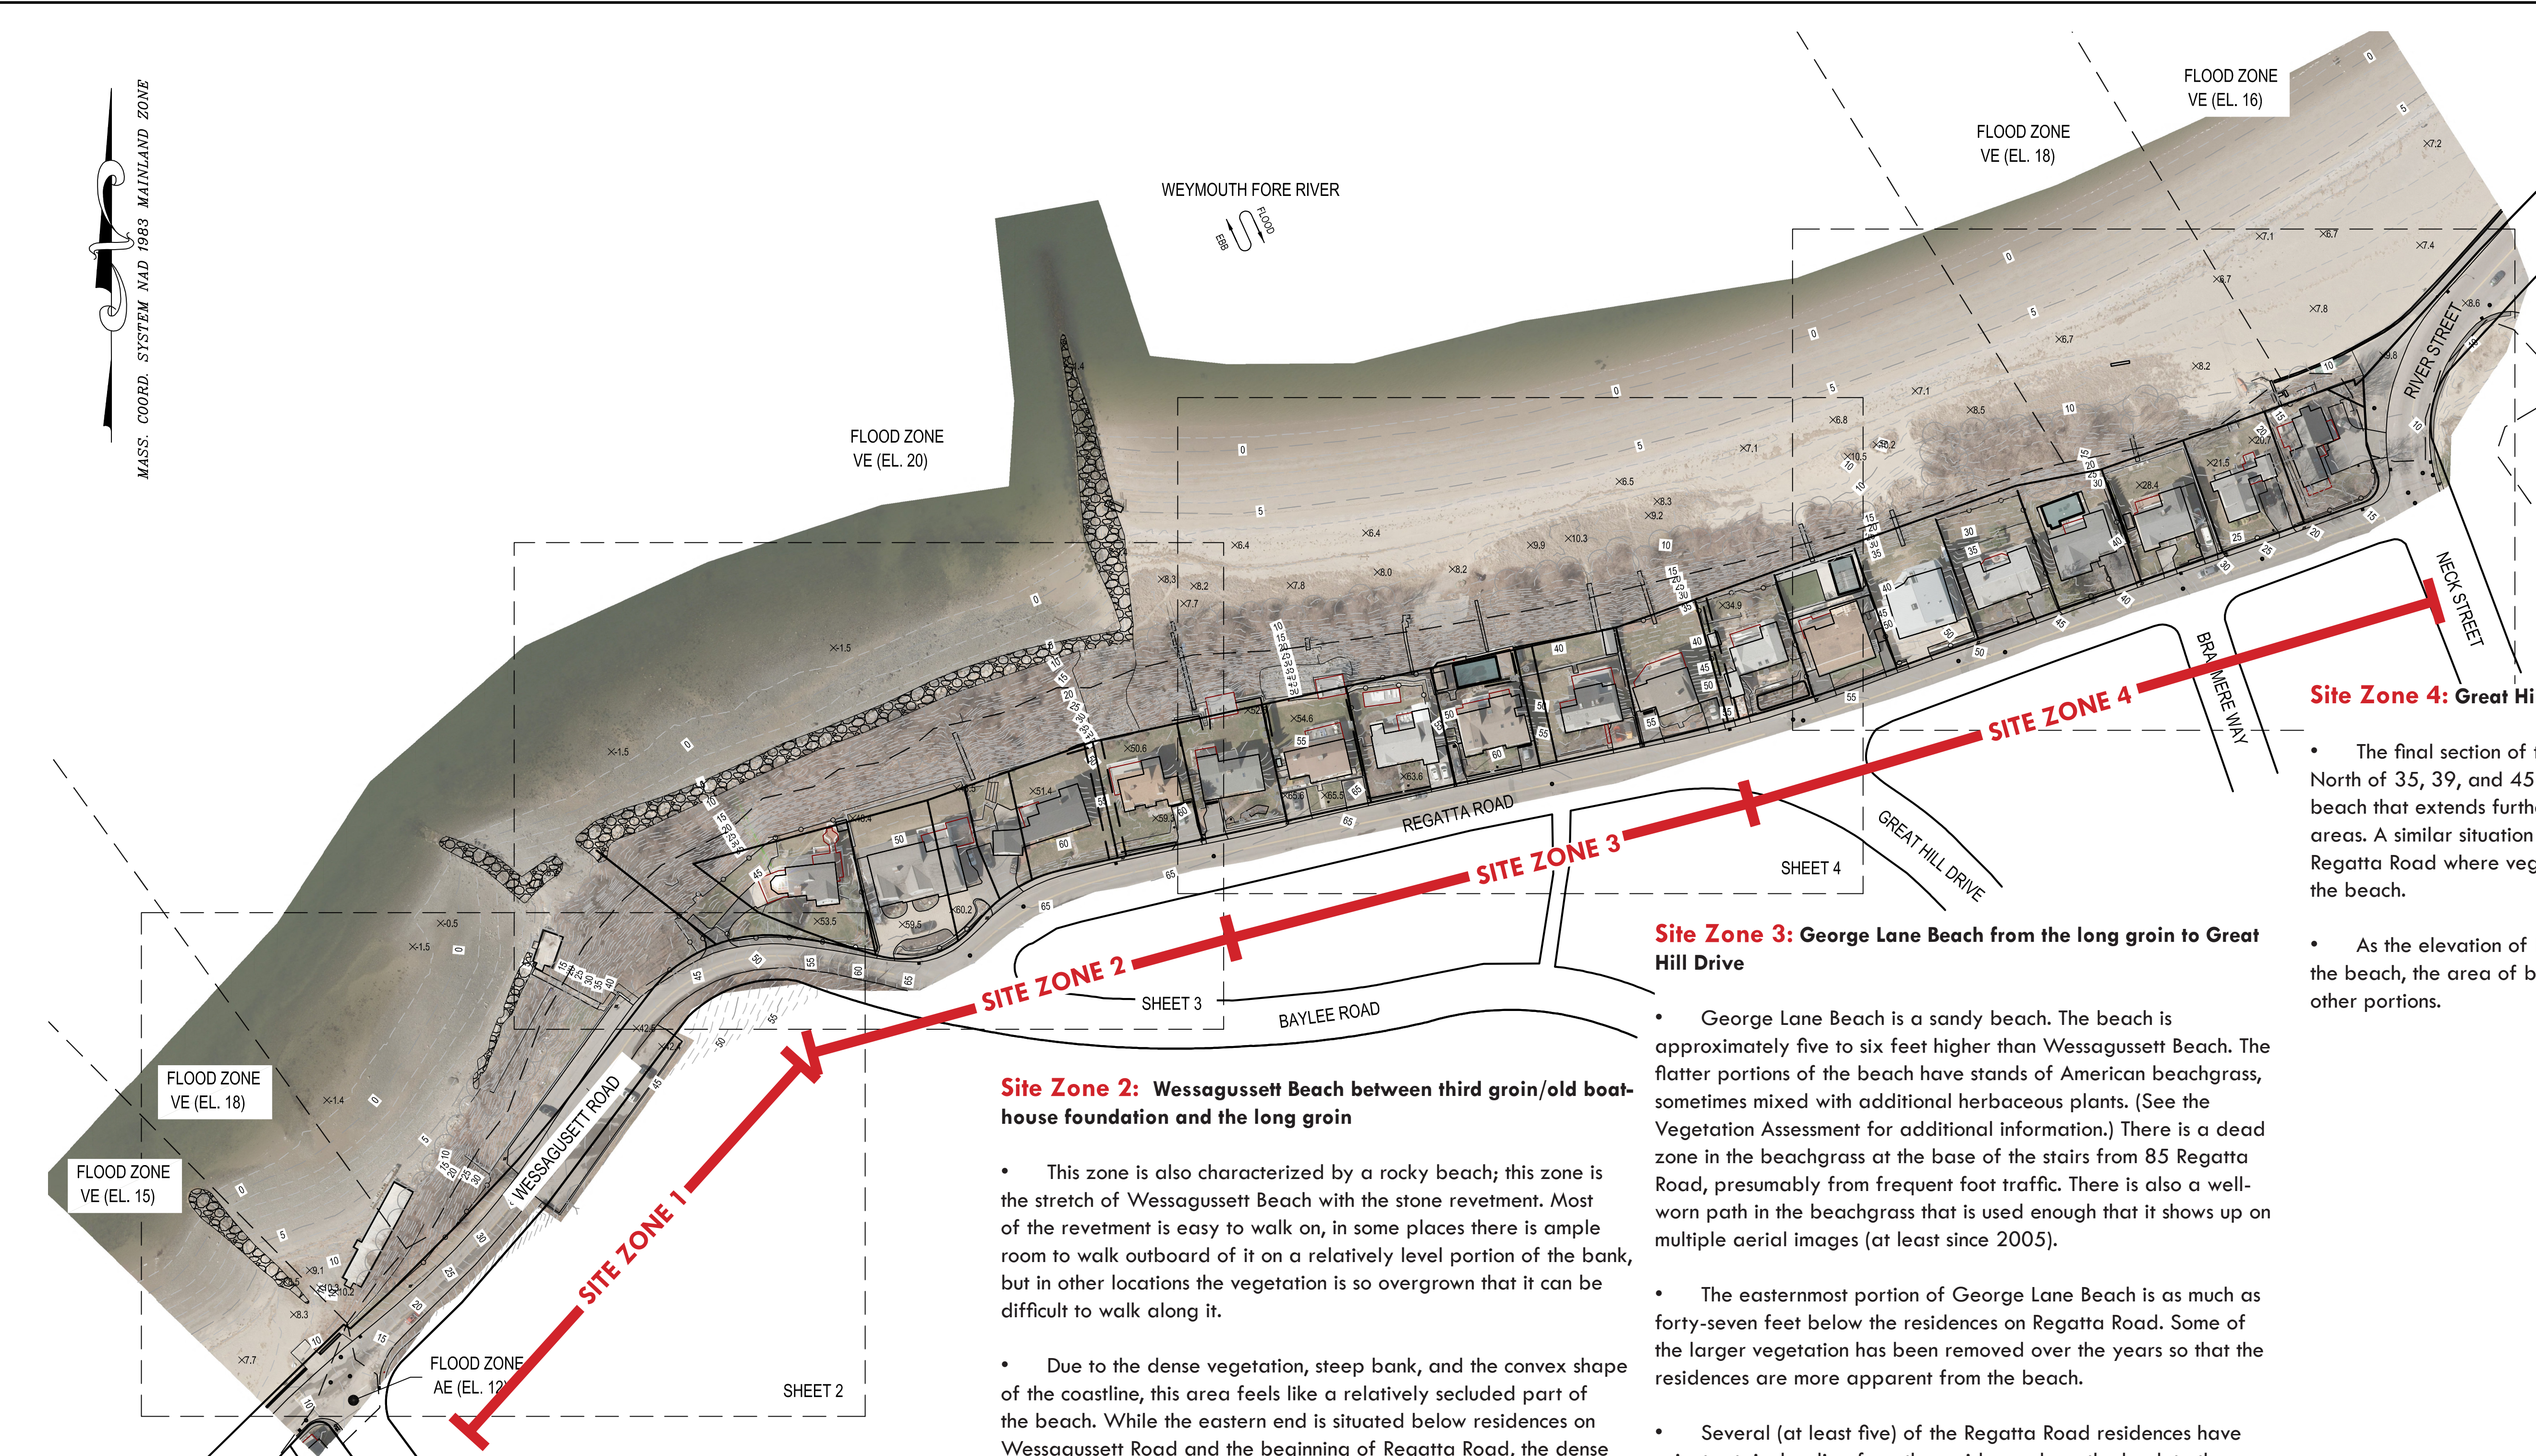
- The zone is characterized by rocky beach with two concrete platforms from the old bath and boat houses. The foundation for the old bathhouse (closer to North Street) appears to be in stable condition and could be used as part of the walkway, location for seating, signage, and/or other site amenities.

- The site is accessed either by sidewalk along Wessagussett Road or from the parking area that straddles Wessagussett Road. The parking area is approximately thirty-seven feet above the mean high-water elevation. No sidewalk connects the parking to the beach, though it is outside of the scope of this project, it should be considered by the Town.

- From the northeast corner of the parking is a concrete stairway which connects to the beach and the old boathouse (now just a concrete foundation). The stairs are in very poor condition and should not be used. The foundation for the old boat house is also in poor condition with significant undermining from wave action. Each site visit reveals more of the concrete blocks detached from the foundation and moved or thrown on to the beach. There is also a significant amount of graffiti, beer bottles, and other debris in the area.

- There is potential to locate an accessible parking space near the North Street intersection. This could provide an accessible route onto the beach and to the beach connection. A boat ramp is in the area however, usage rates are uncertain.

- This zone is also characterized by a rocky beach; this zone is the stretch of Wessagussett Beach with the stone revetment. Most of the revetment is easy to walk on, in some places there is ample room to walk outboard of it on a relatively level portion of the bank, but in other locations the vegetation is so overgrown that it can be difficult to walk along it.

- Due to the dense vegetation, steep bank, and the convex shape of the coastline, this area feels like a relatively secluded part of the beach. While the eastern end is situated below residences on Wessagussett Road and the beginning of Regatta Road, the dense vegetation screens at least the first few residences from the view of the beach.

- There is a fifteen-foot wide drainage easement located between 91 and 97 Regatta Road. A catch basin is located at this easement on Regatta Road, and a 12" diameter PVC pipe outlets the drain. The drain appears to have vegetative debris clogging the outflow; no evidence of outwash was present on the beach. North of this, on the beach side, is a large riprap area which appears that it may have been planted after installation, given the selection of planting materials that are present. (See the Vegetation Assessment for additional information.)

- If a lookout or fishing area is considered as part of the project, the long groin is the logical location. The groin is easy to walk on, for able-bodied people, and extends more than 250 feet, depending on the tide. It is also the clear transition between the two beaches and makes the change in elevation between the two.

- Between 57 and 67 Regatta road is a fifteen-foot town-owned parcel which extends from the road to the beach; this parcel has not been developed by the Town. Two houses to the east, there is another drainage easement (ten-feet wide) on the western end of the 45 Regatta Road parcel. The easement connects a catch basin in Regatta Road. No outlet is visible in the landscape.

- The easternmost portion of George Lane Beach is as much as forty-seven feet below the residences on Regatta Road. Some of the larger vegetation has been removed over the years so that the residences are more apparent from the beach.
- Several (at least five) of the Regatta Road residences have private stairs leading from the residence down the bank to the beach. The stairs appear to be in various states of use and (dis) repair.

- George Lane Beach is a sandy beach. The beach is approximately five to six feet higher than Wessagussett Beach. The flatter portions of the beach have stands of American beachgrass, sometimes mixed with additional herbaceous plants. (See the Vegetation Assessment for additional information.) There is a dead zone in the beachgrass at the base of the stairs from 85 Regatta Road, presumably from frequent foot traffic. There is also a well-worn path in the beachgrass that is used enough that it shows up on multiple aerial images (at least since 2005).

- As the elevation of Regatta Road drops and River Street meets the beach, the area of beach is much more open, less secluded than other portions.

- The final section of the project is the sandiest stretch of beach. North of 35, 39, and 45 Regatta Road there is a stretch of sandy beach that extends further south, towards the bank, than in other areas. A similar situation exists north of 446 Neck Street and 9 Regatta Road where vegetation is sparse between the residence and the beach.

Site Zone 1: Wessagussett Beach along Wessagussett Road between North Street and the third groin/old boathouse foundation

Site Zone 2: Wessagussett Beach between third groin/old boat-house foundation and the long groin

Site Zone 3: George Lane Beach from the long groin to Great Hill Drive

Site Zone 4: Great Hill Drive to River Street

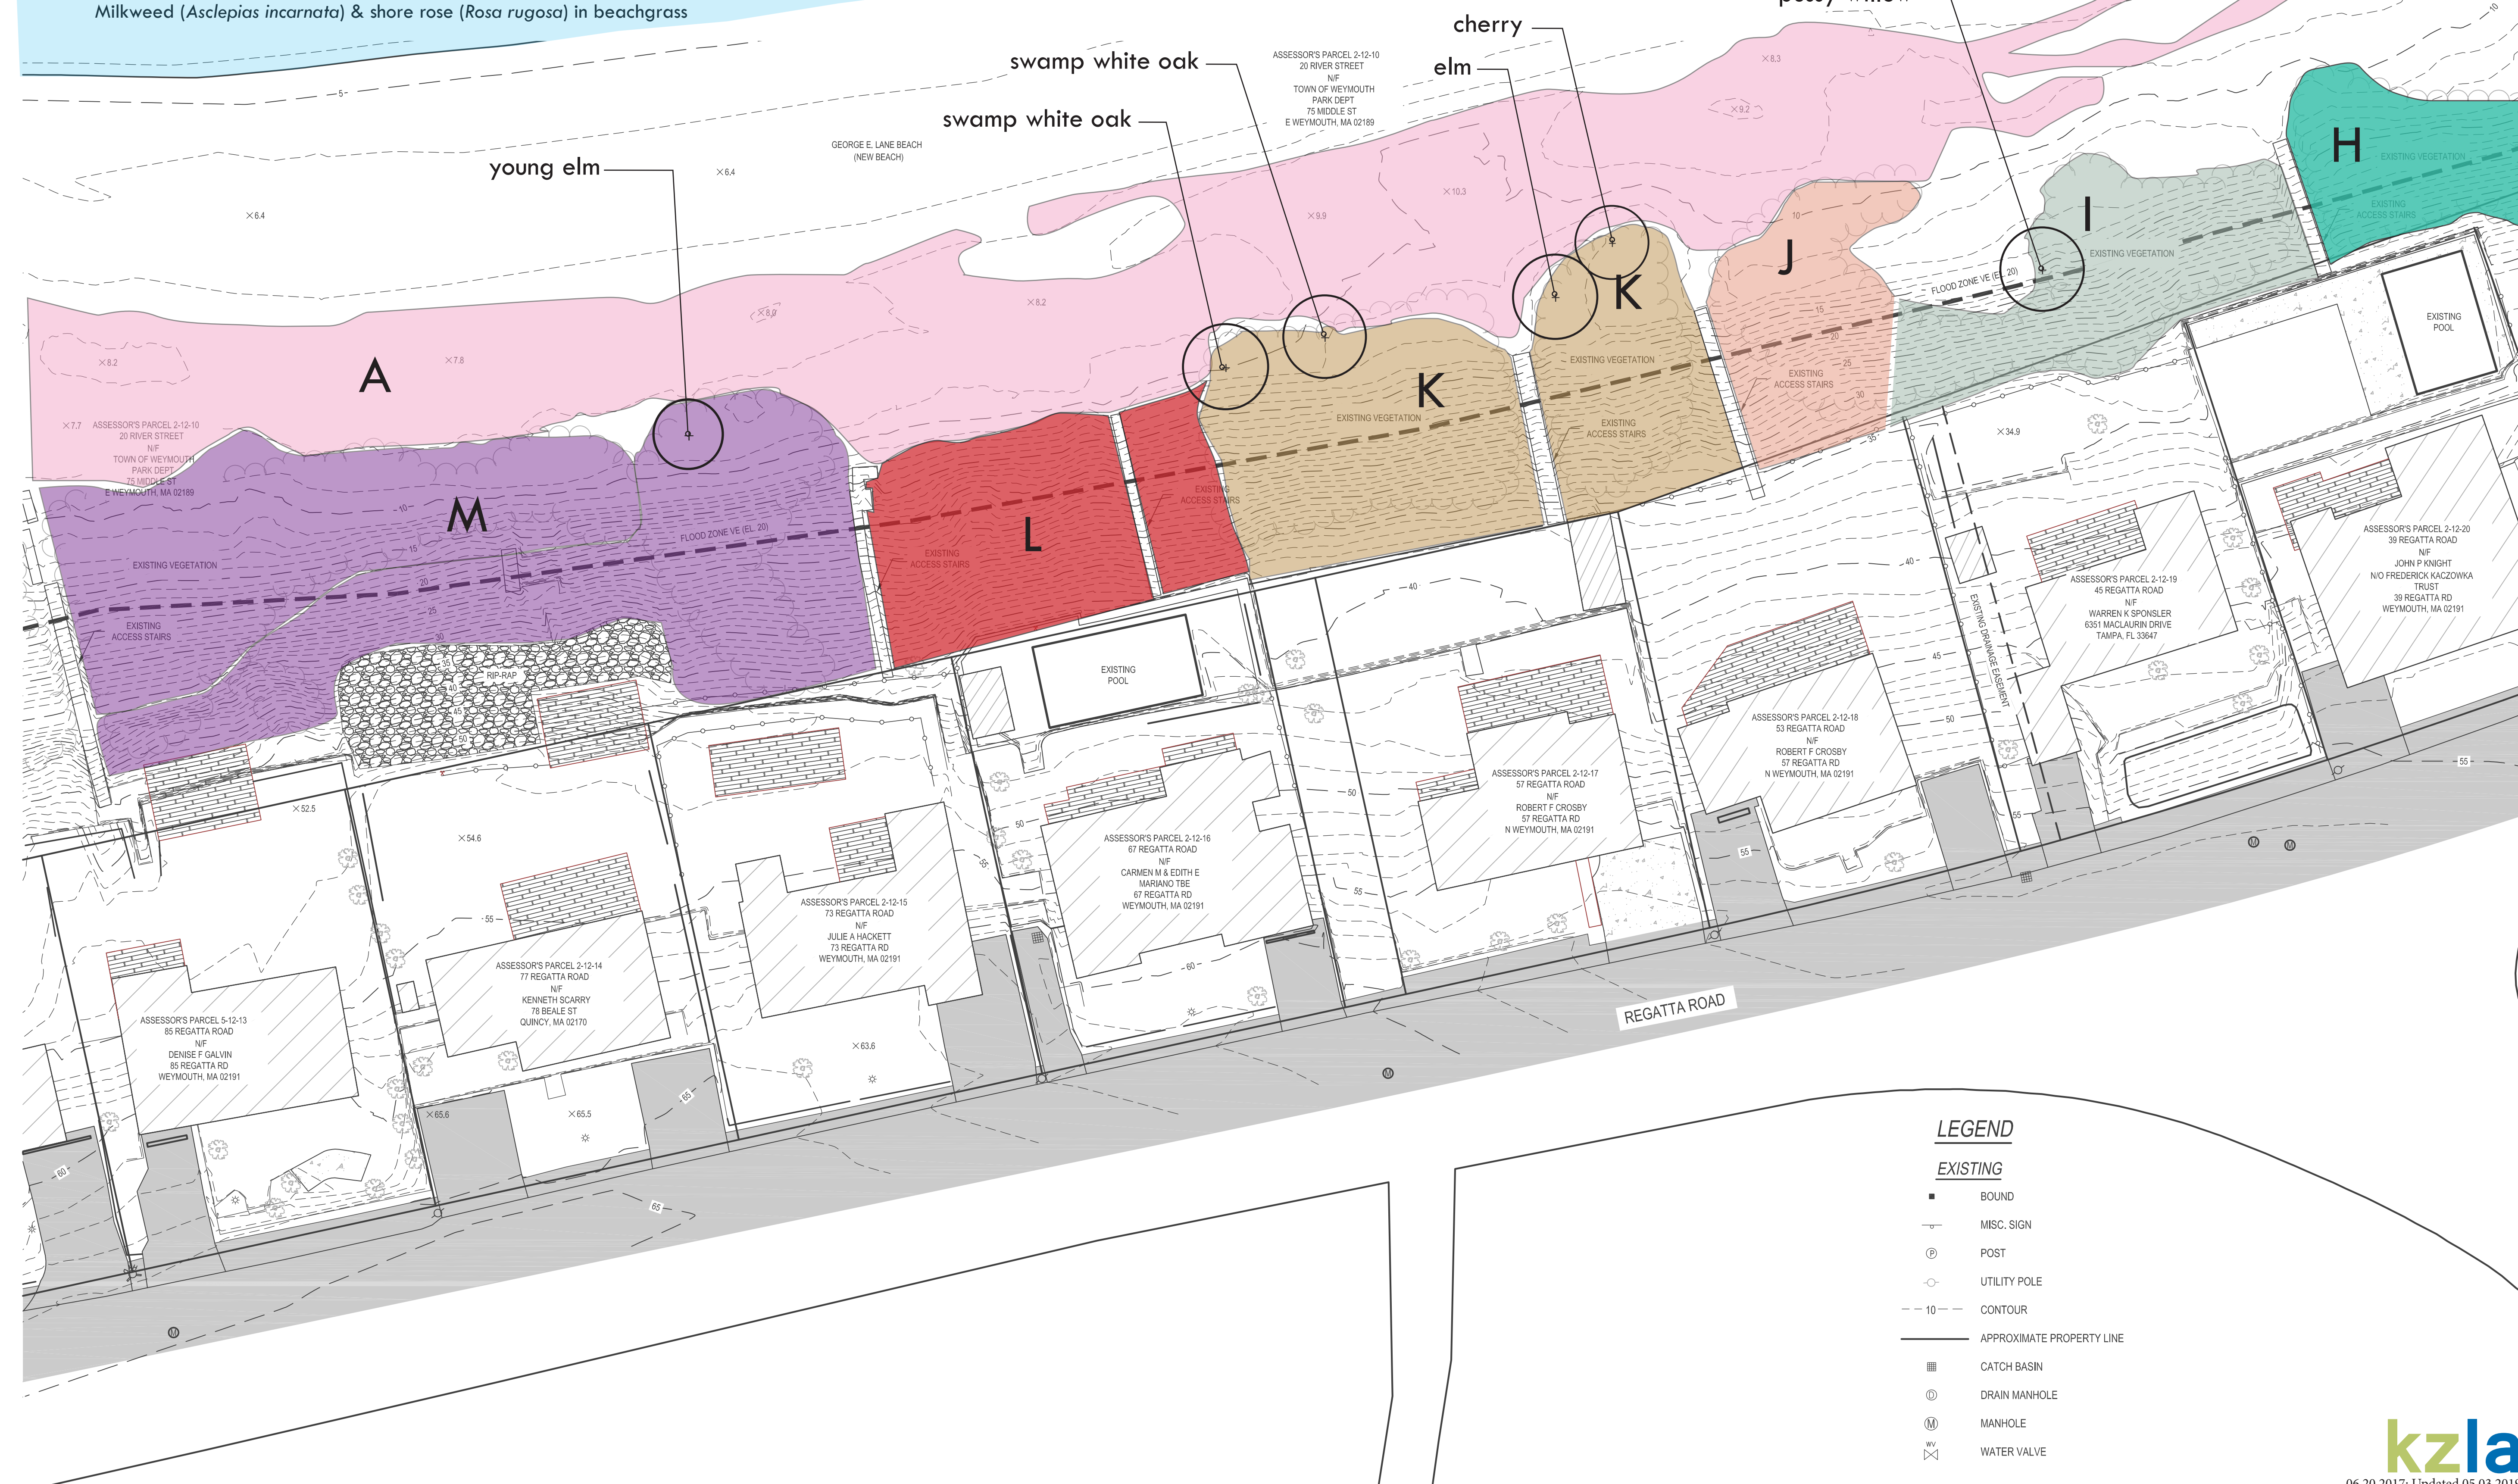
Zone M: Dense canopy: significant Norway maple stand, loads of bittersweet, some multiflora rose, knotweed
Young cherries, young elm trees at toe of bank, staghorn sumac

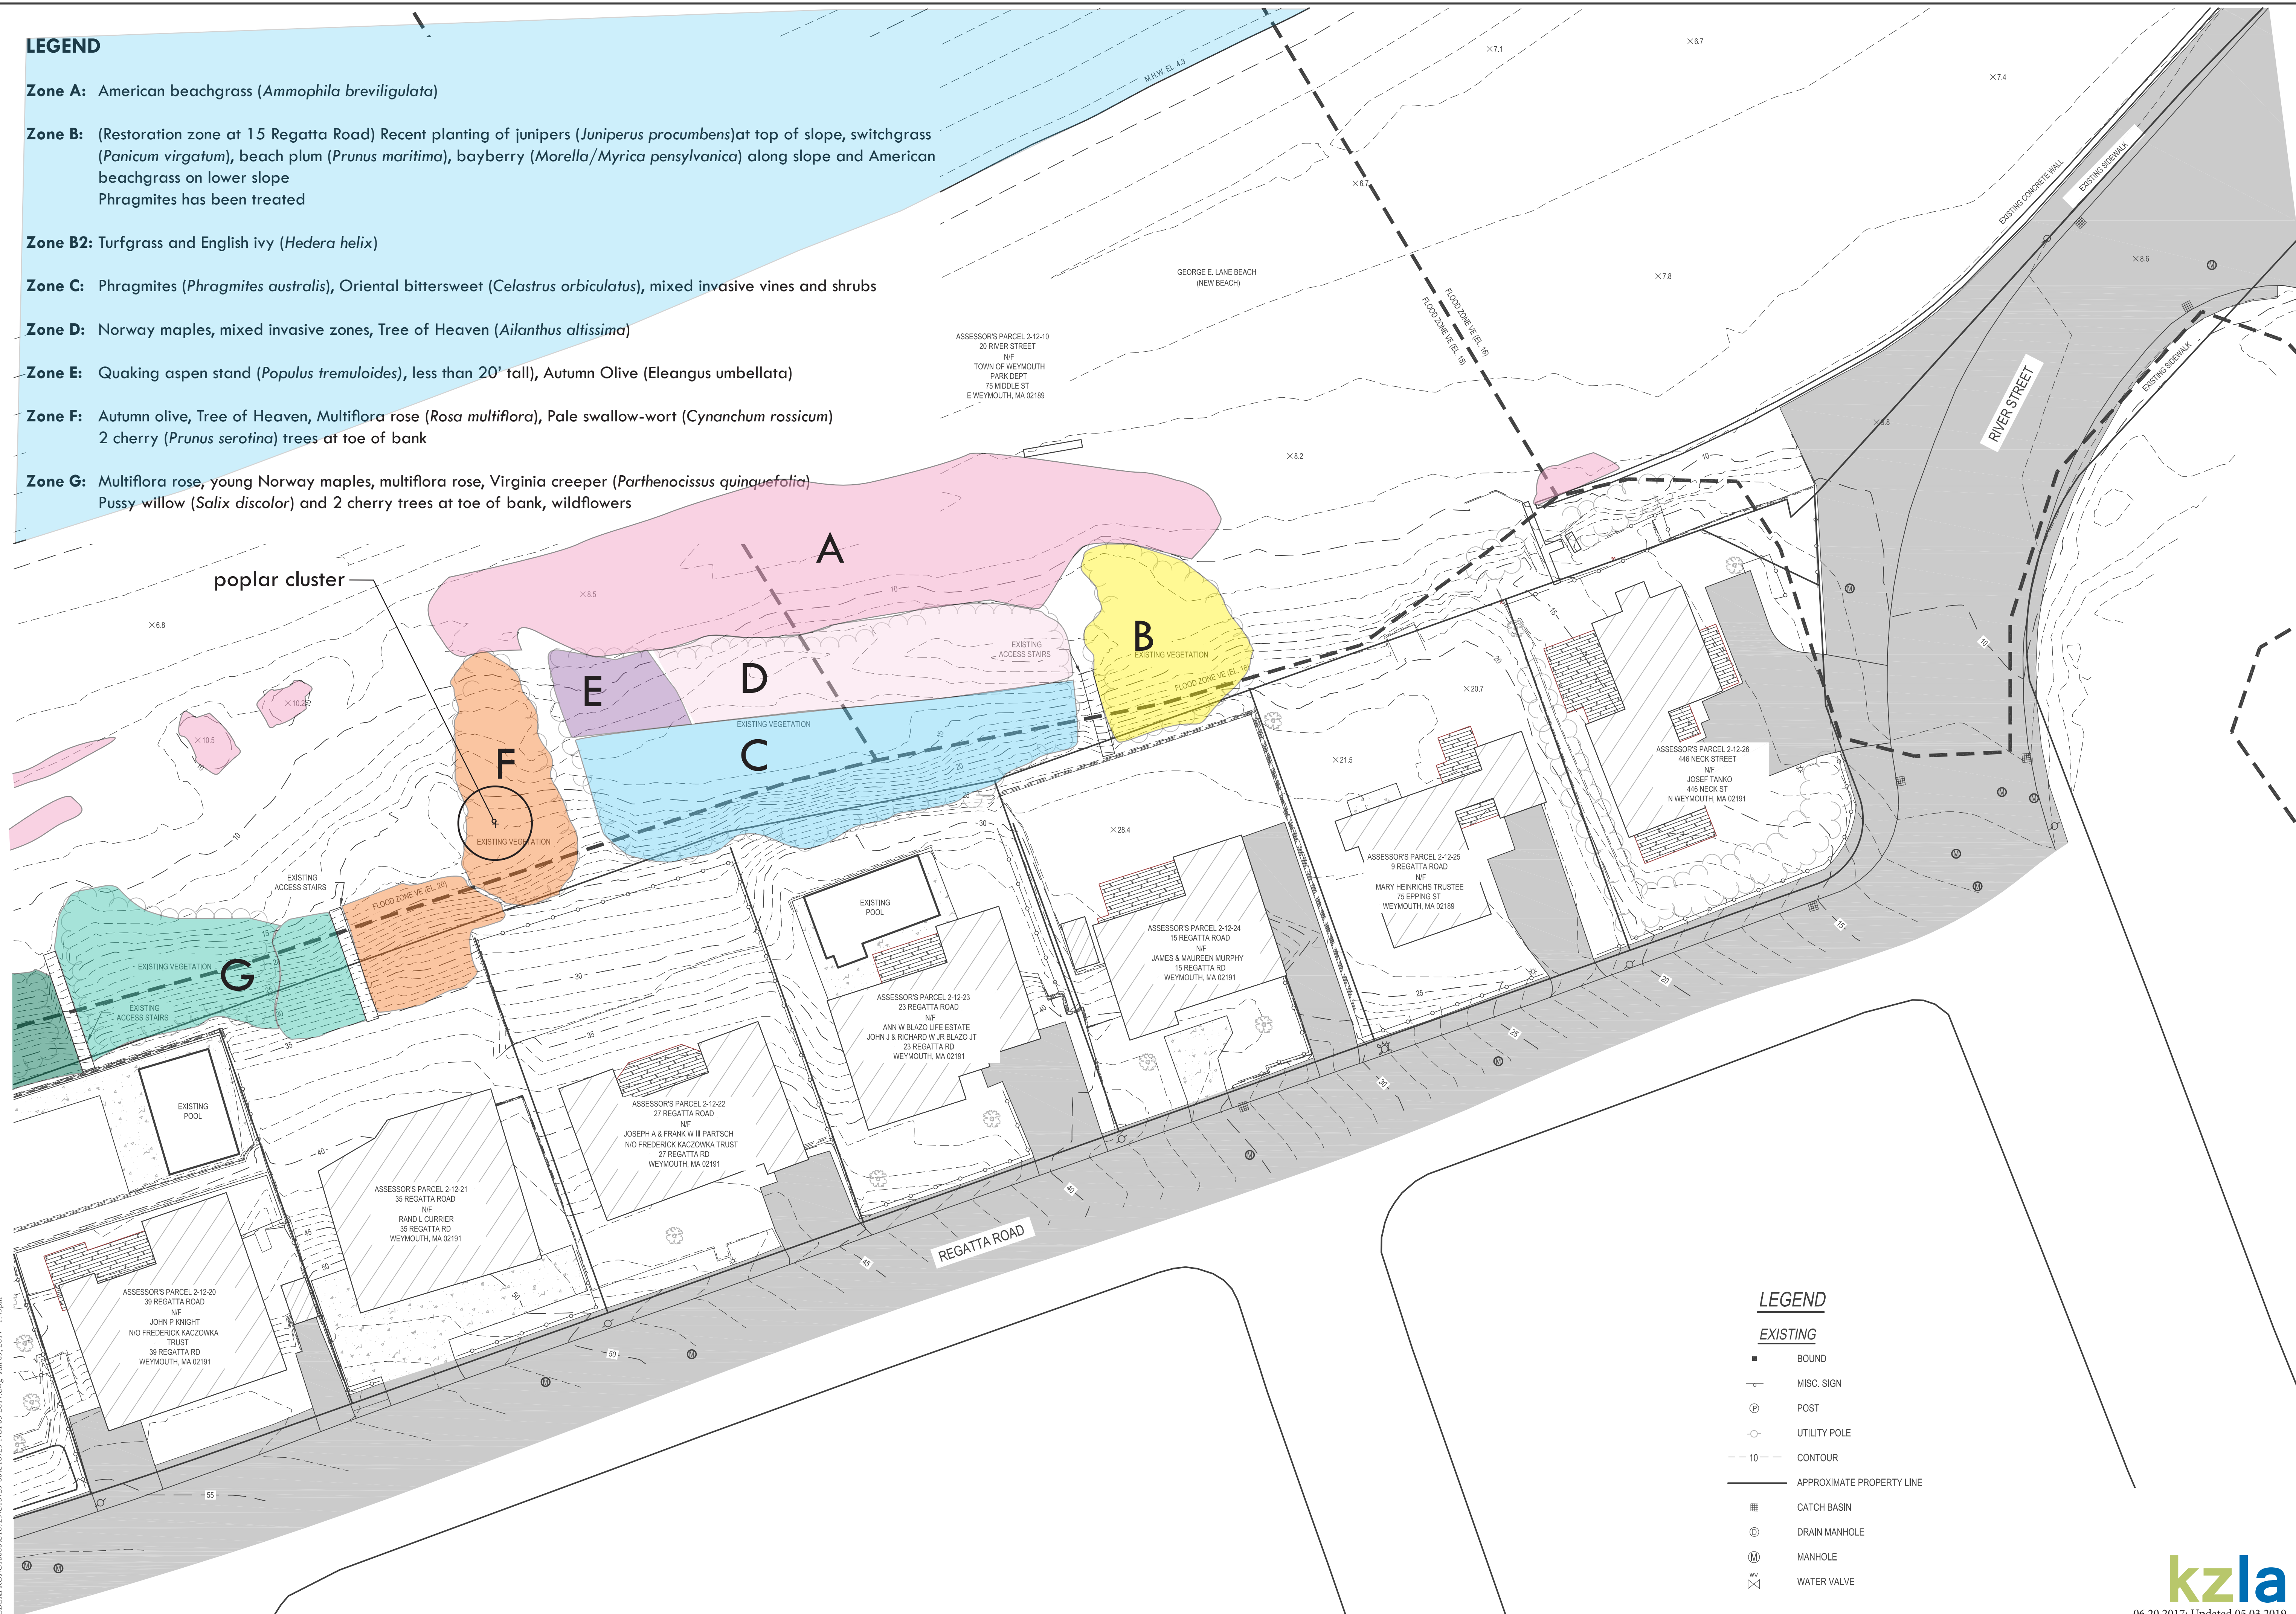
Zone A: American beachgrass (*Ammophila breviligulata*)

Zone B: (Restoration zone at 15 Regatta Road) Recent planting of junipers (*Juniperus procumbens*) at top of slope, switchgrass (*Panicum virgatum*), beach plum (*Prunus maritima*), bayberry (*Morella/Myrica pensylvanica*) along slope and American beachgrass on lower slope
Phragmites has been treated

Zone B2: Turfgrass and English ivy (*Hedera helix*)

Zone C: Phragmites (*Phragmites australis*), Oriental bittersweet (*Celastrus orbiculatus*), mixed invasive vines and shrubs

Zone D: Norway maples, mixed invasive zones, Tree of Heaven (*Ailanthus altissima*)

Zone E: Quaking aspen stand (*Populus tremuloides*), less than 20' tall), Autumn Olive (*Eleagnus umbellata*)

Zone F: Autumn olive, Tree of Heaven, Multiflora rose (*Rosa multiflora*), Pale swallow-wort (*Cynanchum rossicum*)
2 cherry (*Prunus serotina*) trees at toe of bank

Zone G: Multiflora rose, young Norway maples, multiflora rose, Virginia creeper (*Parthenocissus quinquefolia*)
Pussy willow (*Salix discolor*) and 2 cherry trees at toe of bank, wildflowers
