Project #C18729.00

**RE: ENF - RESPONSE TO ONSITE MEETING COMMENTS**  
**Proposed Rock Revetment and Pedestrian Walkway**  
EEA# 15877  
Town of Weymouth  
278 Wessagussett Road and 20 River Street  
Weymouth, MA  
Parcels: 4-21-3 and 2-12-10

A site visit was conducted on July 6, 2018 to view the site and document existing conditions.

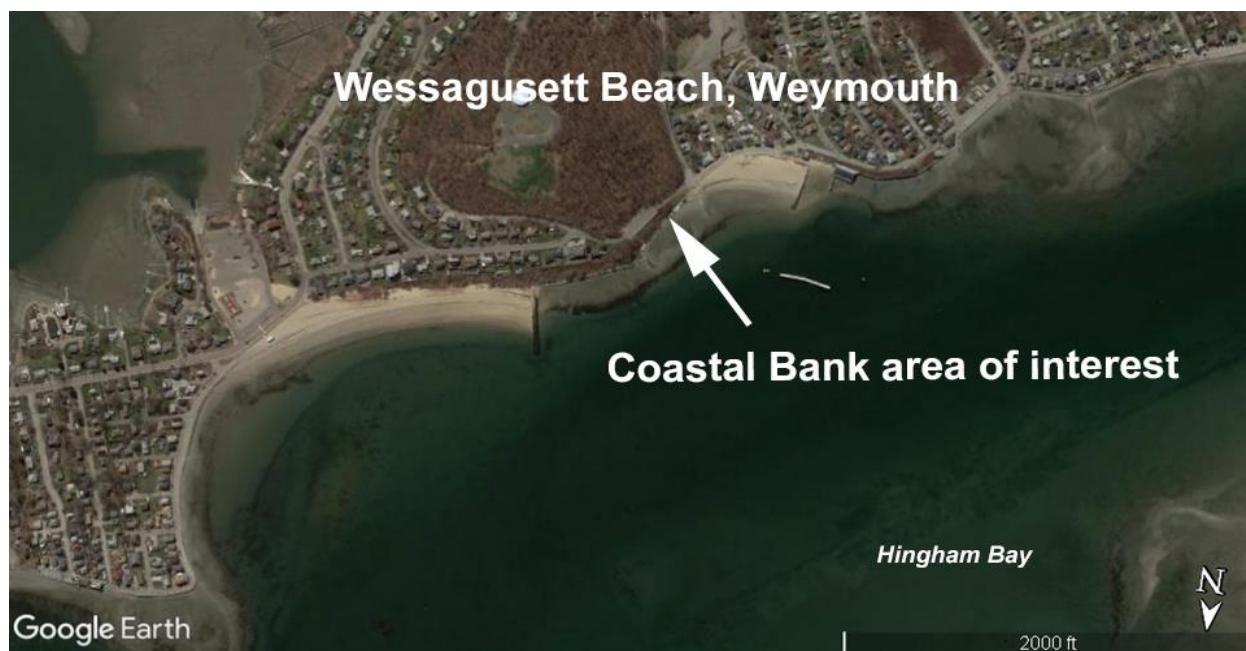
**Fig 1A:** Coastal Bank area of Interest along Wessagusett Beach, Weymouth

The Coastal Bank area of interest is located along a town-owned section of Wessagusett Beach, Weymouth, as shown in **Figures 1A & 1B** below.

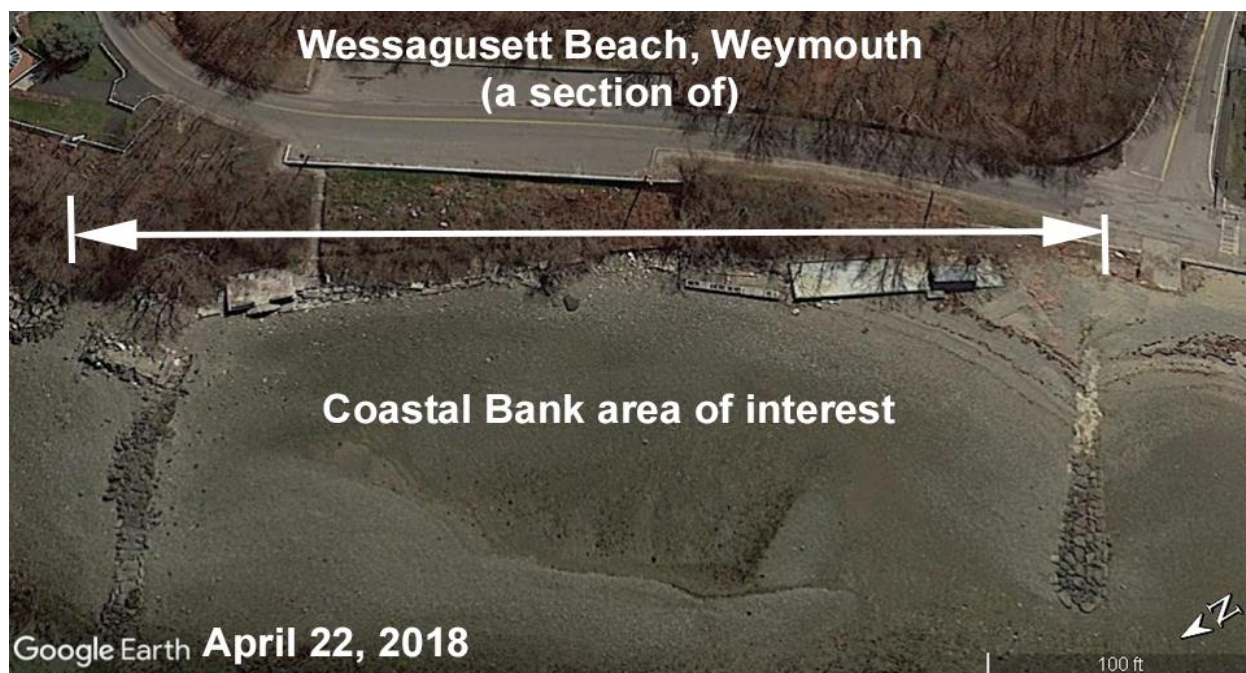
**Fig 4: low altitude Google aerial photo showing the dilapidated condition of the Coastal Bank and Beach along a Town-owned section of Wessagusett Beach, Weymouth**

**Figure 4 above and Figure 5 below** shows the Coastal Bank area of interest which is a highly altered, blighted area including; dilapidated, sections of collapsed concrete seawall/bulkhead fronting an existing vertical concrete seawall/bulkhead; abandoned concrete foundations; cinder blocks and purposely laid cobblestone strewn along the stretch of the mixed sediment beach; and, an existing in-tack vertical concrete seawall/bulkhead along the entire stretch at the Toe of the Coastal Bank landward of the concrete debris.

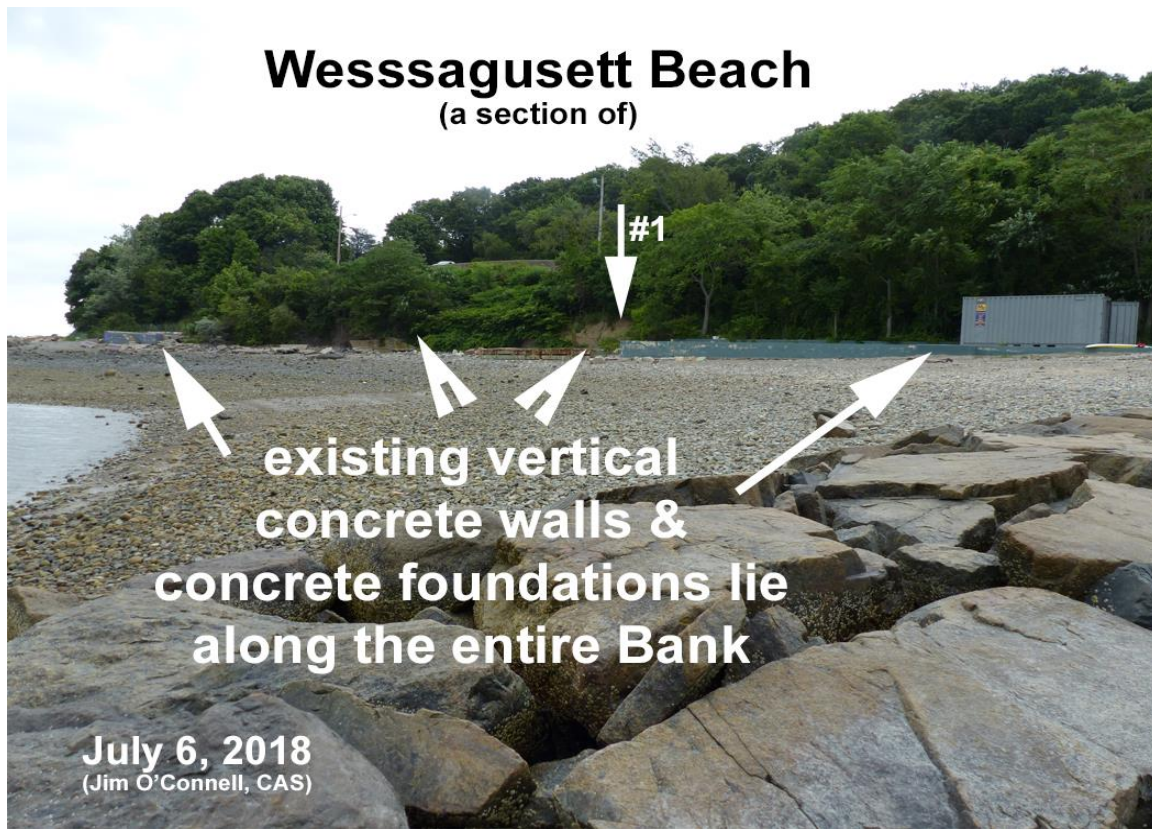
**Fig 5** showing the locations of the existing concrete foundations and concrete walls

**Figure 5 above** shows the 2 existing concrete foundations at each end of the Coastal Beach (east & west ends), and the location of the existing in-tack vertical concrete seawall/bulkhead.

The locations of the ‘existing concrete remnants and debris of old bathhouse foundations’ on each end of the beach and toe of Coastal Bank as shown above in Figure 5 are also shown on the Coastal Engineering Plan #C 3.2.1. and C 3.2.3, dated 5/12/18.

The Coastal Bank is densely vegetated as shown in Figures 5 above, with only a very short section of Bank unvegetated **as shown in Figure 5 above, noted as #1 in the figure and Figure 12.**

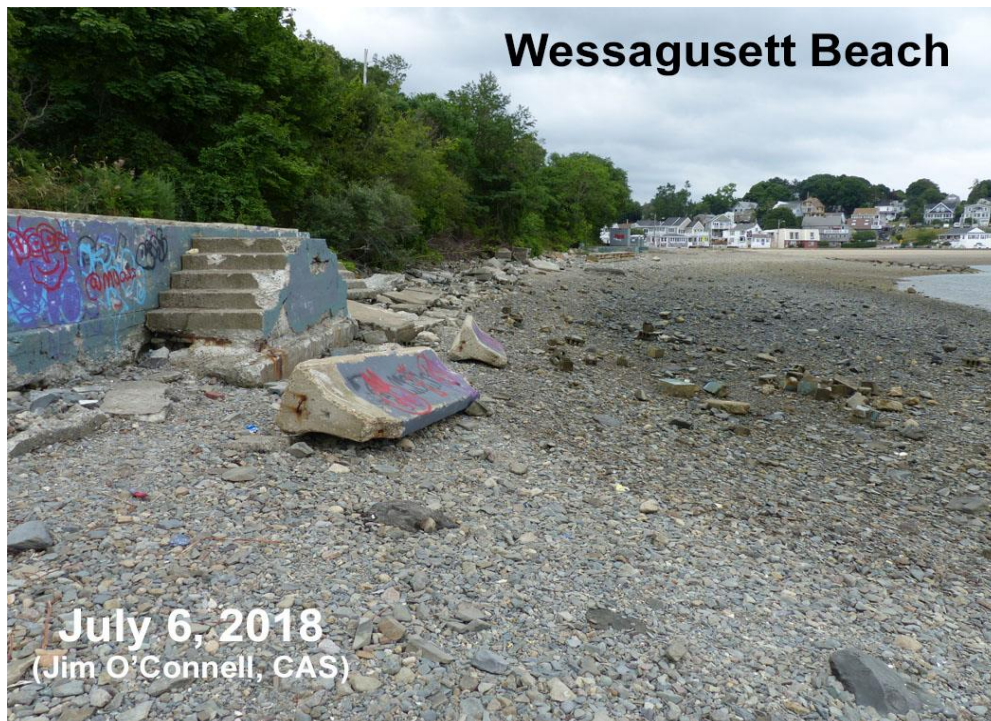
**Figure 6 below** is a close-up of the abandoned old bathhouse concrete foundation against the east end of the Coastal Bank.

**Fig 6** showing the old bathhouse concrete foundation at the east end of the beach & bank

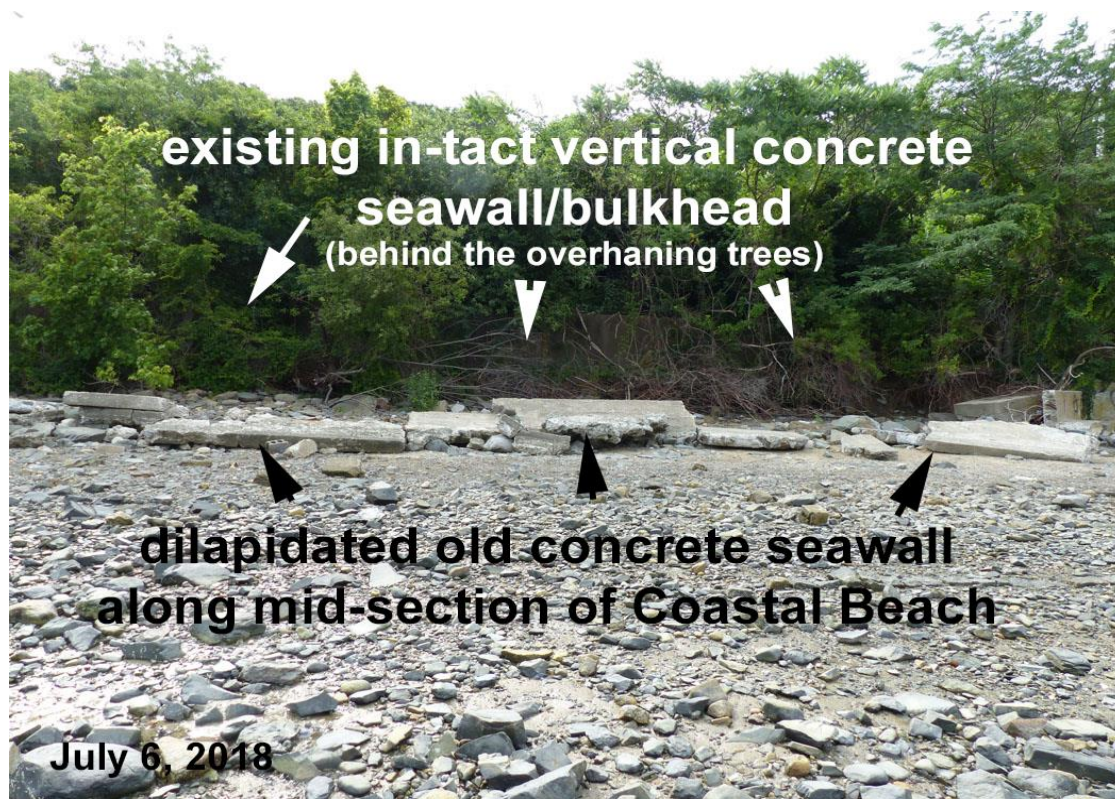
**Figure 7 below** shows an old dilapidated, broken concrete seawall/bulkhead with footing strewn along the beach fronting an existing in-tack vertical concrete seawall/bulkhead at the existing Toe of the Coastal Bank.

**Fig 7** showing the dilapidated broken sections of seawall strewn on the beach fronting an existing in-tact vertical concrete seawall/bulkhead

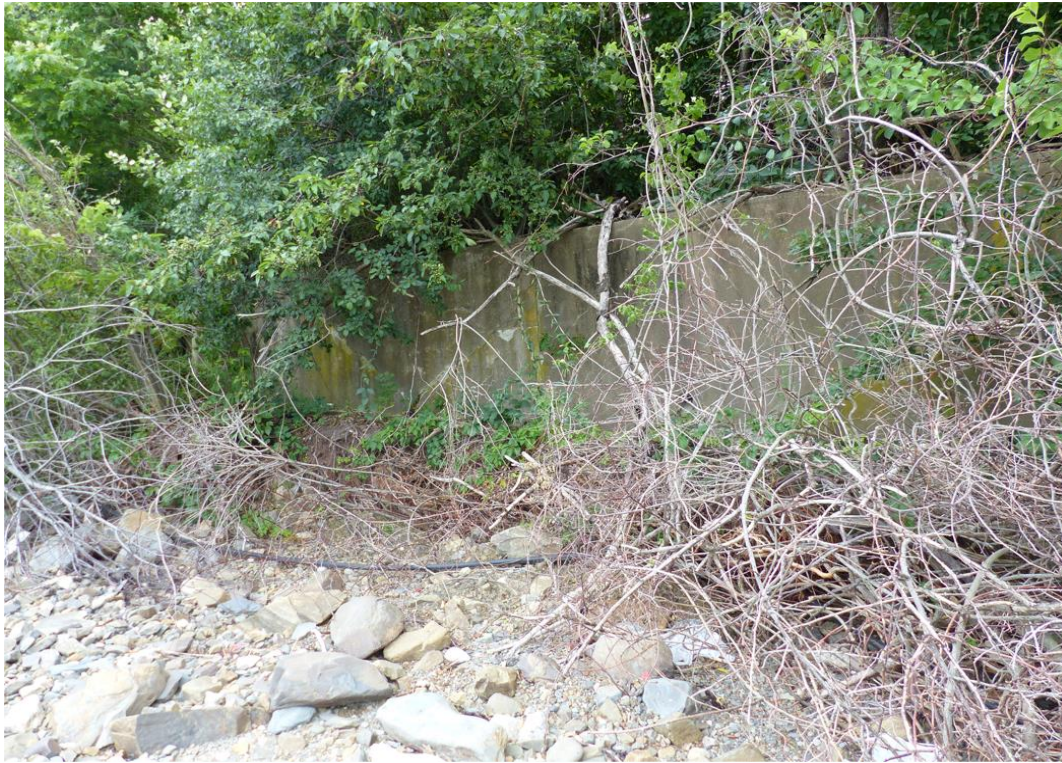
**Figure 8 below** is a close-up of the existing, in-tack 8' high vertical concrete seawall/bulkhead that exists along the entire length of the eastern section at the Toe of the Coastal Bank.

**Fig 8** is a close-up of the existing, in-tack vertical concrete seawall/bulkhead that lies along the entire length at the Toe of the Coastal Bank

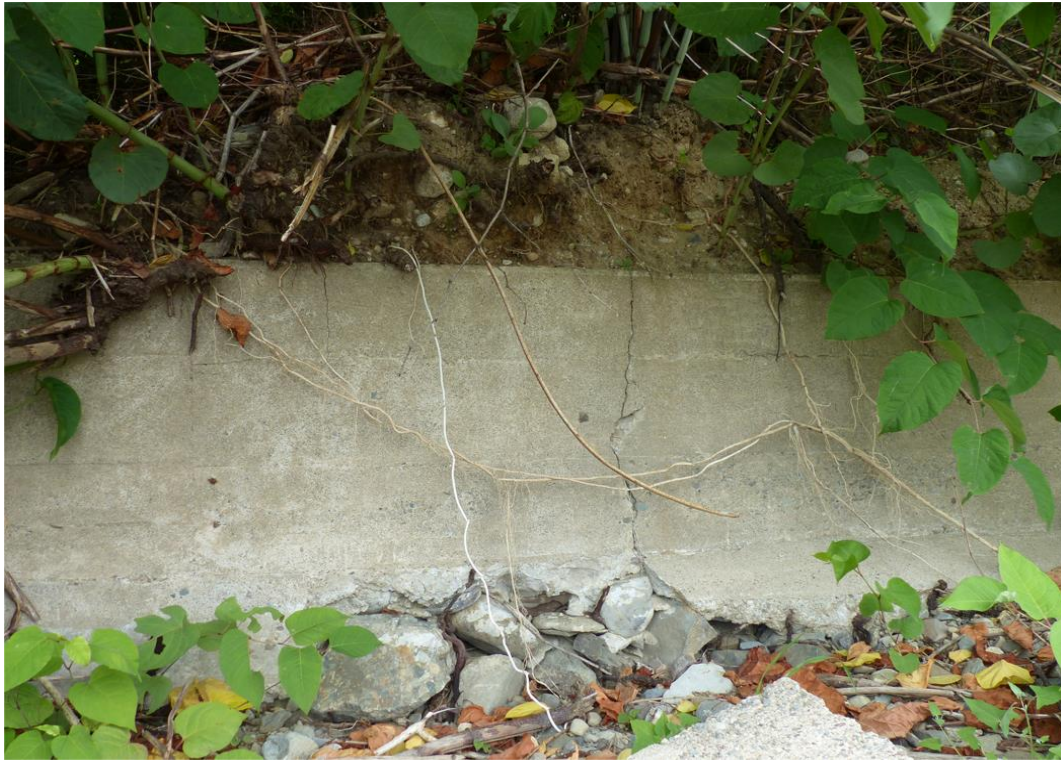
**Figure 10 below** is a close-up of the existing, in-tack 3-4' high vertical concrete seawall/bulkhead that exists along the entire length of the western section at the Toe of the Coastal Bank.

**Fig 10** shows the existing 3-4' high seawall/bulkhead that lies along the western section at the Toe of the Coastal Bank

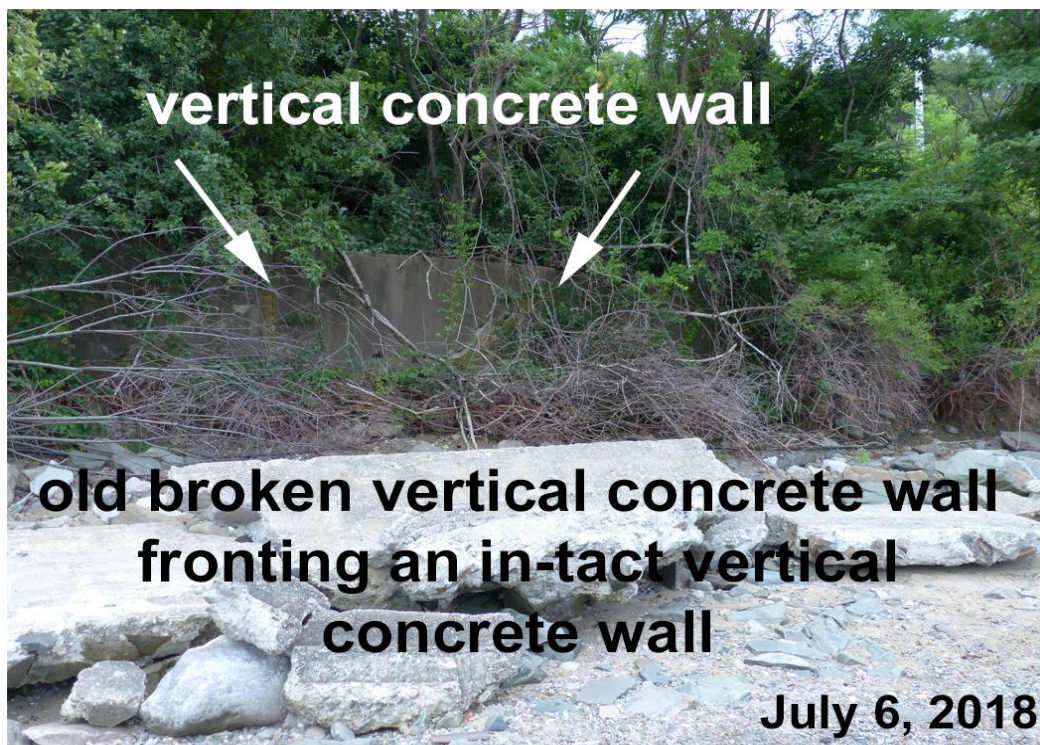
**Fig 11** showing sections of a broken seawall/bulkhead that lie strewn on the beach fronting the CB.

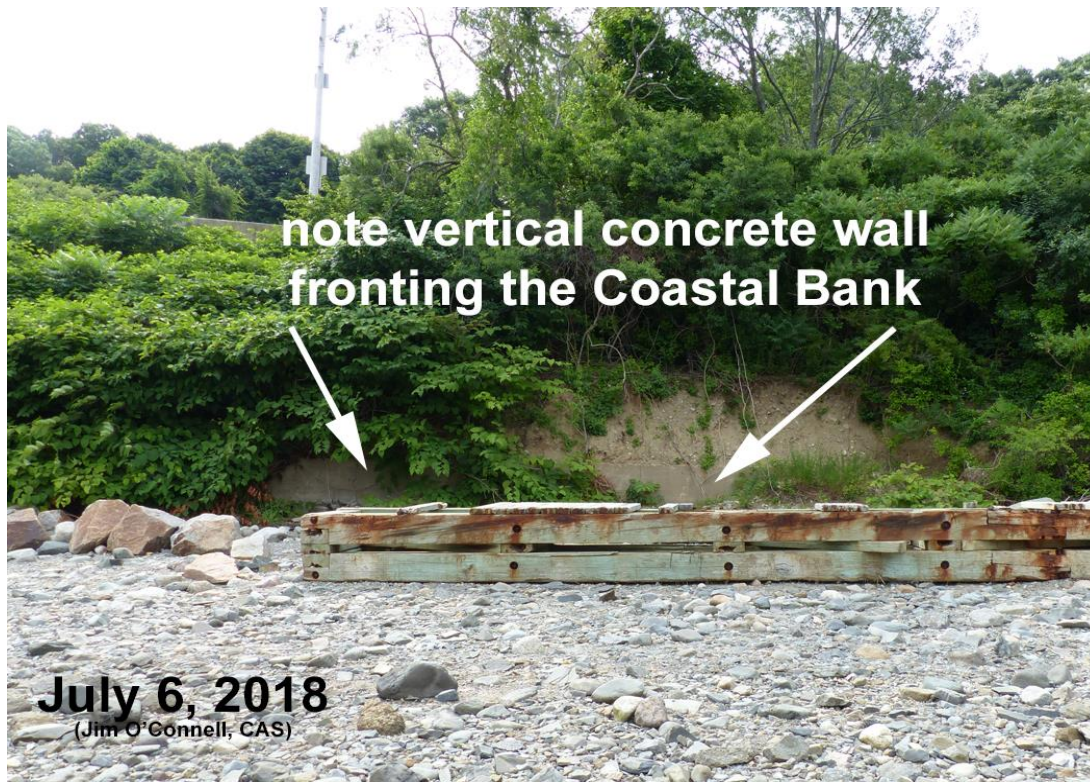
**Fig 12** showing the only area along the Coastal Bank that is not densely vegetated, possibly due to run-off

**Figure 12 above** shows the only area along the Coastal Bank that is not densely vegetated, possibly due to rain run-off. If it were storm waves, the entire Bank would be similarly unvegetated. However, note that the unvegetated area is above an existing in-tact vertical concrete seawall/bulkhead, and fronted by boulders placed along the beach.

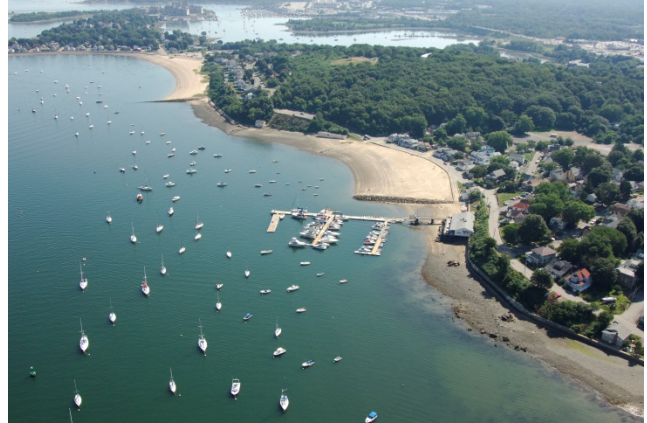
Figure 1 - Aerial of Project Location

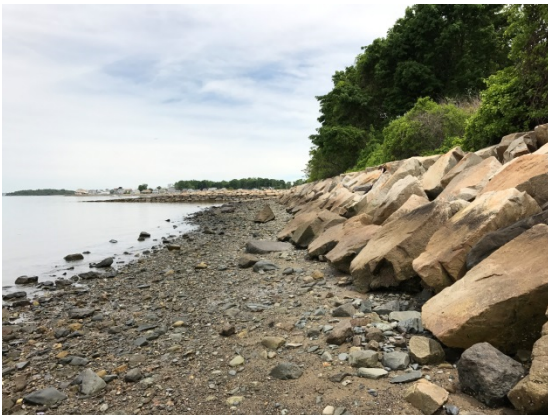
Figure 2 - Picture showing existing revetment and rocky intertidal shore

A section of the coastal bank at the site is armored at its toe by a licensed rock revetment (MA-DPW Contract No. 2098, issued May, 1960) that was constructed in 1960. This revetment starts at the stone groin located at the southwest end of George E. Lane Beach and extends southwesterly about 500 linear feet along the toe of the coastal bank where it ends at another stone groin. The top of this rock revetment is situated at about EL. 10 (NAVD 88) and provides coastal bank toe erosion protection to maintain the coastal bank slope stability for the last four dwellings along the road above. The rock revetment is in fair condition and needs to be reconstructed because the toe stones are no longer embedded below grade and the rocks making up the revetment are becoming unraveled.

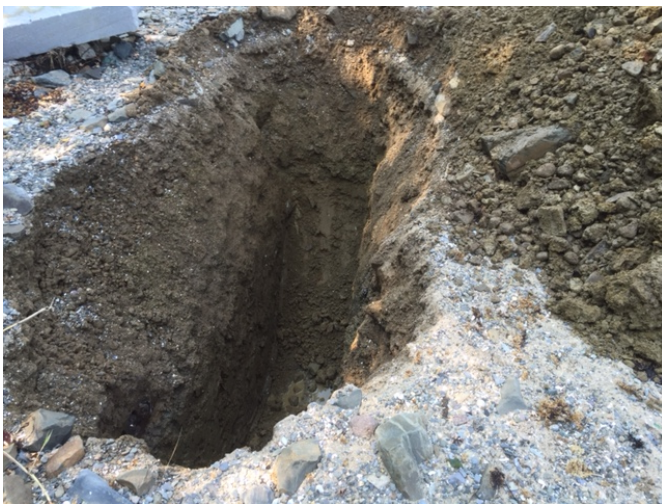
**Figure 3 - Test pit showing glacial till**

Based upon both published surficial geology maps for Weymouth and a recent series of test pits made at the site using a backhoe, the area located seaward of the toe of the coastal bank at the site consists of very dense consolidated glacial till. Glacial till is defined as unsorted glacial sediment derived from the erosion and entrainment of material by the moving ice of a glacier. Glacial till is the material that was deposited as the glacial ice melted and dropped the soil and rock fragments, and consists of dense, consolidated deposits of unsorted clay, silt, sand, gravel, and boulders. The rocky intertidal shore seen at the site is the result of the slow, long term erosion of the dense glacial till soil deposit at the site where the finer grain soil is washed away and the larger stones and boulders are left behind to remain in place on the surface to form the rocky intertidal shore we currently see at the site today. There is strong published and physical evidence that the

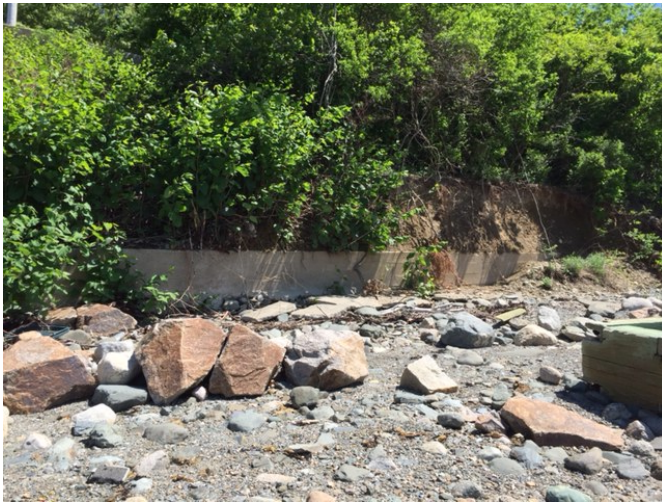
foundation, and the construction of an inter-connecting cast-in-place concrete retaining wall that was located at the toe of the coastal bank and extended between the building structures at the site. All of these building superstructures have been removed from the site, but their concrete foundations still remain at the site in various stages of disrepair. The retaining wall that is located at the toe of the coastal bank in this area has partially collapsed due to long term shorefront storm erosion, but presently exists at the toe of the coastal bank as large sections of concrete debris. It is interesting to note that this wall still has a date of 1928 cast into its face at one location. This stability of this concrete wall was first noticed to be in jeopardy in 1994 due to shoreline erosion caused by coastal storms that occurred that year. Consequently, the Weymouth Conservation Commission issued a Certification of Emergency in August of that year to allow the stabilization of the wall by the placement of gravel fill on the seaward side of the wall. Please note that this Certificate included a sketch plan that shows the existence of all the concrete walls located on the coastal bank at that time. It appears that most of that gravel fill placed at that time has been eroded away and the wall is now in the partially collapsed state that we see at the site today.

There presently remains a second tier of a continuous, intact, cast-in-place concrete retaining wall on the coastal bank that is located about 10 feet landward of, and parallel to the failing concrete wall that is located at the toe of the coastal bank. This second concrete retaining wall relies on the lower concrete retaining wall for its stability and is currently in jeopardy of failure due to the deteriorating condition of the lowest wall on the coastal bank. In addition to these two concrete walls, there presently exists a third cast-in-place concrete wall that is located on the coastal bank near its top. This third concrete wall provides stability for Wessagussett Road and for a 180-foot long Town owned paved parking area (The Shelf) for public parking to provide access to this shorefront for all Weymouth residents. The existence of these concrete structures and concrete walls is documented on a license plan for a former adjacent beach improvement project issued by the Massachusetts DPW in July, 1958 (DPW Contract No. 1955). The existing concrete structures and walls at the site were not proposed to be licensed at that time because the license plan clearly shows that all of these structure and wall components were located landward of the MHW line at that time.

**Figure 4 - Photo depicting existing concrete walls and remnants**

The design of this project includes the complete removal of the extensive unsightly concrete foundation components, concrete stairs, and collapsed concrete wall components presently existing at the site. The project design proposes to collect and crush all of these concrete components to a useable size on site, after which the material thus obtained can be utilized as part of the engineered fill material that will be required for the foundation of the proposed pedestrian walkway at the site. Such an operation will eliminate the need to transport all of these concrete components away from the site for delivery to a suitable disposal facility. The remaining existing concrete walls supporting the coastal bank in this area of the site will be left in place and incorporated into the proposed revetment and walkway design.
