ROAD SAFETY AUDIT

Route 3A from Evans Street to Abigail Adams State Park

Town of Weymouth

October 12, 2016

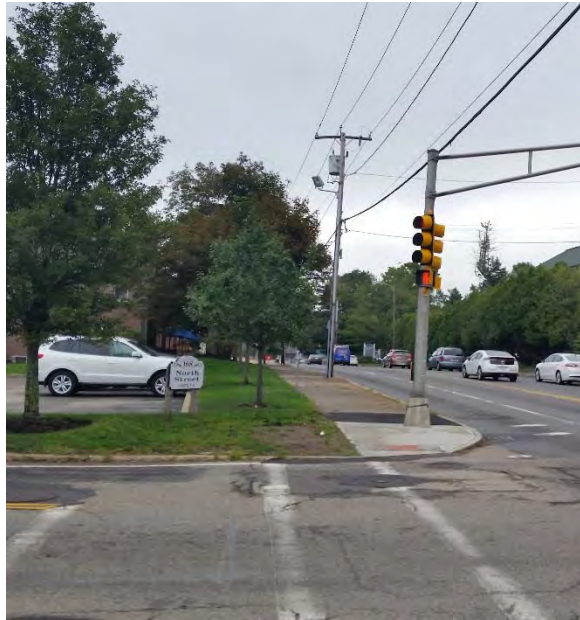
Crosswalks and stop bars at all intersections are very faded, and the ends of crosswalks do not always match to the wheelchair ramp openings. Lane line and double yellow centerline markings are also faded throughout the corridor, which could lead to driver confusion, and unintended lane encroachment which are potential safety deficiencies.

Image 1: This crosswalk across North Street does not align with the wheelchair ramps.

Restripe all pavement markings within the project limits. Realign crosswalks that currently lead away from wheelchair ramp openings. At the southbound approach of the North Street intersection, relocate the STOP bar location to be four feet from the crosswalk per the latest edition of the Manual on Uniform Traffic Control Devices (MUTCD). This crosswalk should also be realigned and be widened.

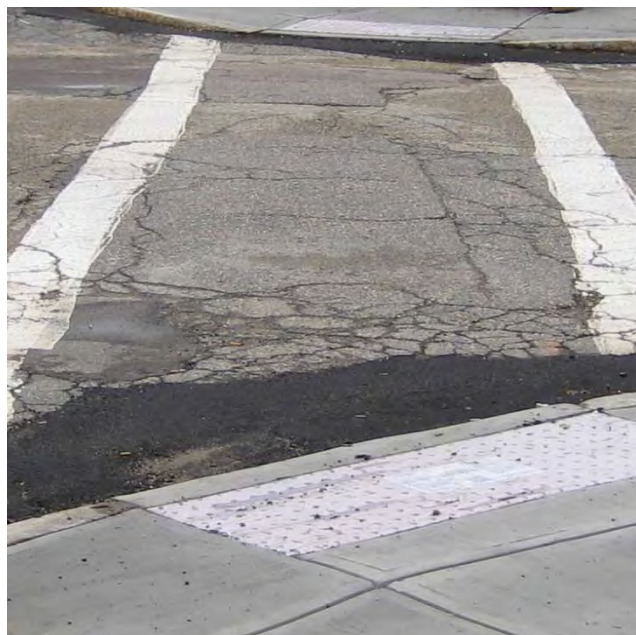
Sidewalk grading issues were also observed. The majority of the sidewalk cross-slopes appear to exceed the maximum ADA allowable cross-slope of 2 percent. Wheelchair ramps were observed at a few locations to have lips between the ramp opening and edge of roadway (such as at Blackstone Street). This is not in accordance with ADA standards, which require a flush transition. Corner ramps such as those along the north side of the North Street intersection were observed to open toward one crosswalk but have raised curb at the end of the crosswalk in the perpendicular direction.

Image 2: Some recently-installed wheelchair ramps have a lip between the edge of roadway and the ramp entrance, which is not in accordance with ADA standards requiring a flush transition.

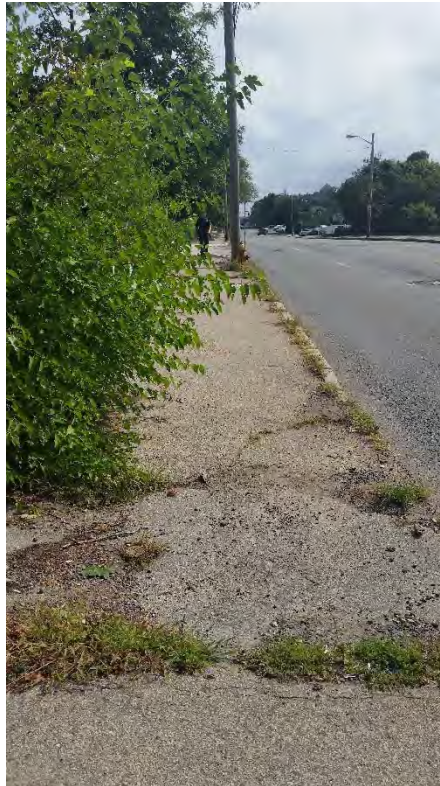
Route 3A sidewalks have issues mostly at narrow roadway areas and at some crosswalk locations. Sidewalk along the north side of Route 3A between Sea Street and North Street has overgrown vegetation extending nearly out to the roadway which could force pedestrians into the roadway to bypass this segment of the sidewalk. Sidewalk widths are also reduced by the presence of utility poles.

Image 3: Sidewalk between Sea Street and North Street is narrow with overhanging vegetation.

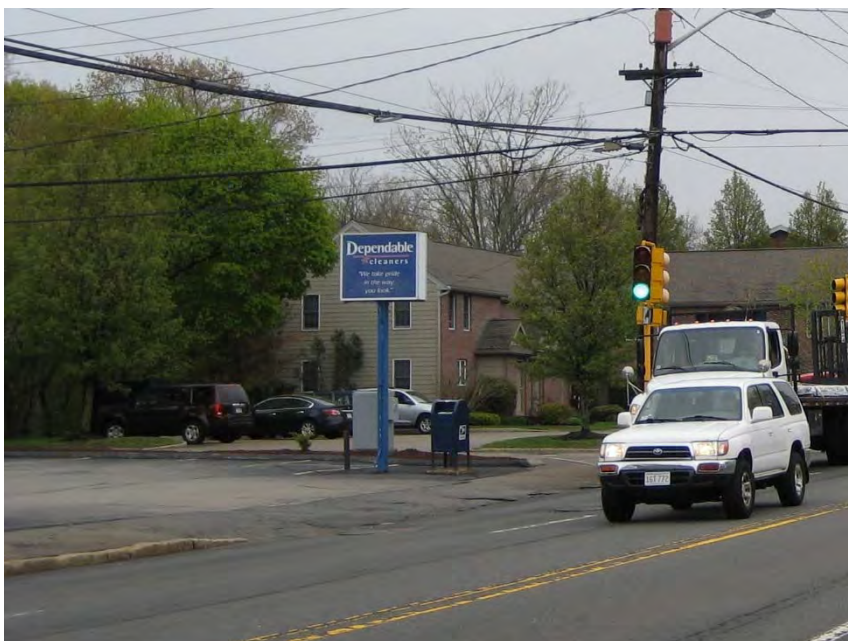
Driveway openings are excessively wide, poorly defined, and densely spaced on Route 3A. This results in numerous vehicular conflict points along the corridor. The presence of these conflict points results in an increased risk of angle and rear-end collisions. Excluding signalized intersections, there were 18 reported angle collisions and 18 reported rear-end collisions in 2013-2015 within the project limits. Curb cuts near the North Street intersection, among other locations, were also noted to be excessively wide – the curb cuts at the dry cleaners are approximately 50 feet wide, and the westernmost curb cut is shared as a driveway opening for several houses. Drivers also turn left out of driveways onto Route 3A, which requires them to cross in front of two opposing lanes of traffic. This is especially a concern between the Dunkin' Donuts and the Citgo gas station along the south side of Bridge Street between Green Street / Neck Street and Riverway Plaza, where Bridge Street is not physically divided. At the Green Street intersection, there is also concern that traffic could be stopped when drivers from the Route 3A eastbound

Image 4: The entrance curb cut to the dry cleaners' at the North Street intersection is approximately 50 feet wide and the pavement at the driveway entrance is in poor condition.

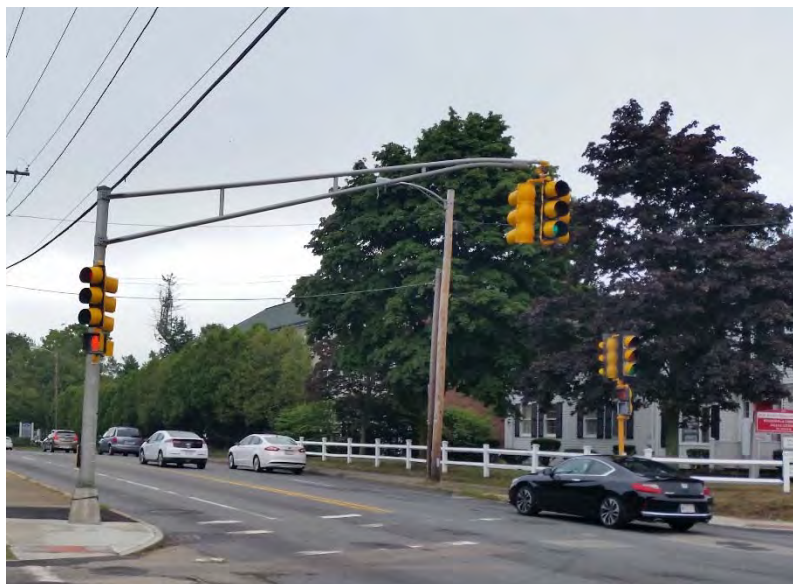
On the Route 3A westbound approach, a single signal head is mounted over the crosswalk of the west intersection leg and does not have the minimum separation distance of 40 feet (per standards of the latest edition of the MUTCD) between the stop bar and the signal heads. This creates a visibility issue since the signal head for the westbound approach is too high for drivers stopped near the STOP bar to see on this approach. A second signal head for the westbound approach is mounted on the southeast corner of the intersection and it is located outside of the MUTCD recommended cone of vision. The improper signal head locations may be a factor in the five red light running crashes and the nine rear-end crashes reported at this intersection from 2013-2015.

Image 5: This mast arm at North Street has a signal head for the westbound approach too close (almost above) the stop line, a pedestrian signal head without a countdown, and a pushbutton facing the wrong way.

At the North Street / Route 3A intersection, the yellow and all-red clearance times should be checked and updated to current MassDOT standards. Providing an advance protected left turn phase for the westbound traffic on Route 3A will help left-turning movements on this approach. Adjust the location of the vehicle signal heads at this intersection to meet the standards of the latest edition of the MUTCD. Review and adjust loop detector settings (short delay timing) to avoid unnecessary false calls.

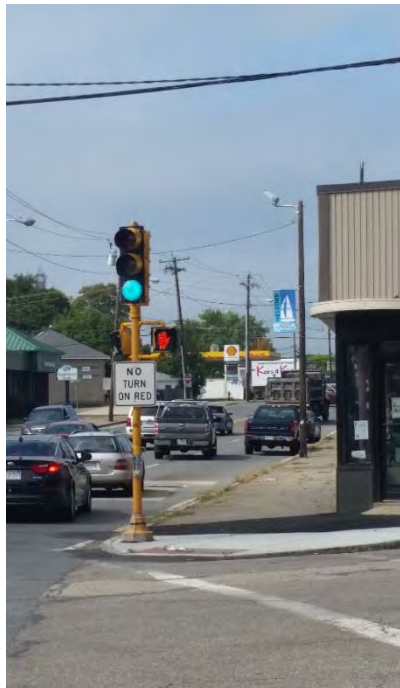
Parking in the right lane on the westbound approach of Route 3A was observed adjacent to the shops immediately west of Sea Street (between Bridge-Wey Tailors and Cleaners and Fore River Holistic Therapy and Skin Care). As a result, westbound traffic must merge into the left lane immediately after

Image 6: Illegal parking (see pick-up truck) on the westbound right lane west of Sea Street restricts vehicle flow on Route 3A.

crossing the Sea Street intersection. Vehicles unexpectedly changing lanes to avoid the parked vehicles may cause sideswipe crashes. There is no known regulation record allowing parking on Route 3A in this area. There is a narrow (approximately one-foot-wide) shoulder present on Route 3A at this location. There is a gravel parking lot behind these shops off of Sea Street.

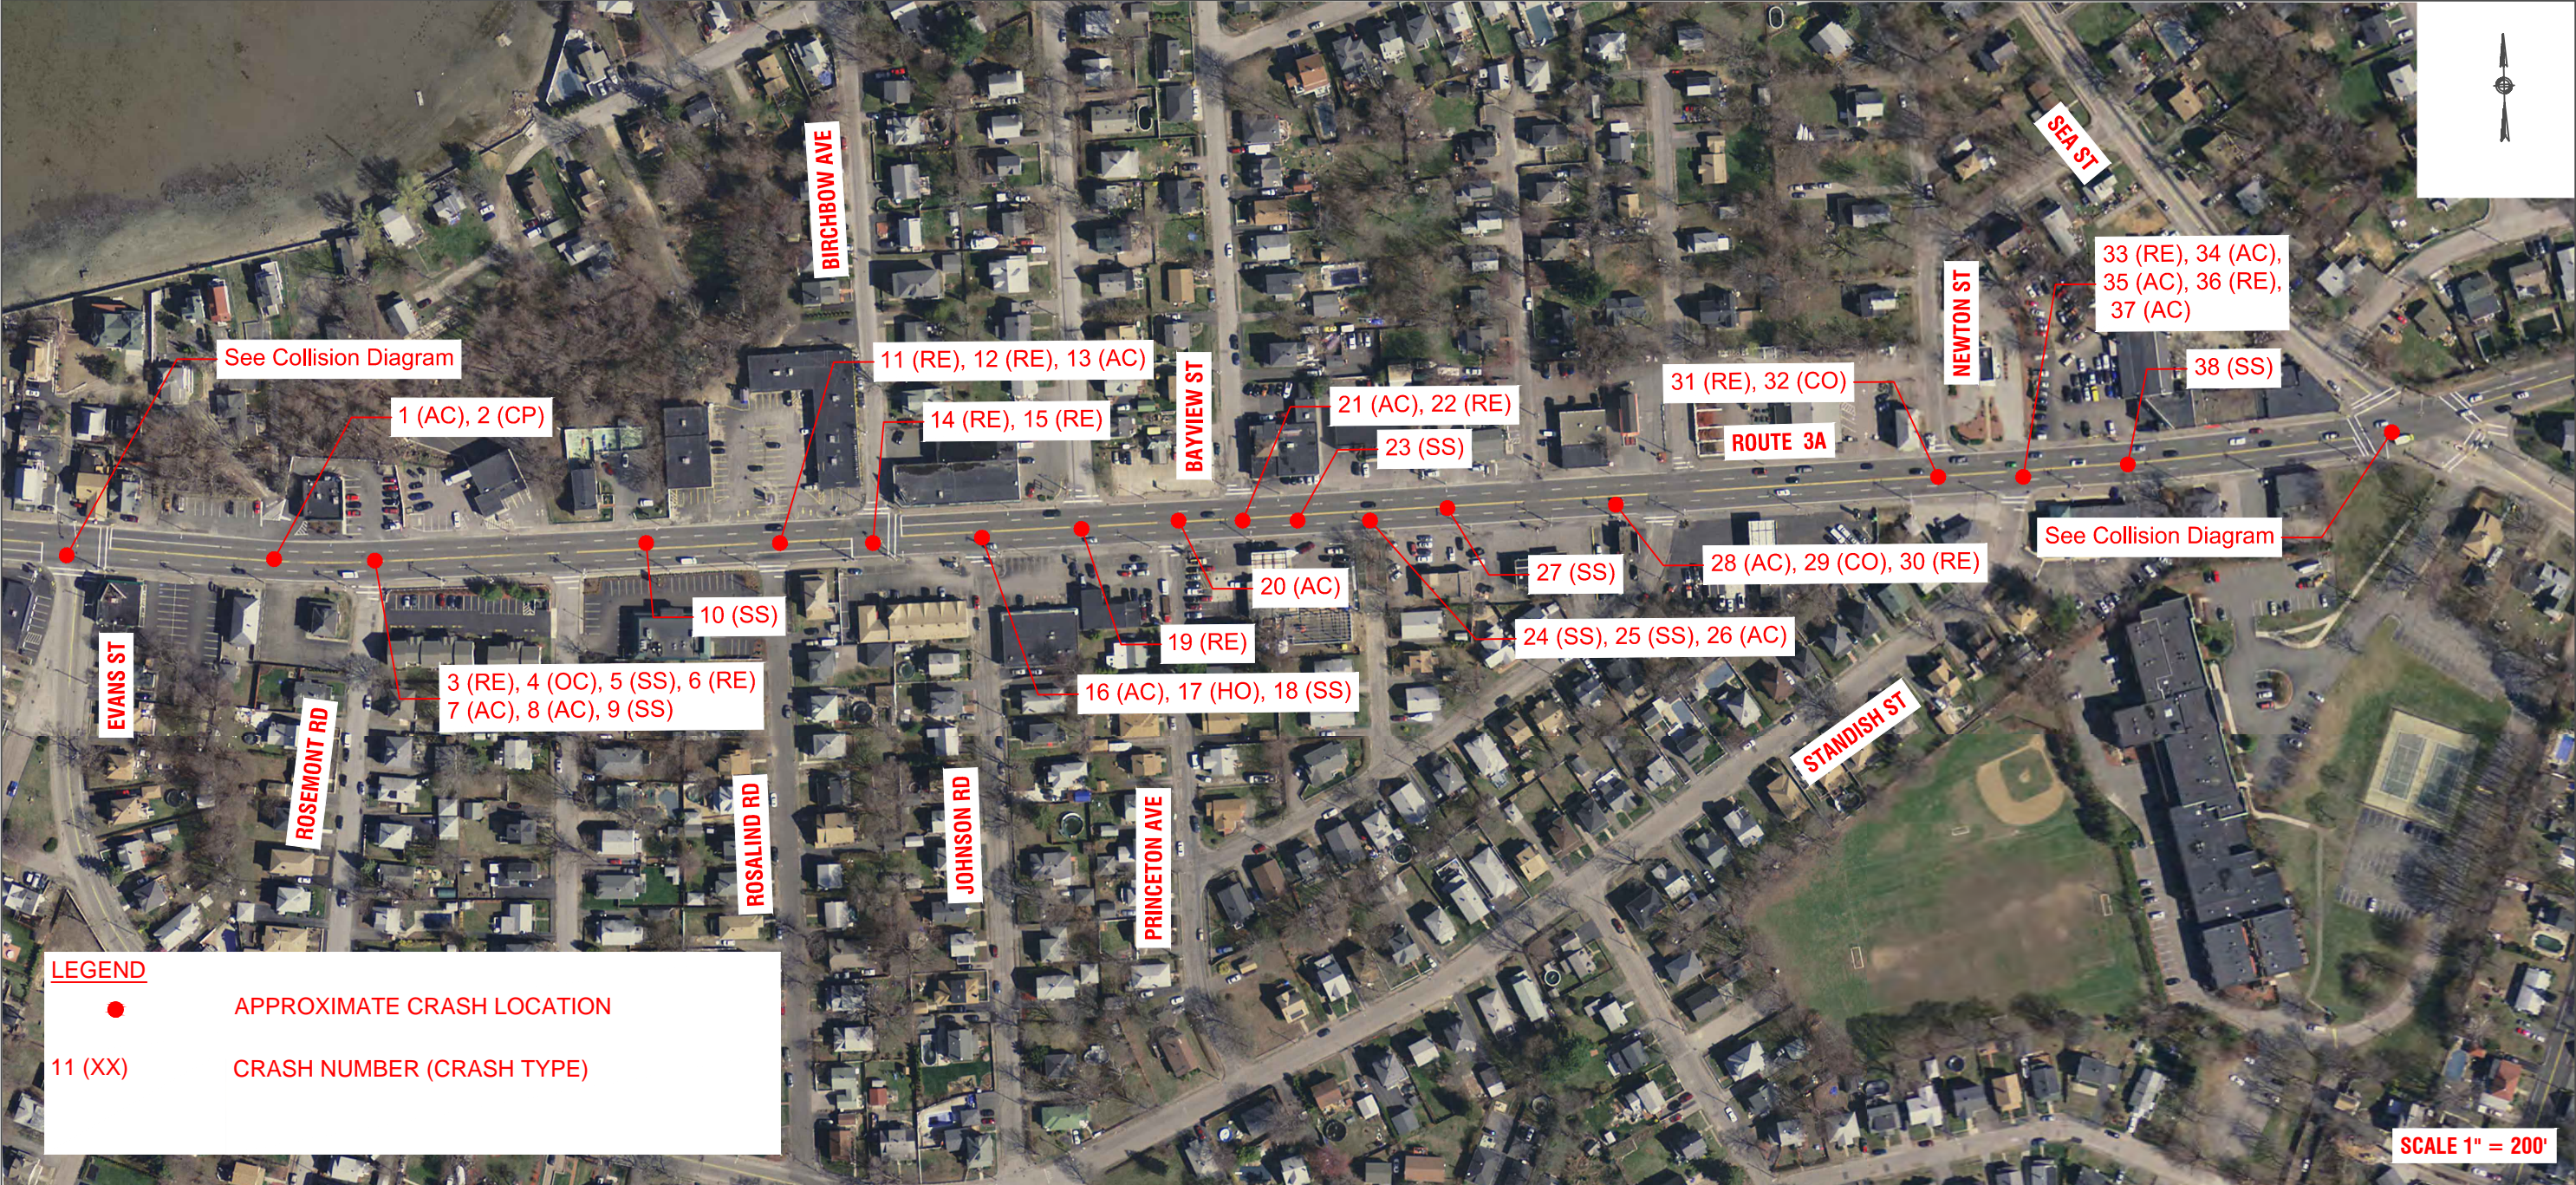
● APPROXIMATE CRASH LOCATION

NUMBER	TYPE OF COLLISION	VEHICLES INVOLVED	ROADWAY CONDITION	LIGHT CONDITION	SEVERITY	DATE	DIRECTION
1	AC	2	DRY	DAYLIGHT	PD	2/18/2013	S/W
2	CP	1	DRY	DARK (LIT)	PI	10/22/2013	E
3	RE	2	DRY	DAYLIGHT	PD	5/16/2014	W
4	OC	2	DRY	DAYLIGHT	PD	11/1/2013	W
5	SS	2	WET	DAYLIGHT	PD	3/7/2013	W
6	RE	2	DRY	DAYLIGHT	PD	6/2/2014	E
7	AC	3	DRY	DAYLIGHT	PD	1/14/2015	W
8	AC	3	DRY	DAYLIGHT	PI	2/6/2015	W/E
9	SS	2	DRY	DAYLIGHT	PI	9/16/2015	W/E
10	SS	2	DRY	DAYLIGHT	PD	11/19/2013	W/E
11	RE	2	DRY	DAYLIGHT	PD	10/25/2014	W
12	RE	3	DRY	DAYLIGHT	PI	6/7/2014	W
13	AC	2	DRY	DAYLIGHT	PD	2/21/2015	S/W
14	RE	2	DRY	DAYLIGHT	PD	8/11/2013	W
15	RE	3	DRY	DAYLIGHT	PI	4/11/2014	E

NUMBER	TYPE OF COLLISION	VEHICLES INVOLVED	ROADWAY CONDITION	LIGHT CONDITION	SEVERITY	DATE	DIRECTION
16	AC	2	DRY	DAYLIGHT	PI	6/26/2015	N/E
17	HO	2	SNOW	DAYLIGHT	PD	2/14/2015	N/S
18	SS	2	WET	UNKNOWN	PD	11/12/2015	W
19	RE	2	DRY	DAYLIGHT	PI	12/12/2015	E
20	AC	2	WET	DARK (LIT)	PI	2/12/2013	E
21	AC	2	DRY	DAYLIGHT	PD	9/5/2014	W
22	RE	2	WET	DAYLIGHT	PD	8/9/2013	W
23	SS	3	WET	DAYLIGHT	PI	3/12/2013	W
24	SS	2	DRY	DAYLIGHT	PD	6/11/2013	W
25	SS	2	DRY	DARK (LIT)	PI	11/5/2014	E
26	AC	2	DRY	DAYLIGHT	PD	3/9/2015	W/E
27	SS	2	DRY	DAYLIGHT	PD	11/15/2014	E
28	AC	1	DRY	DARK (LIT)	PD	11/15/2013	N/W
29	CO	1	DRY	DAYLIGHT	PI	7/28/2014	W
30	RE	2	DRY	DAYLIGHT	PI	5/15/2015	E

NUMBER	TYPE OF COLLISION	VEHICLES INVOLVED	ROADWAY CONDITION	LIGHT CONDITION	SEVERITY	DATE	DIRECTION
31	RE	2	DRY	DAYLIGHT	PI	11/5/2014	E
32	CO	1	DRY	DARK (LIT)	PD	5/13/2015	E
33	RE	2	DRY	DARK (LIT)	PD	6/26/2013	E
34	AC	2	DRY	DAYLIGHT	PD	1/1/2014	W/E
35	AC	2	WET	DUSK	PI	12/23/2015	N/E
36	RE	2	DRY	DAYLIGHT	PD	3/15/2014	E
37	AC	2	DRY	DAYLIGHT	PI	10/4/2015	W/E
38	SS	2	DRY	DAYLIGHT	PD	11/9/2013	W

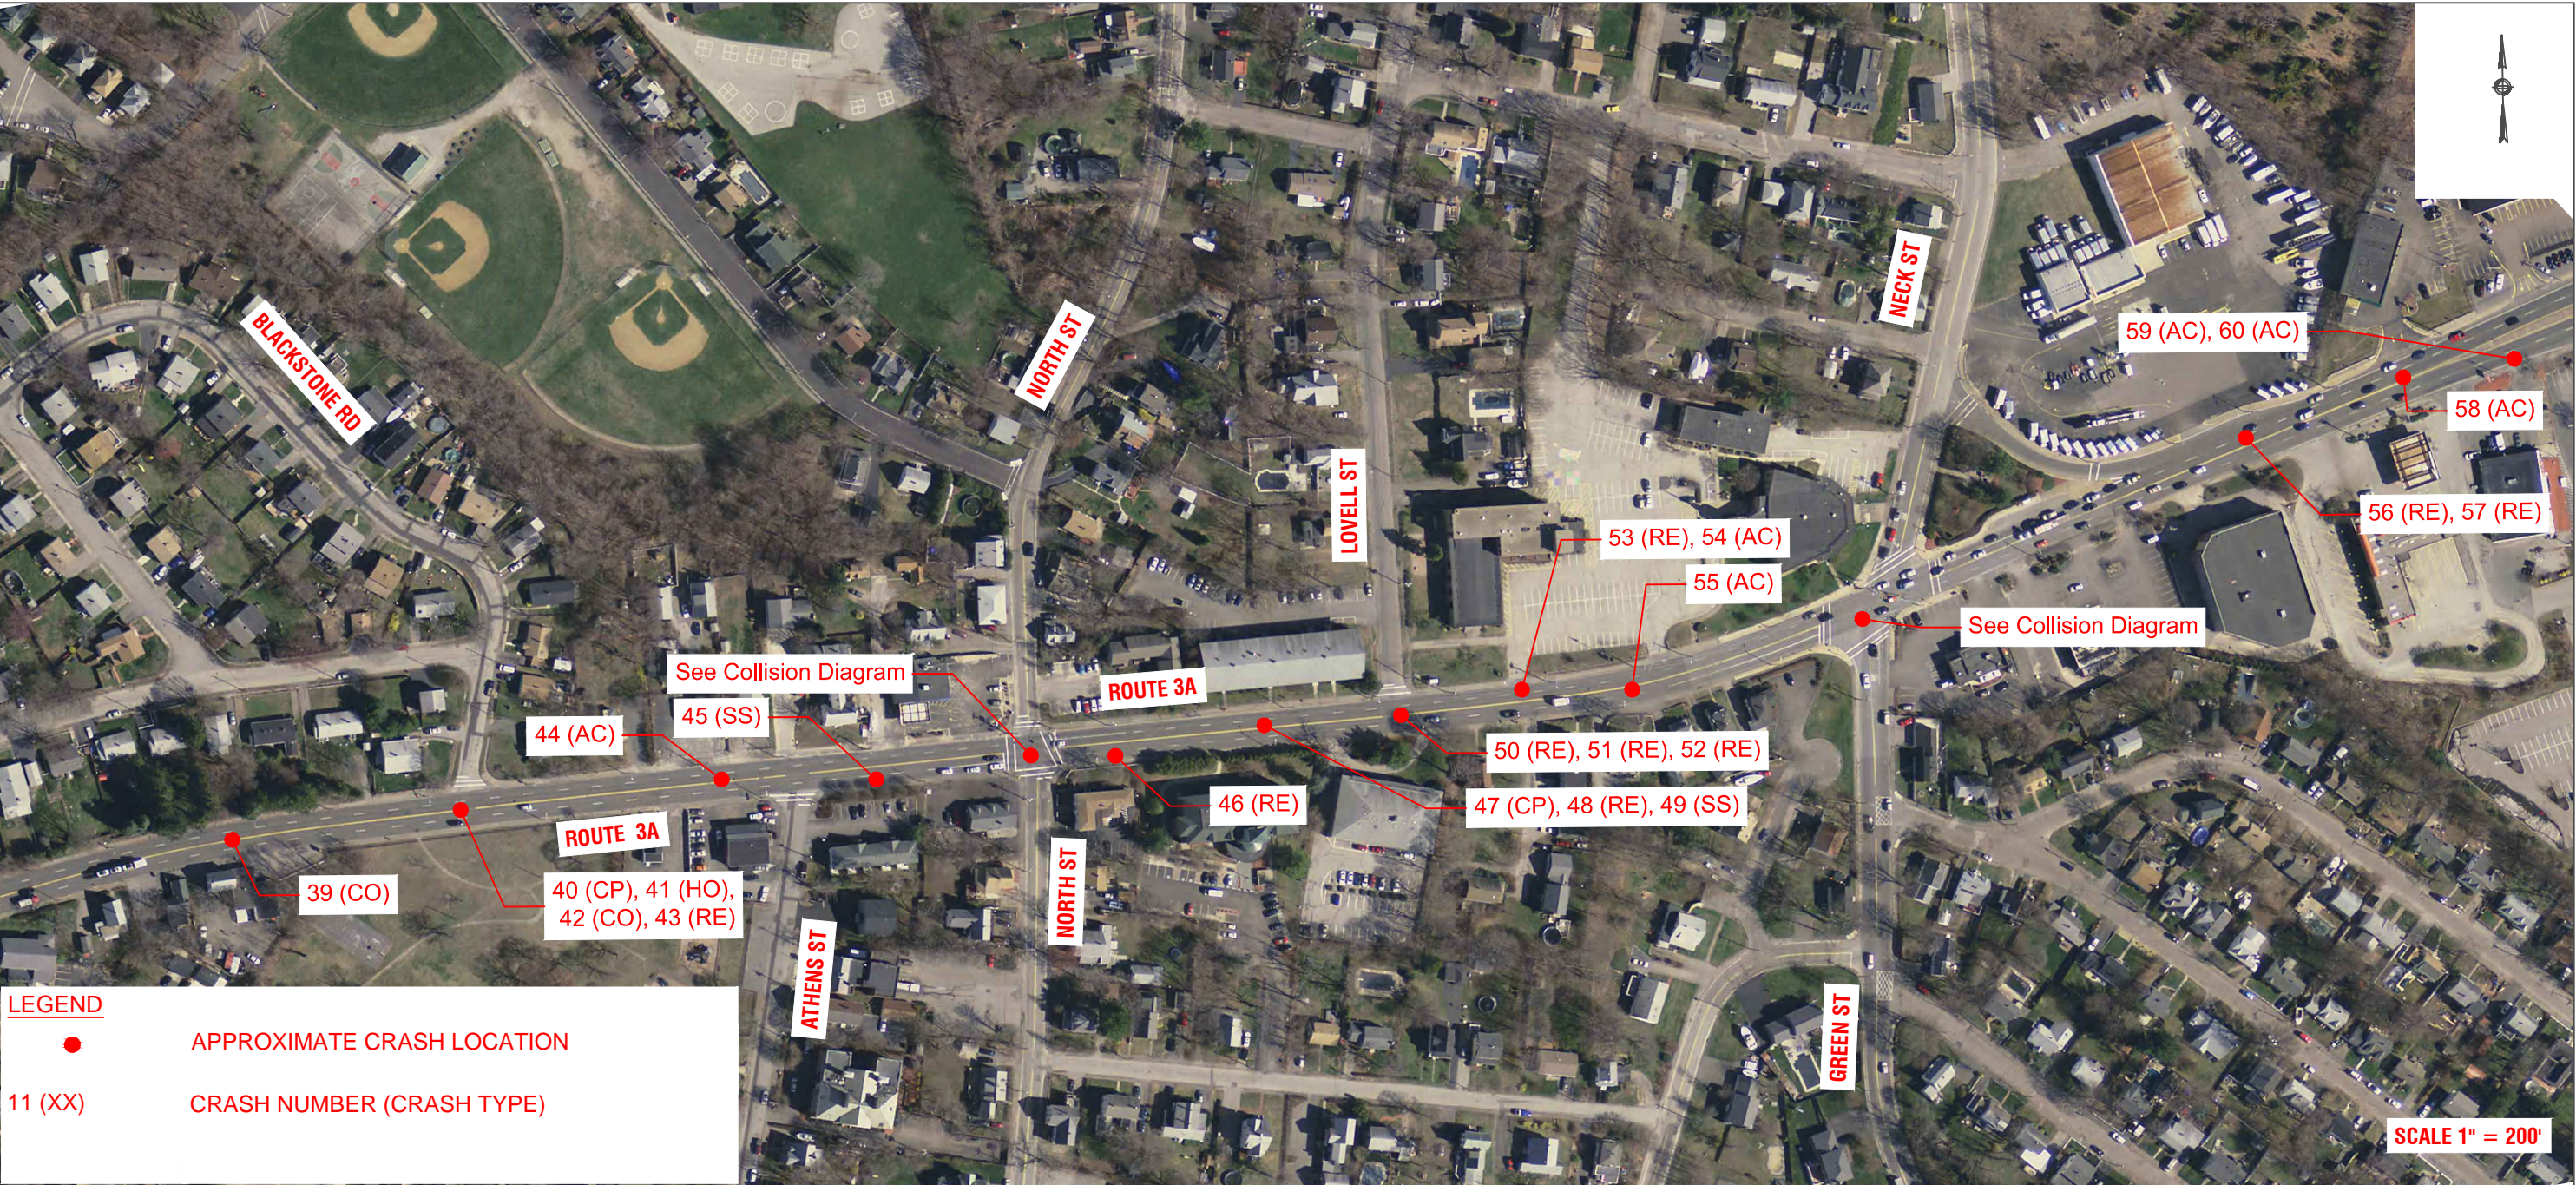
CRASH REPORT DATA

NUMBER	TYPE OF COLLISION	VEHICLES INVOLVED	ROADWAY CONDITION	LIGHT CONDITION	SEVERITY	DATE	DIRECTION
39	CO	1	DRY	DARK (LIT)	PD	10/12/2013	W
40	CP	1	WET	DARK (LIT)	PI	12/6/2014	W
41	HO	4	DRY	DAYLIGHT	PI	2/10/2014	W/E
42	CO	1	DRY	DARK (LIT)	PD	11/28/2013	W
43	RE	2	DRY	DAYLIGHT	PI	5/5/2015	W
44	AC	2	WET	DARK (LIT)	PI	3/30/2014	S/W
45	SS	2	DRY	DARK (LIT)	PD	1/23/2013	E
46	RE	4	DRY	DAYLIGHT	PD	7/3/2013	E
47	CP	1	WET	DARK (LIT)	PI	12/6/2013	W
48	RE	2	DRY	DAYLIGHT	PD	9/1/2015	E
49	SS	2	DRY	DAYLIGHT	PD	7/21/2015	W
50	RE	2	DRY	DAYLIGHT	PD	8/28/2013	E
51	RE	2	DRY	DARK (LIT)	PD	5/13/2015	E
52	RE	2	DRY	DARK (LIT)	PD	10/2/2014	E
53	RE	2	DRY	DAYLIGHT	PD	3/21/2013	E

NUMBER	TYPE OF COLLISION	VEHICLES INVOLVED	ROADWAY CONDITION	LIGHT CONDITION	SEVERITY	DATE	DIRECTION
54	AC	2	WET	DAYLIGHT	PD	3/14/2015	E
55	AC	3	DRY	DAYLIGHT	PD	4/29/2013	N/E
56	RE	2	DRY	DARK (LIT)	PD	6/4/2013	E
57	RE	2	DRY	DAYLIGHT	PI	1/13/2014	W
58	AC	2	WET	DAYLIGHT	PD	4/24/2013	W
59	AC	2	DRY	DAYLIGHT	PD	10/31/2014	N/E
60	AC	2	WET	DAYLIGHT	PD	3/15/2015	N/E
