Update to Basis of Design Report

Old Swamp River Dam Removal and Restoration

**Libbey Industrial Parkway
Weymouth, Massachusetts**

Presented to
**Massachusetts Division of Ecological
Restoration (DER)**
251 Causeway Street, Suite 400
Boston, MA 02114

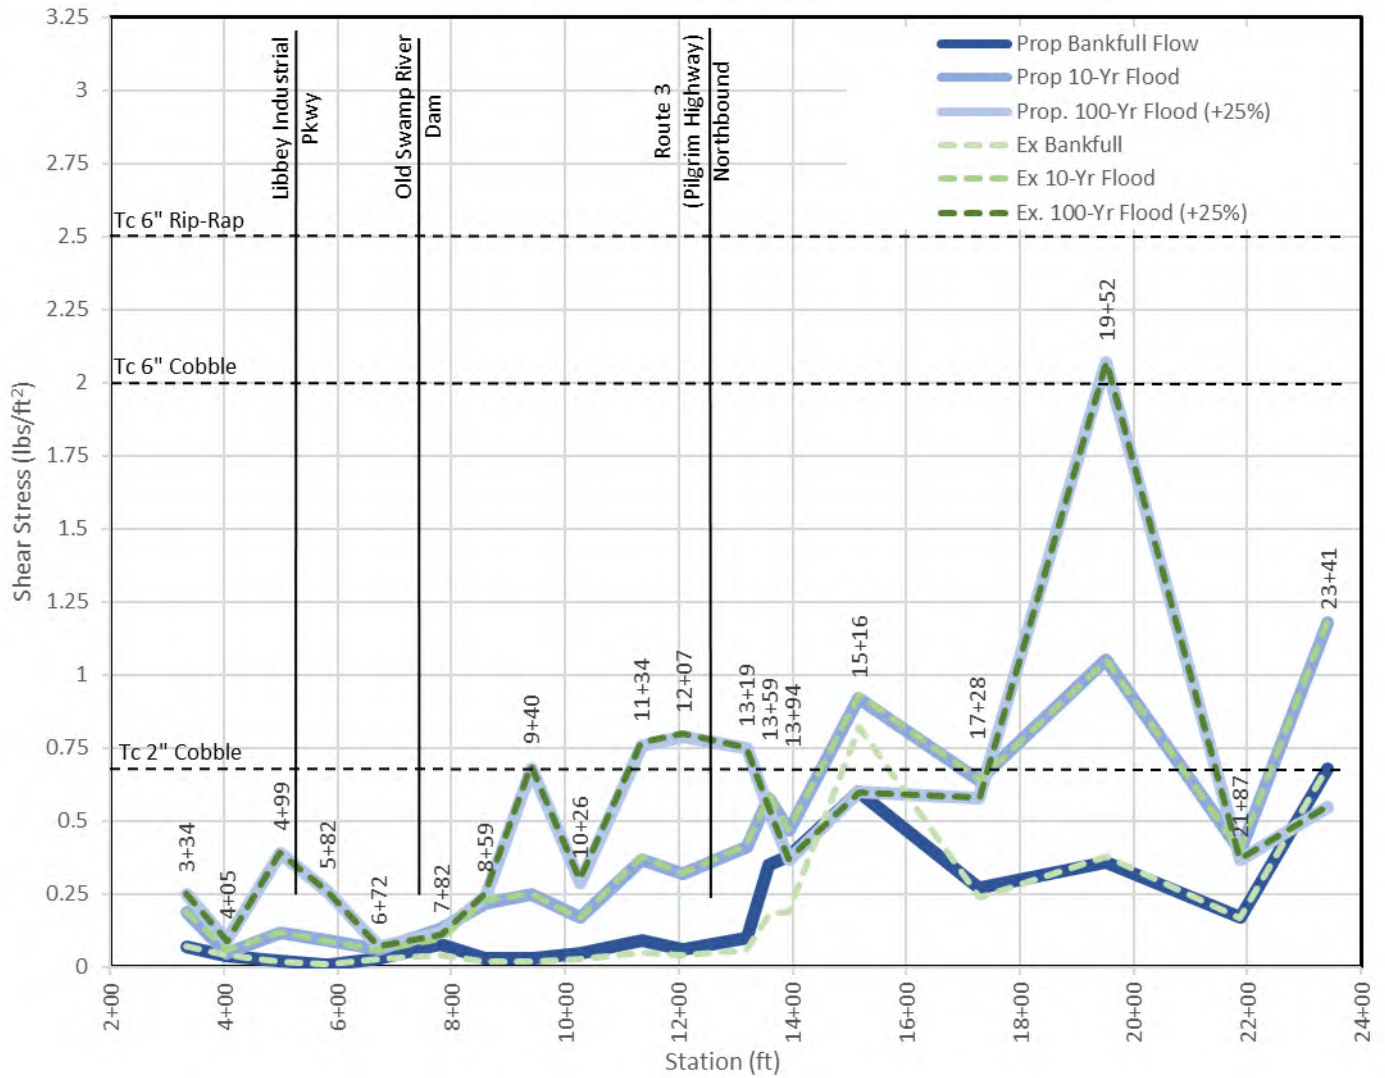
Figure 16: Existing and Proposed Conditions Shear Stress with Fischensch Substrate Types

Existing and Proposed Conditions Channel Shear Stress

The highest velocity and shear stress occur at cross section 1952 upstream of the project area with a velocity of 9.4 feet per second and a shear stress of 2.1 pounds per square foot in the 100-year plus 25 percent event; however, the comparison of existing and proposed conditions indicates that there is little change post-dam removal. Within the area of proposed channel grading and stabilization at the dam removal (Station 782), velocities are predicted at 1.6 feet per second and shear stresses are predicted to be 0.1 pound per square foot in the 100-year plus 25 percent flood within the main channel, which falls within the lower range of permissible velocity and shear stress for 2-inch cobble. The proposed riffle conservatively provides 6-inch cobble as substrate. The greatest increase in velocity is anticipated upstream of the Route 3 culvert (Station 1394) where velocity

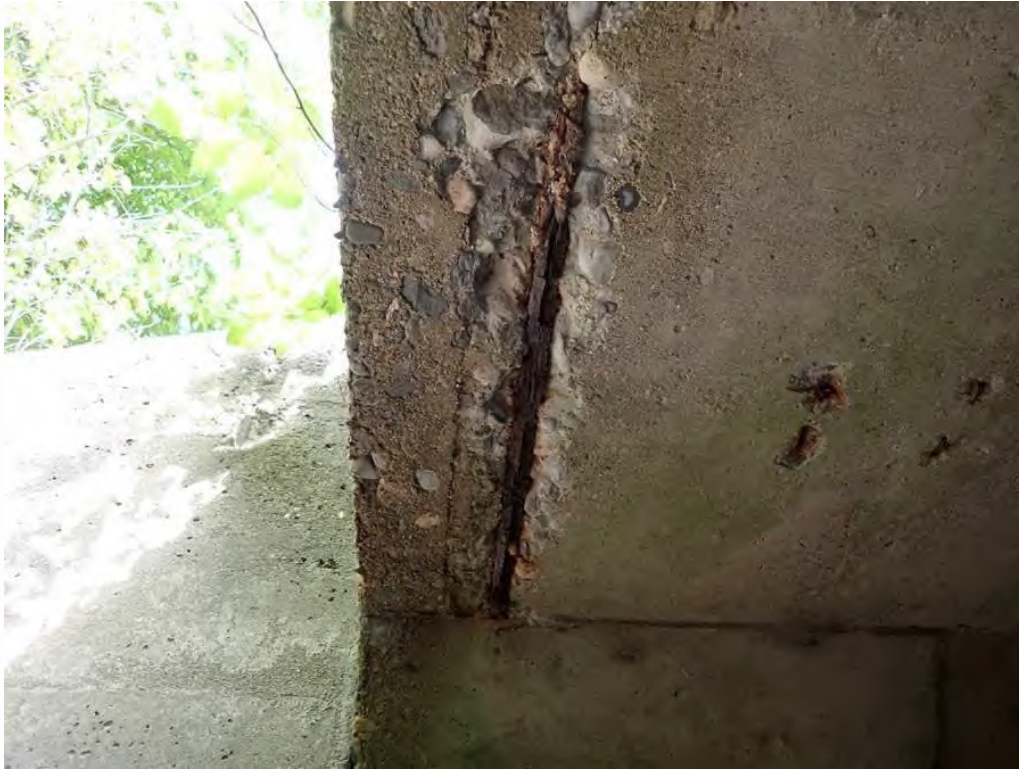
Photo 1: West end of the roof by the north breastwall, spall with exposed rusted rebar with insignificant section loss. Just east, 8 pop-outs with rebar

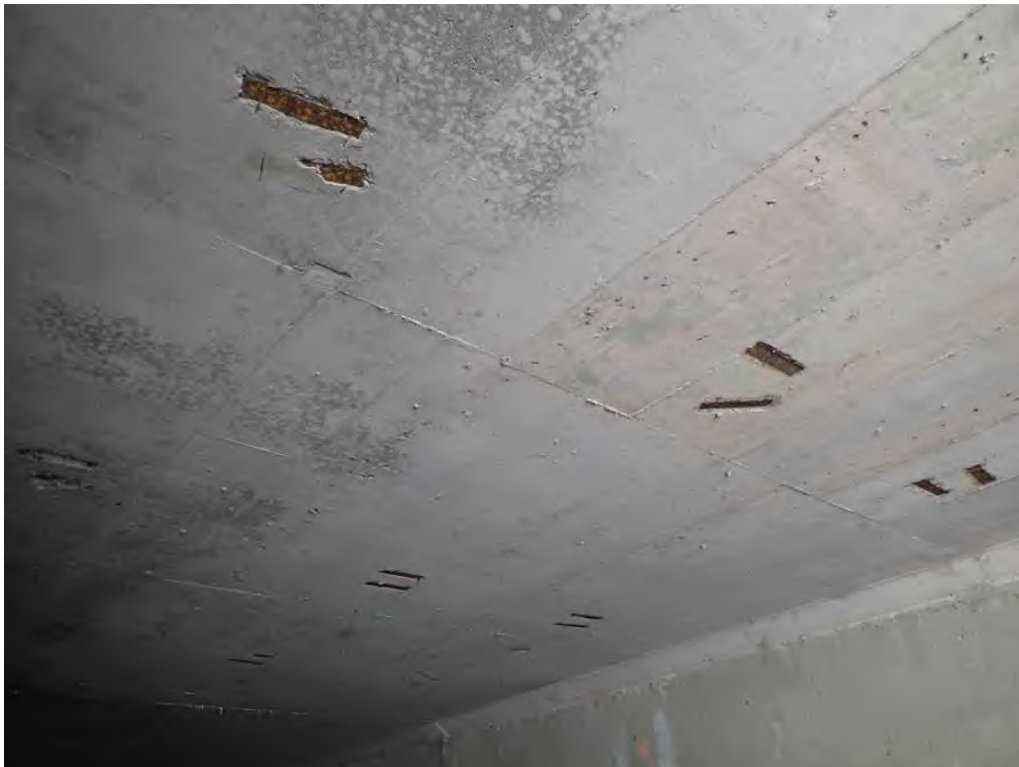
Photo 2: West end of roof, 7', 13' and 18' in, there are three pairs of exposed metal plates, left side, center, and right side of roof

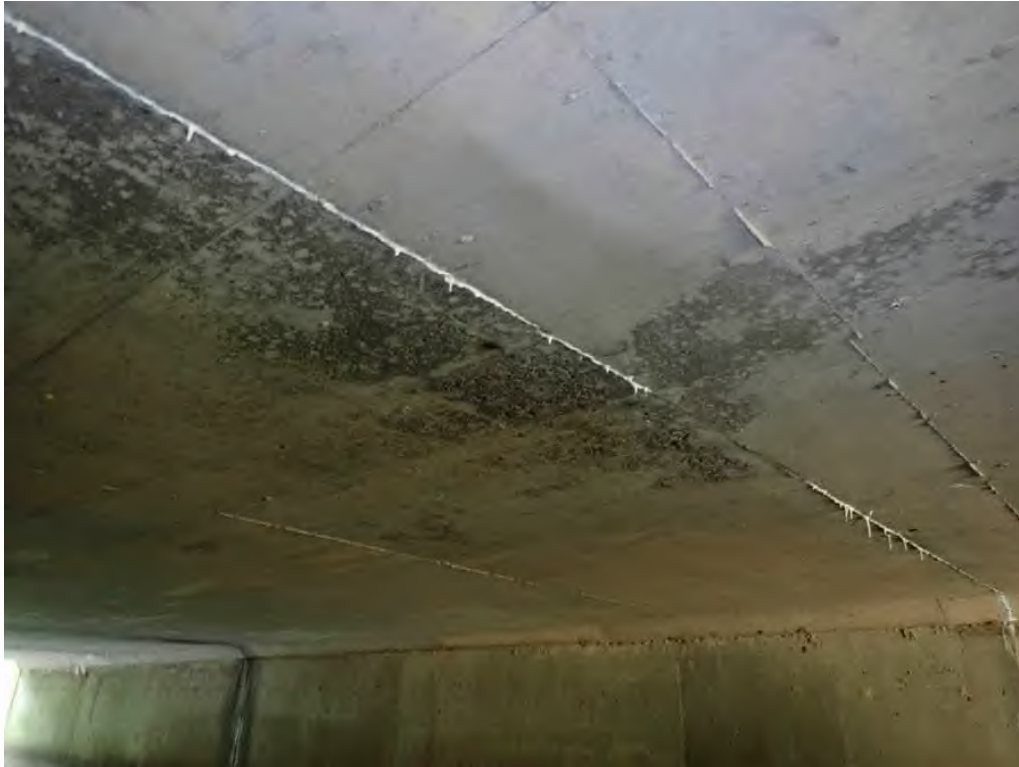
Photo 3: Underside of roof 25' from the west end, cracking with efflorescence and stalactites full width

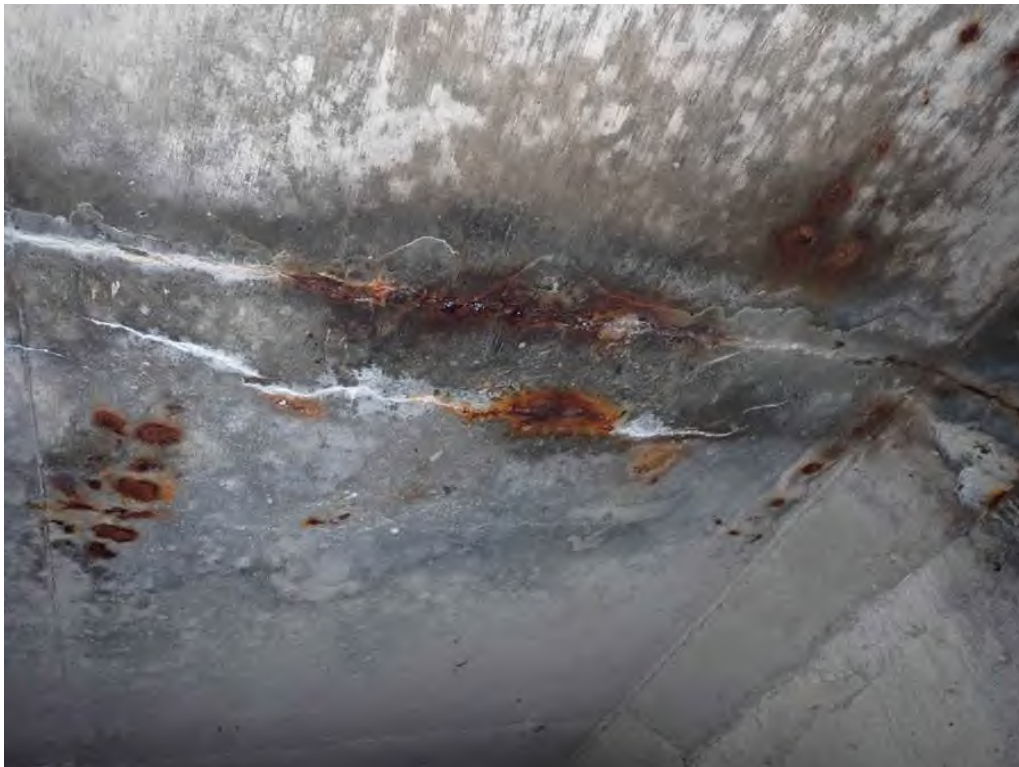
Photo 4: Roof joint 25' from the east end, hairline cracking with efflorescence, rust staining and water staining adjacent to the south wall

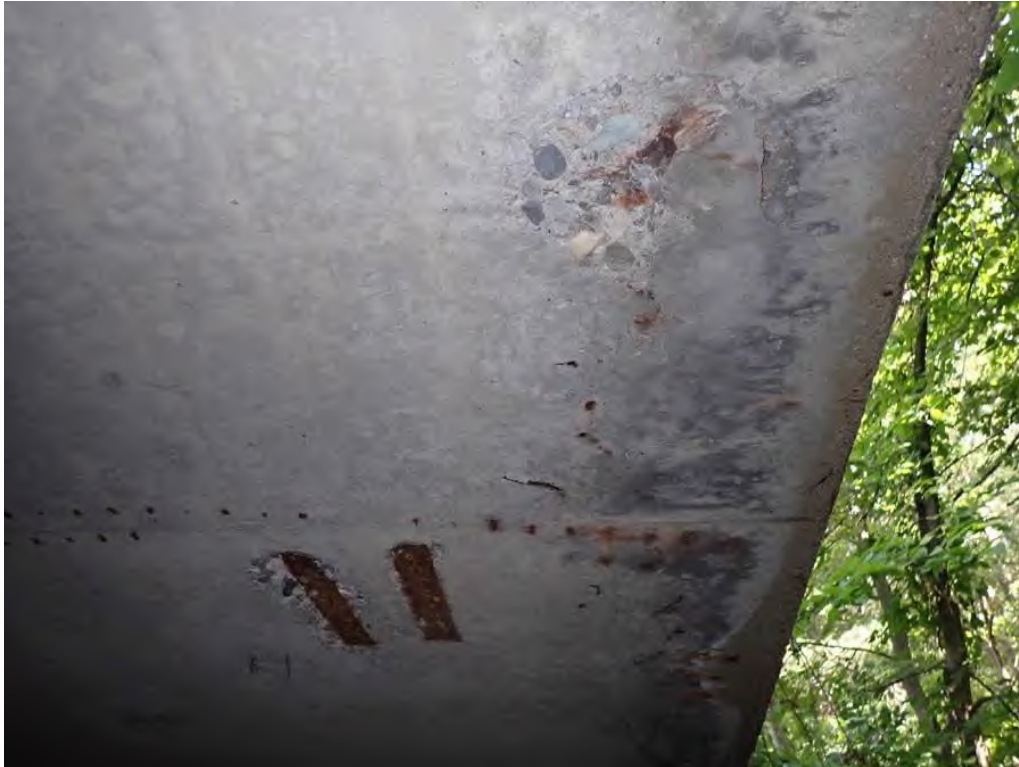
Photo 5: East end of roof, two 2" x 10" exposed metal, one with delamination and minor spall just south of exposed metal at midspan

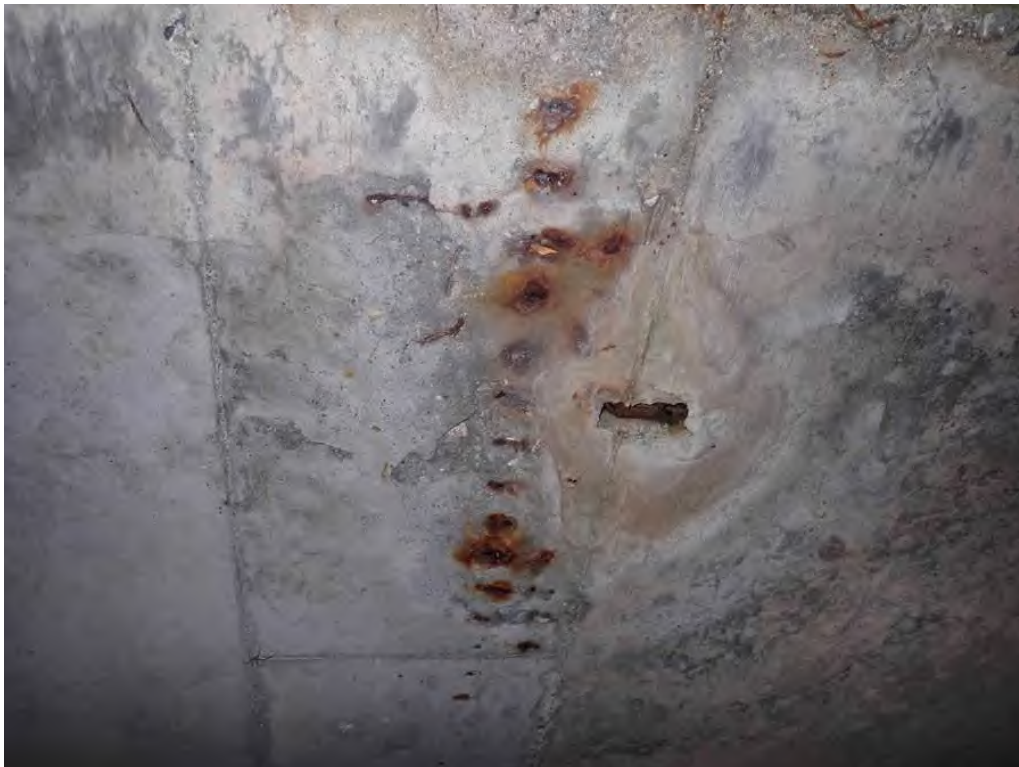
Photo 6: East end of the roof, minor spalling and delamination with exposed metal plates on the north side

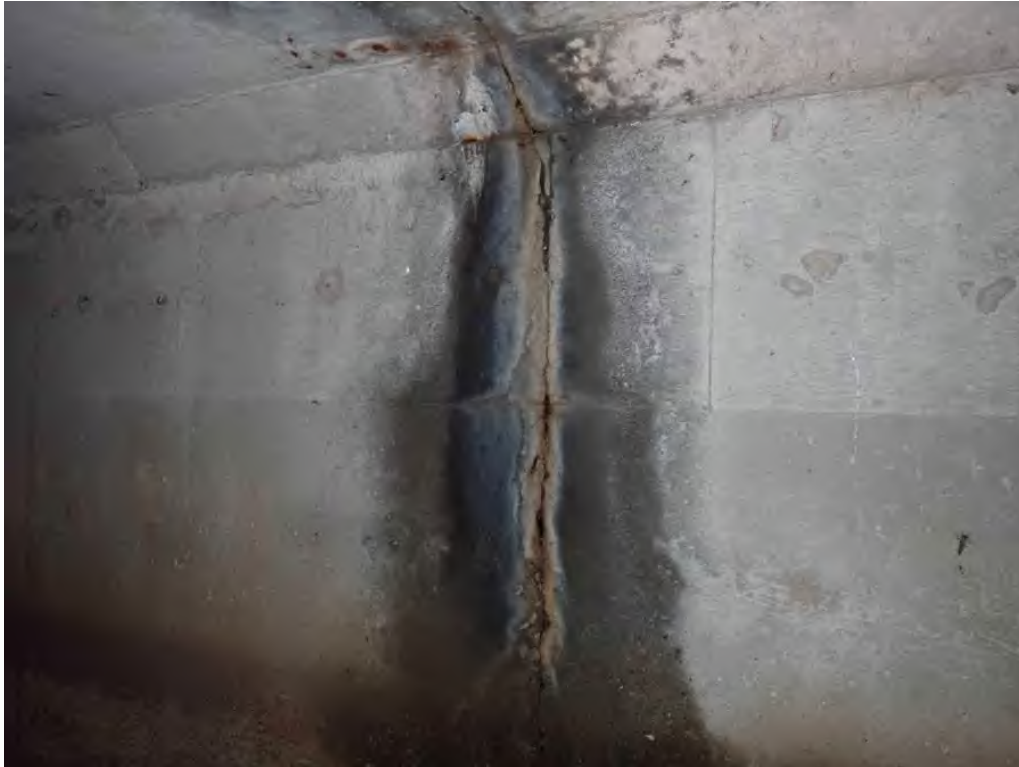
Photo 7: South wall 25' from east end, full height moderate crack, rust, efflorescence, and water staining, same at opposite wall

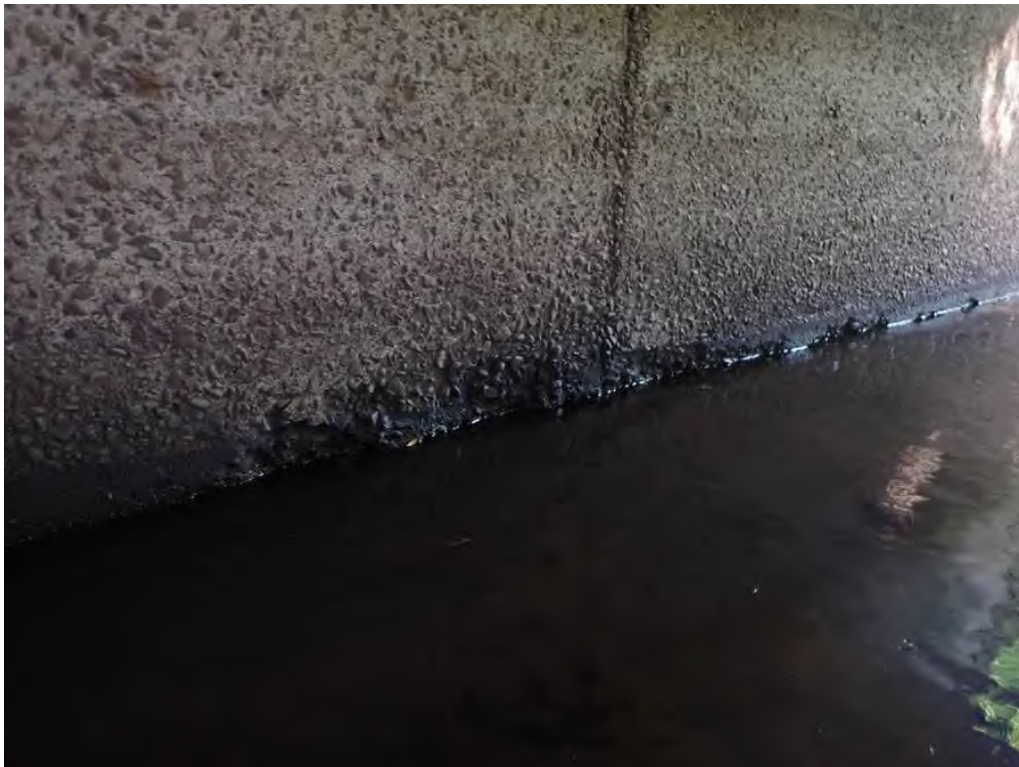
Photo 8: Ratholing at the waterline along the north wall by the east end

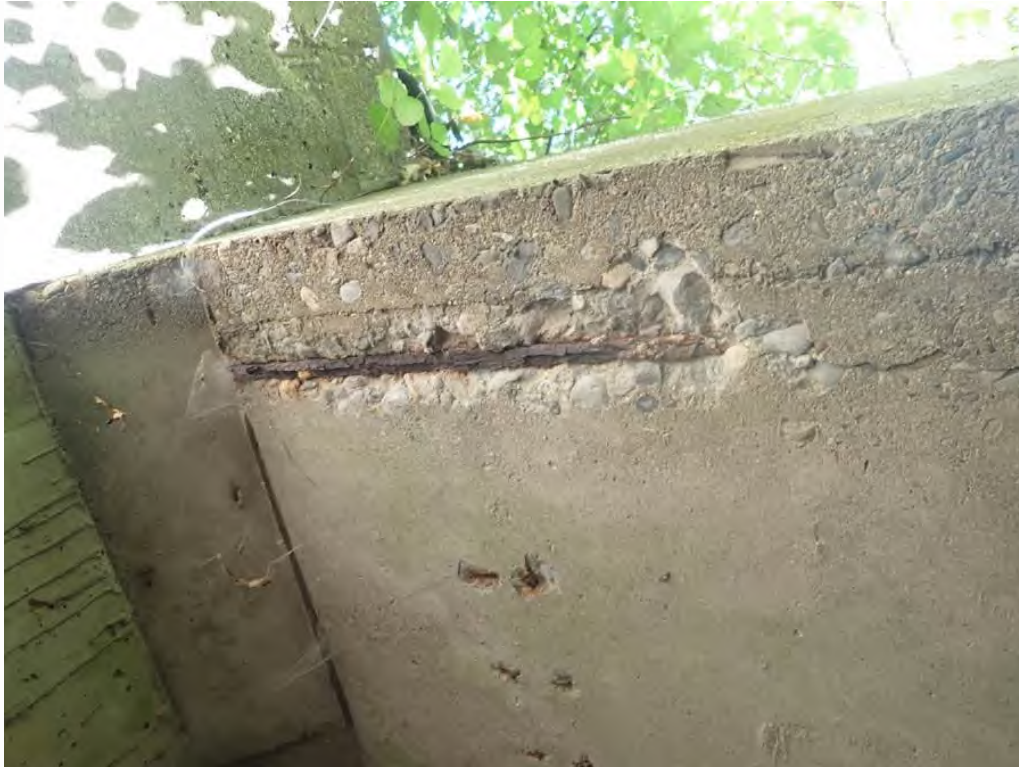
Photo 1: West end of the roof by the north breastwall, spall with exposed rusted rebar with insignificant section loss. Just east, 8 pop-outs with rebar

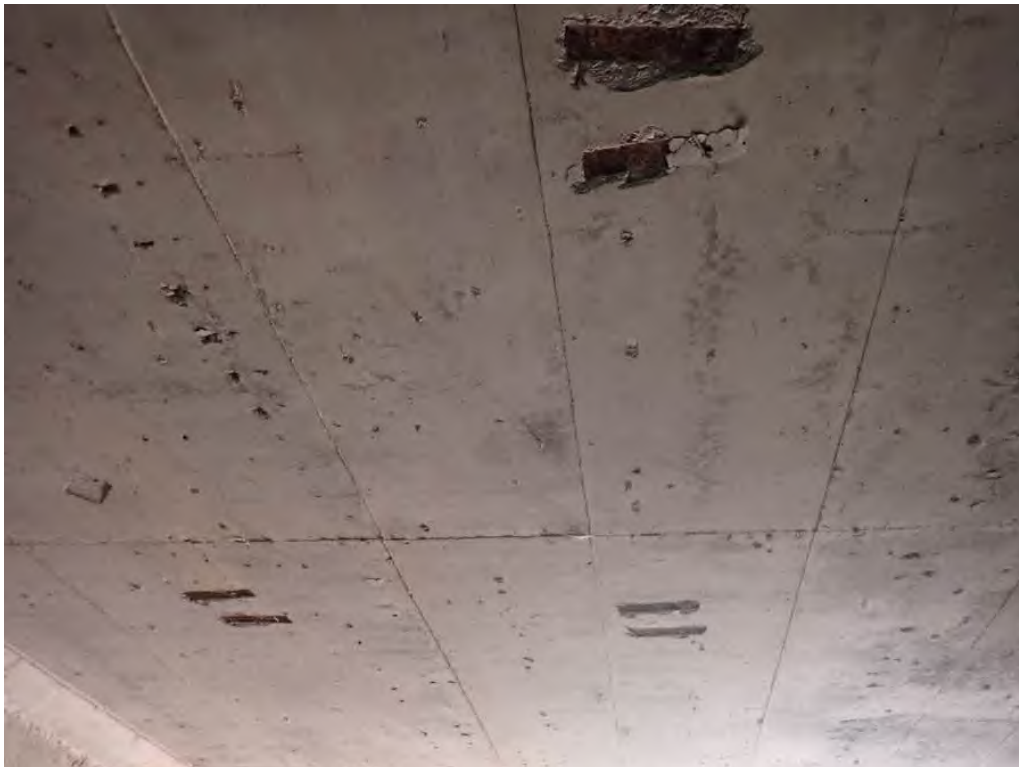
Photo 2: West end of roof, 7', 13' and 18' in, there are three pairs of exposed metal plates, left side, center, and right side of roof

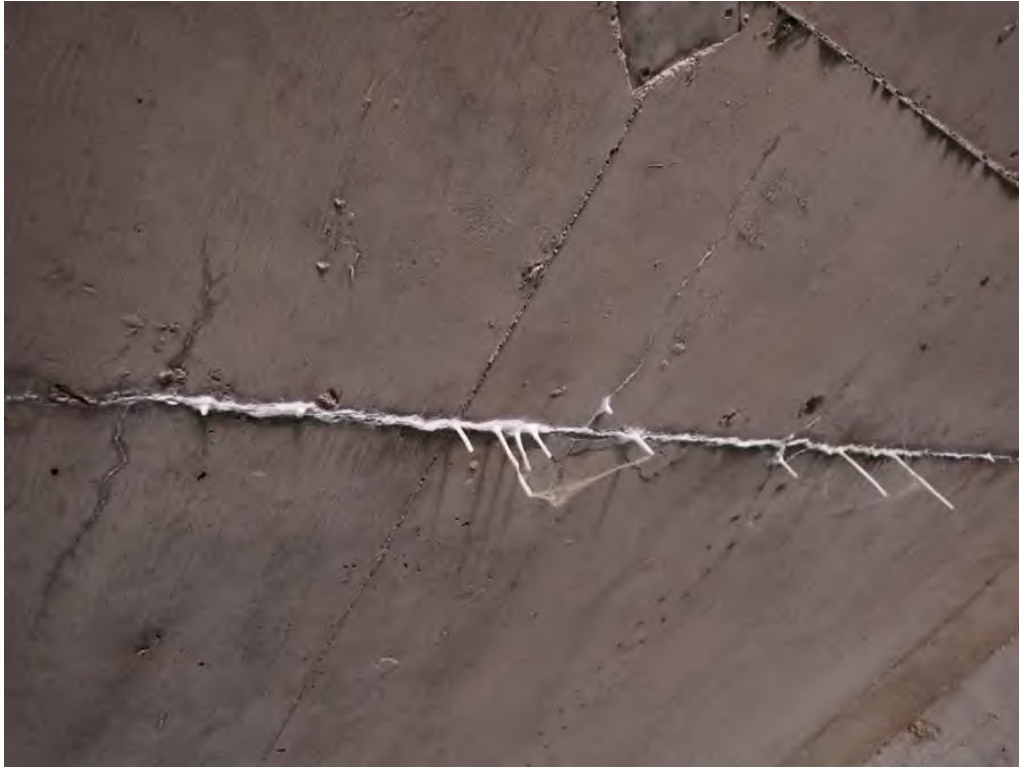
Photo 3: Underside of roof 1/4 way in from the west end, cracking with efflorescence and stalactites full width

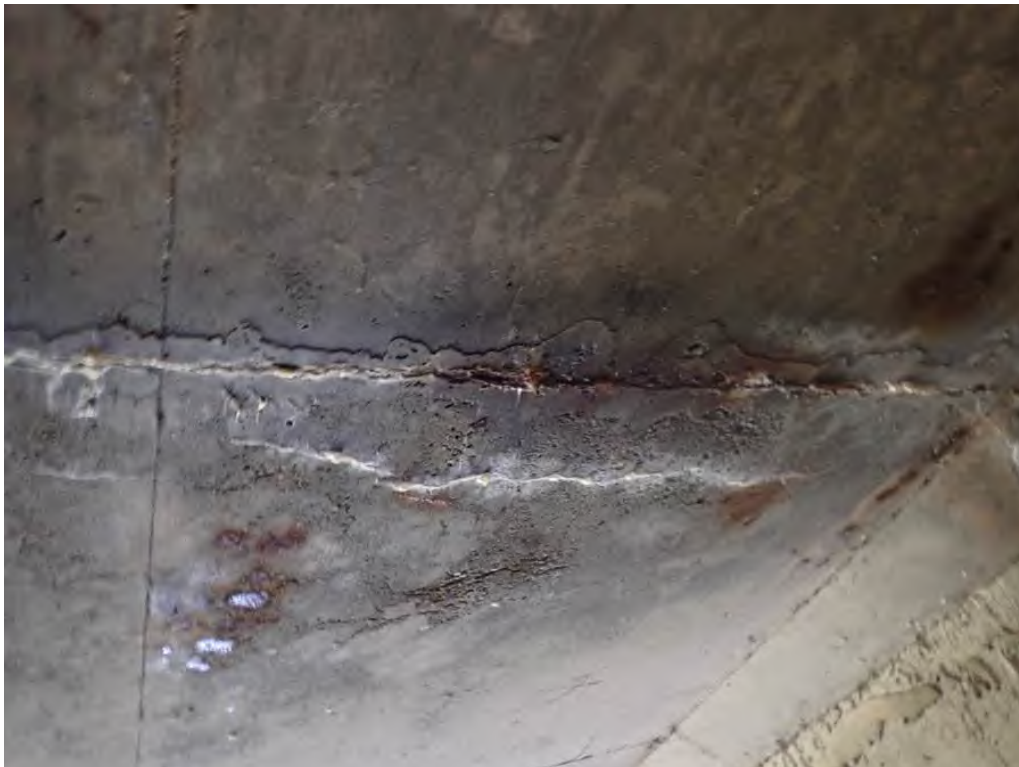
Photo 4: Roof joint 1/4 way in from the east end, hairline cracking with efflorescence, rust staining and water staining at south wall

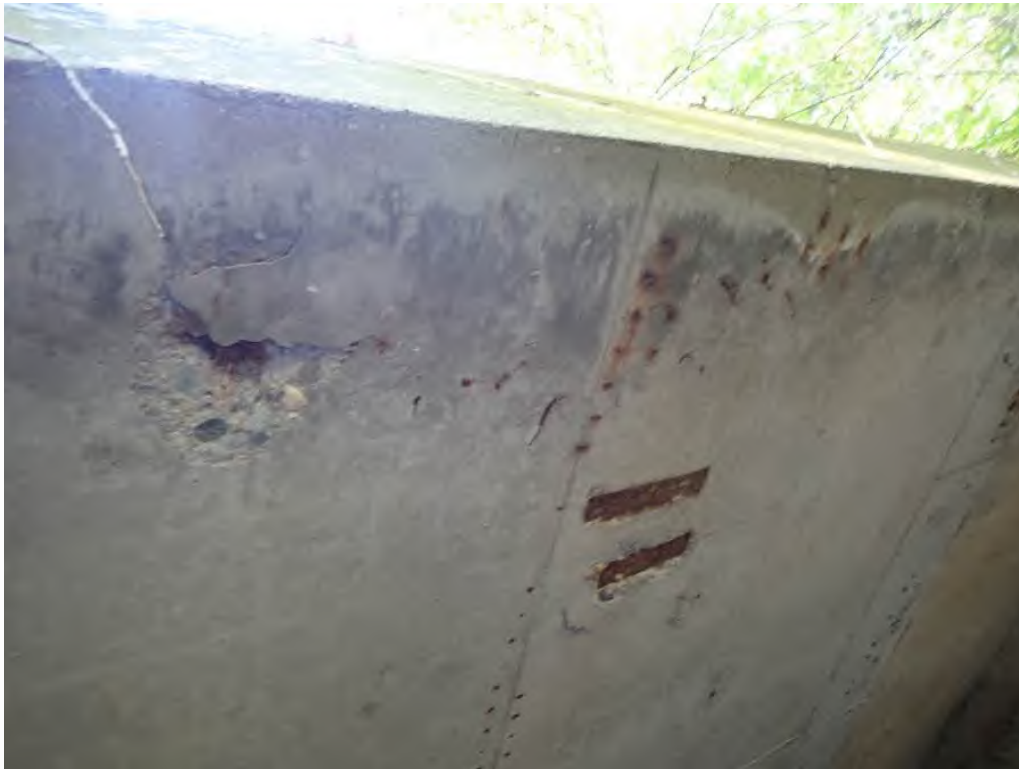
Photo 5: East end of roof, two 2" x 10" exposed metal, one with delamination and minor spall just south of exposed metal at midspan

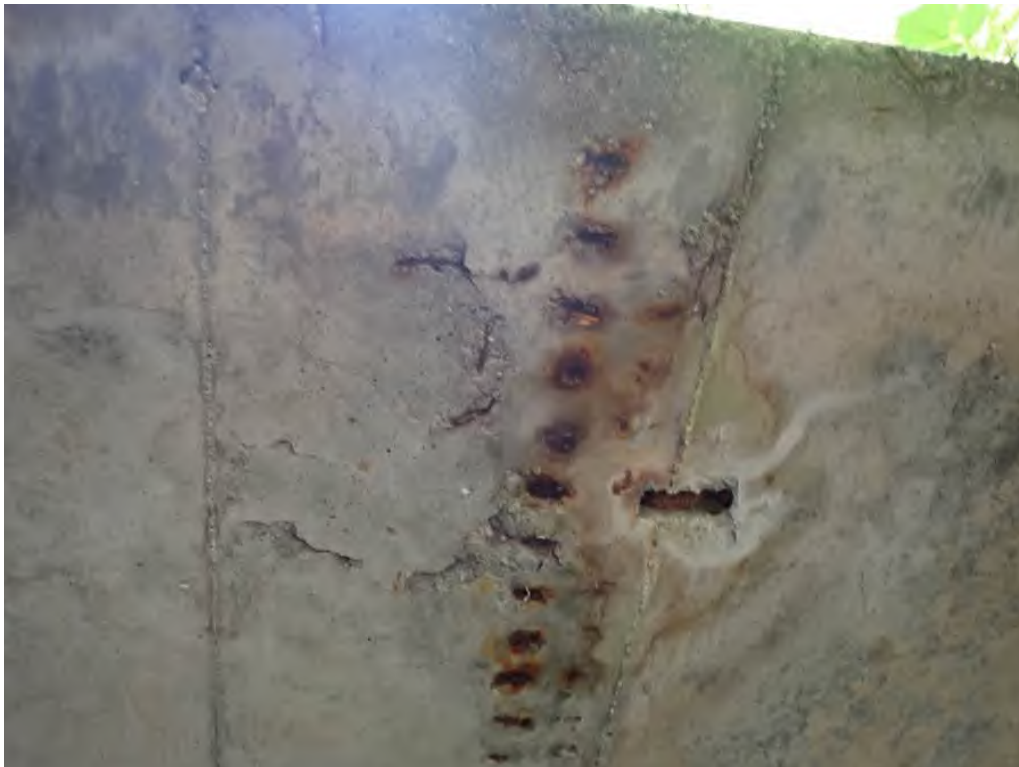
Photo 6: East end of the roof, minor spalling and delamination with exposed metal plates on the north side

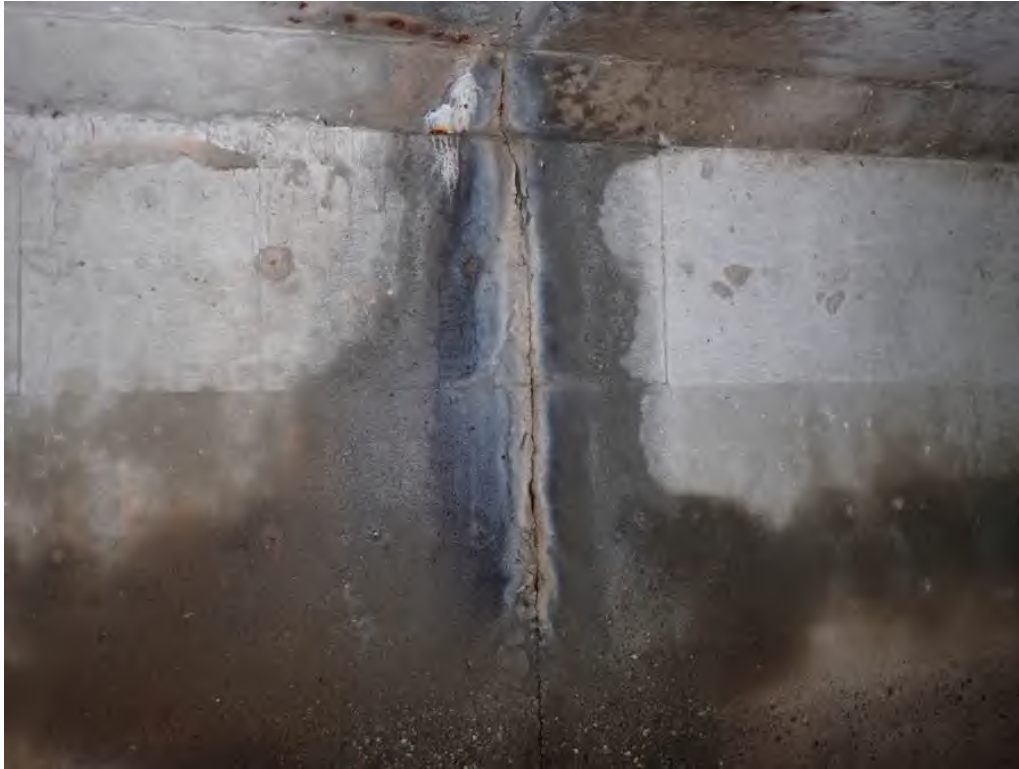
Photo 7: South wall 1/4 way in from east end, full height moderate crack, rust, efflorescence, and water staining, same at opposite wall

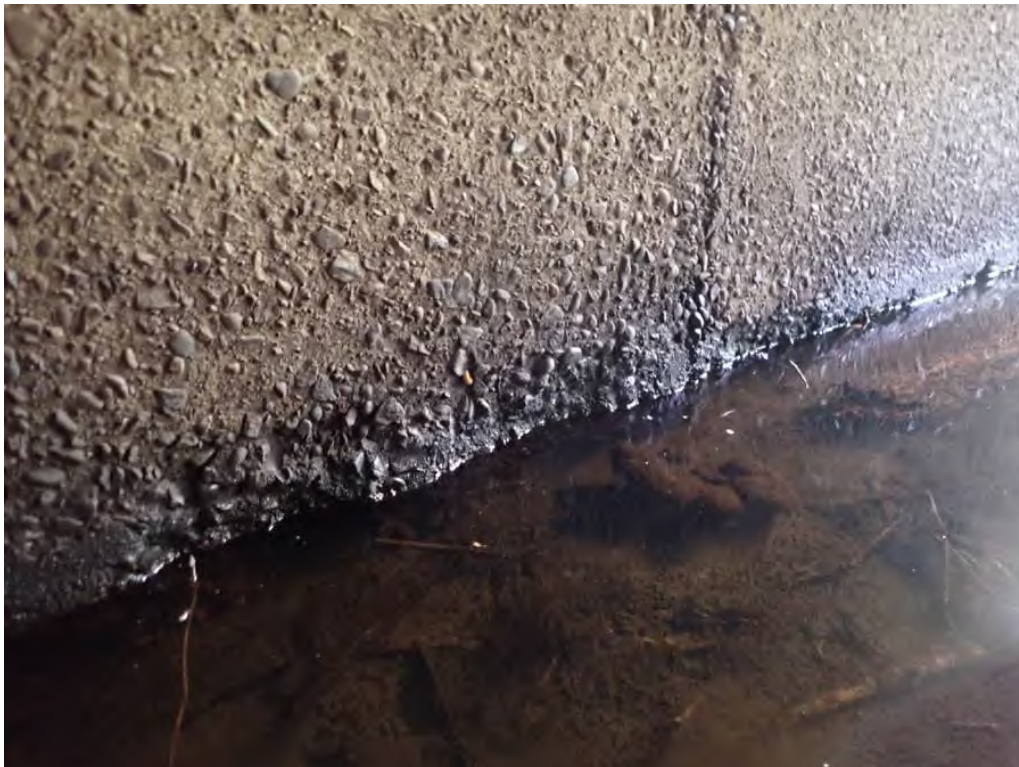
Photo 8: Ratholing at the waterline along the north wall by the east end

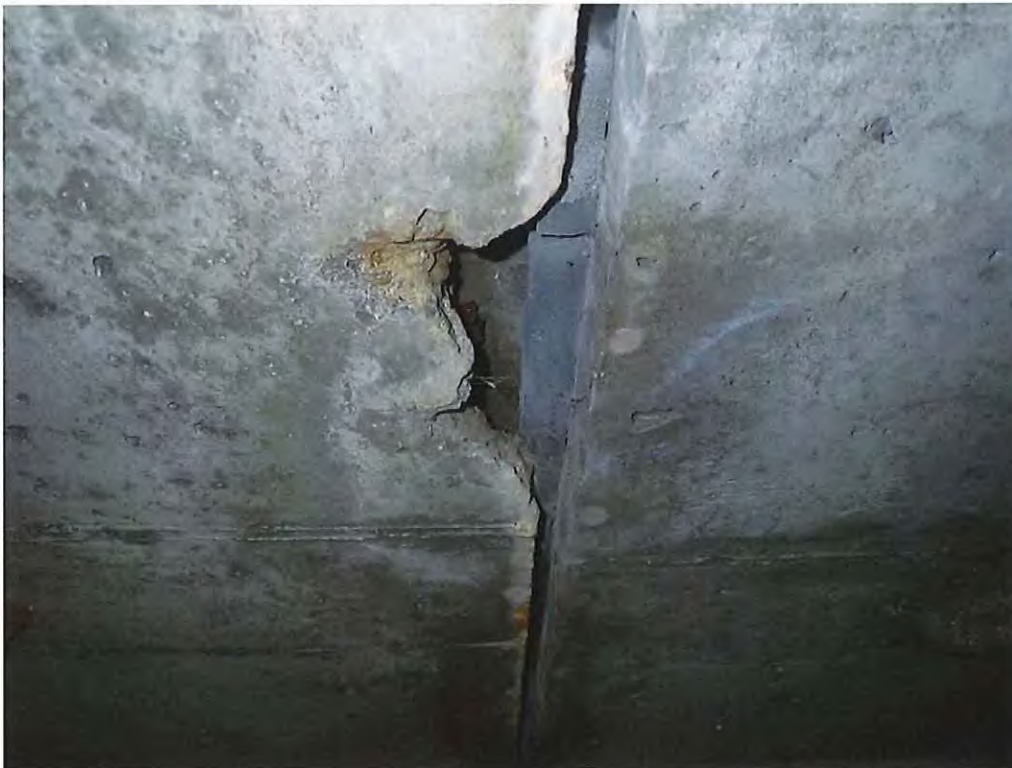
Photo 2: Minor spall in the roof at the south edge of joint #1 in span #1

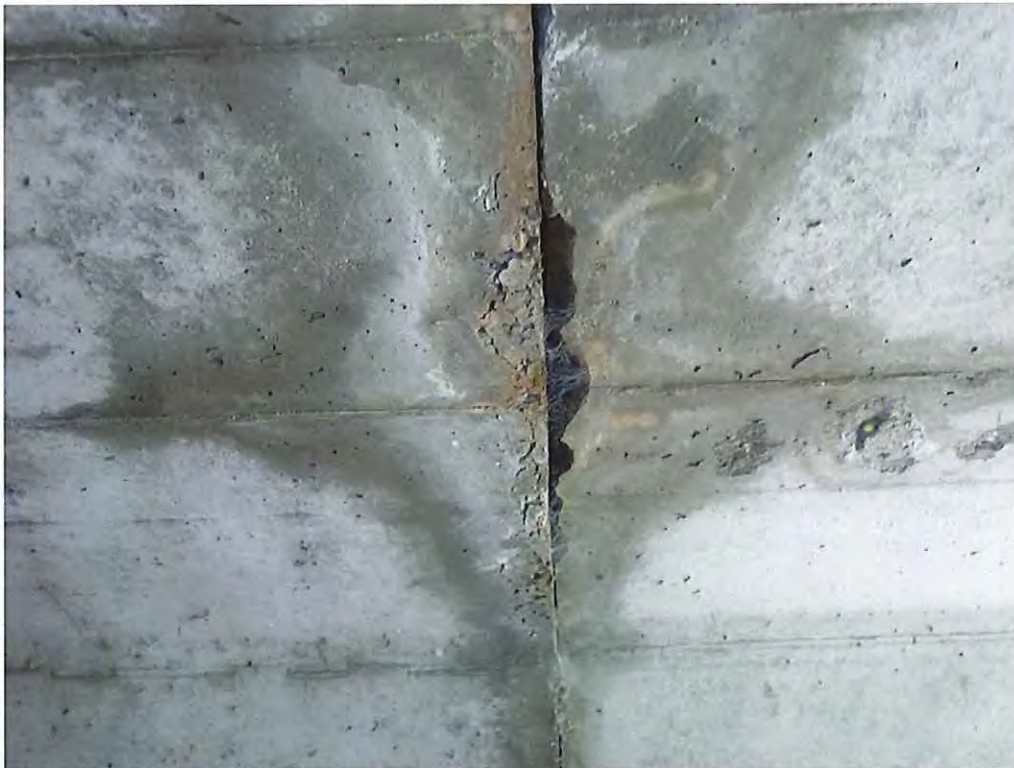
Photo 4: Minor spalling in the roof in span #2 at joint #6 and just north of joint #6

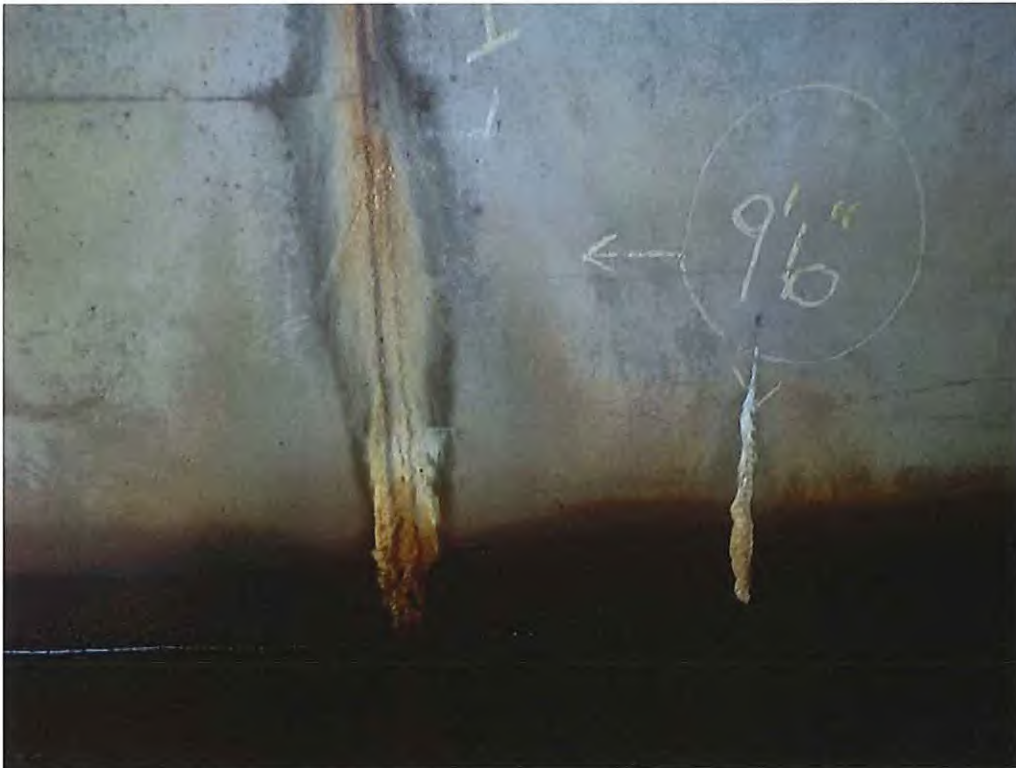
Photo 6: Heavy efflorescence at joint #1 of the west wall in span #1 and typical vertical crack with efflorescence

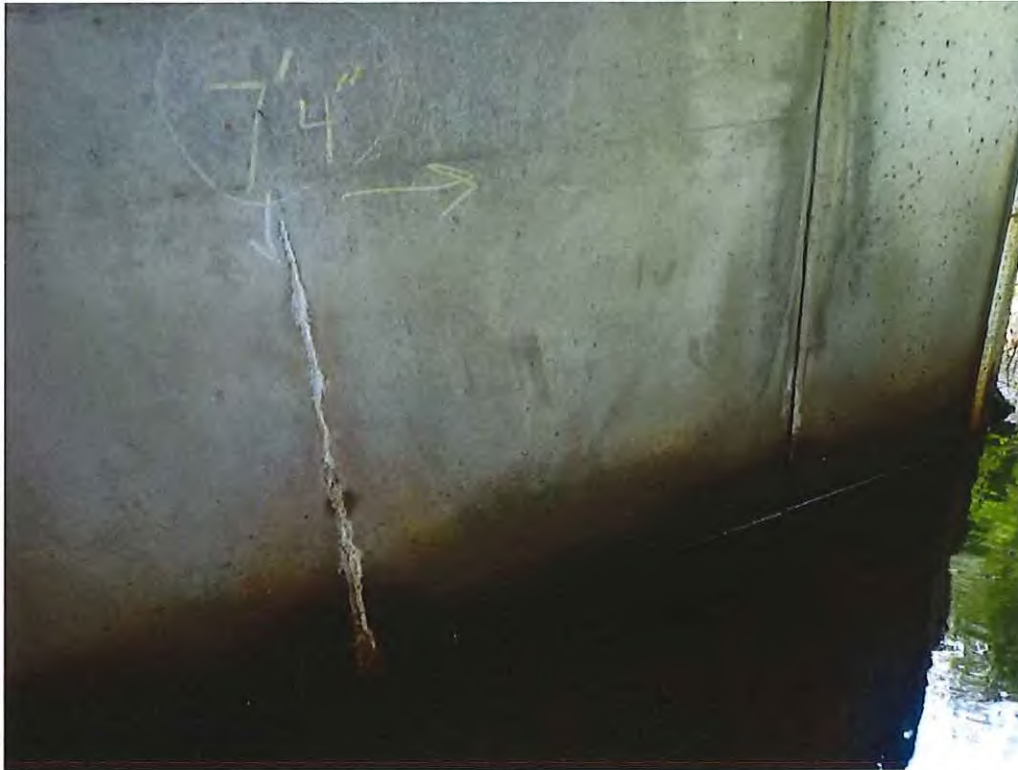
Photo 7: Typical vertical cracks with efflorescence in span #2 at the south end of the west wall

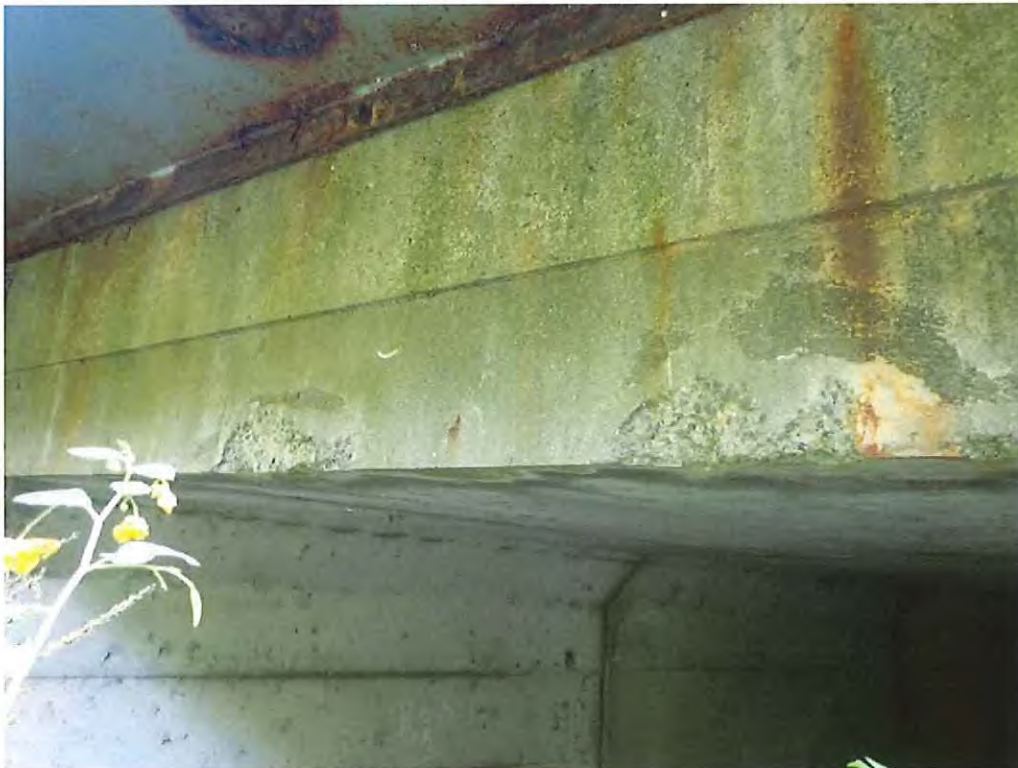
Photo 8: Two minor spalls at the bottom of the south headwall in span #2

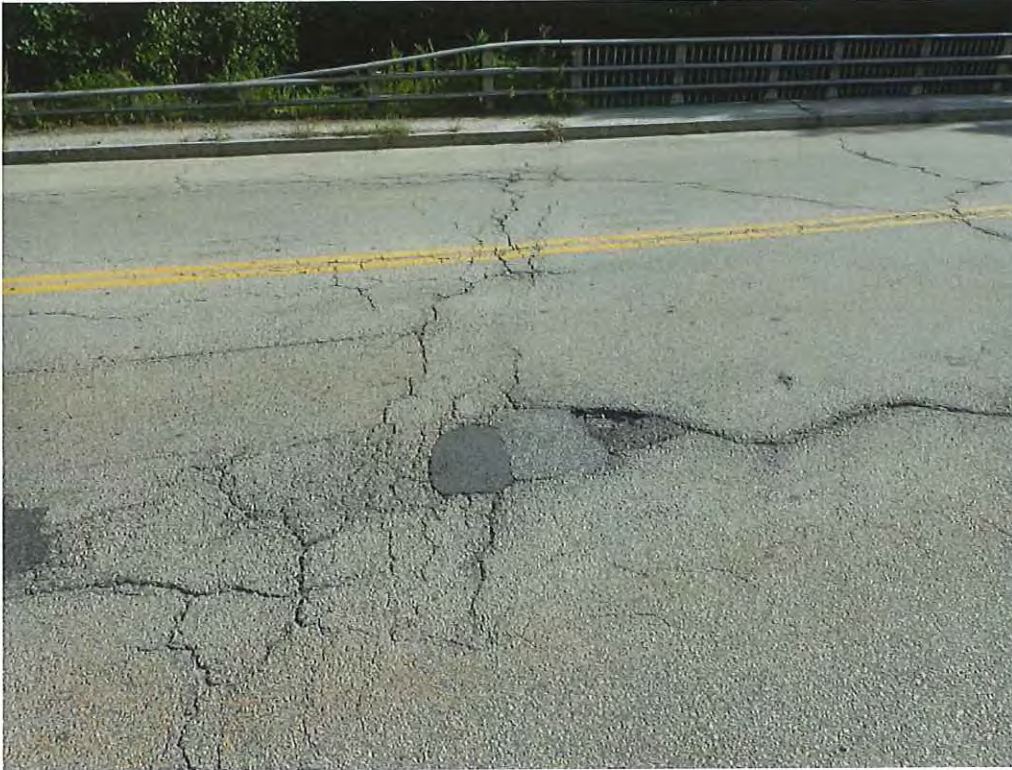
Photo 9: Transverse cracking over the west abutment with bituminous patching and a pothole in the eastbound approach roadway

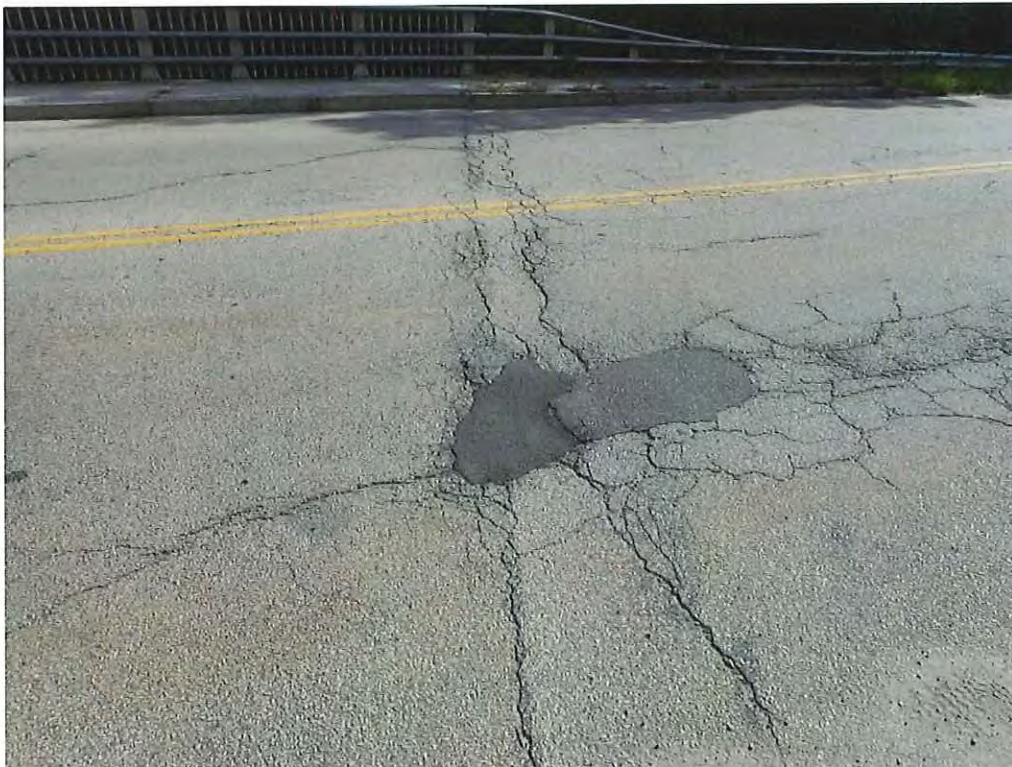
Photo 10: Moderate cracking over the east abutment with bituminous patching in the eastbound roadway extending into the east approach

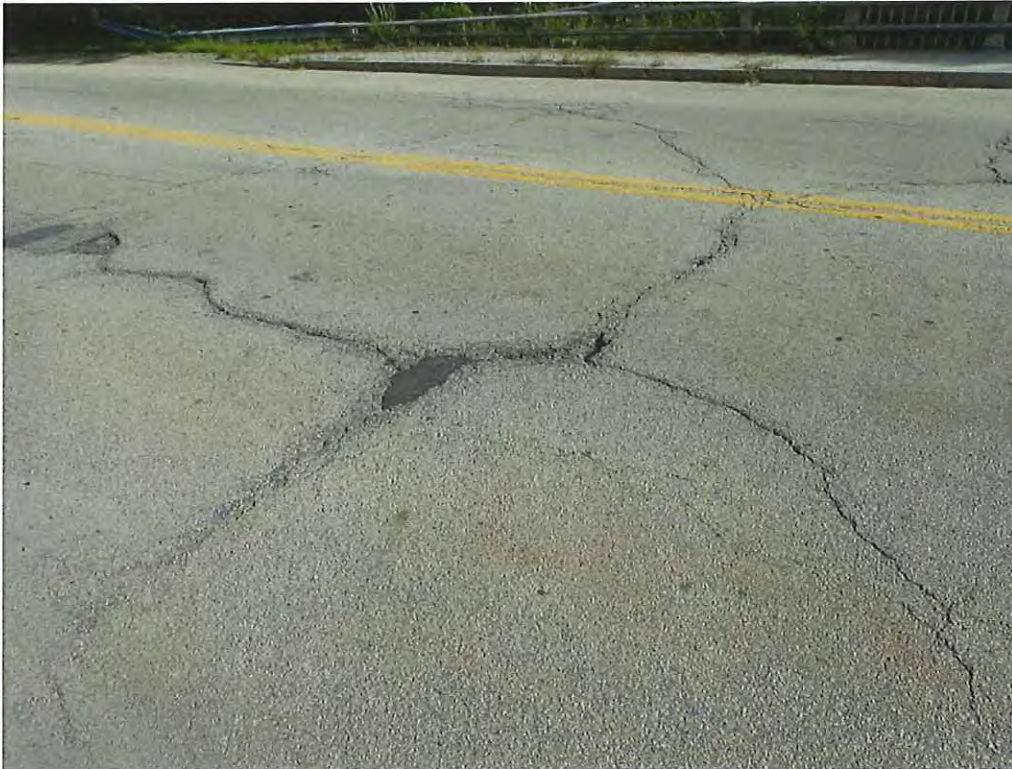
Photo 11: Typical moderate cracking with bituminous breaking up in the wearing surface, note pothole near midspan of eastbound travel lane

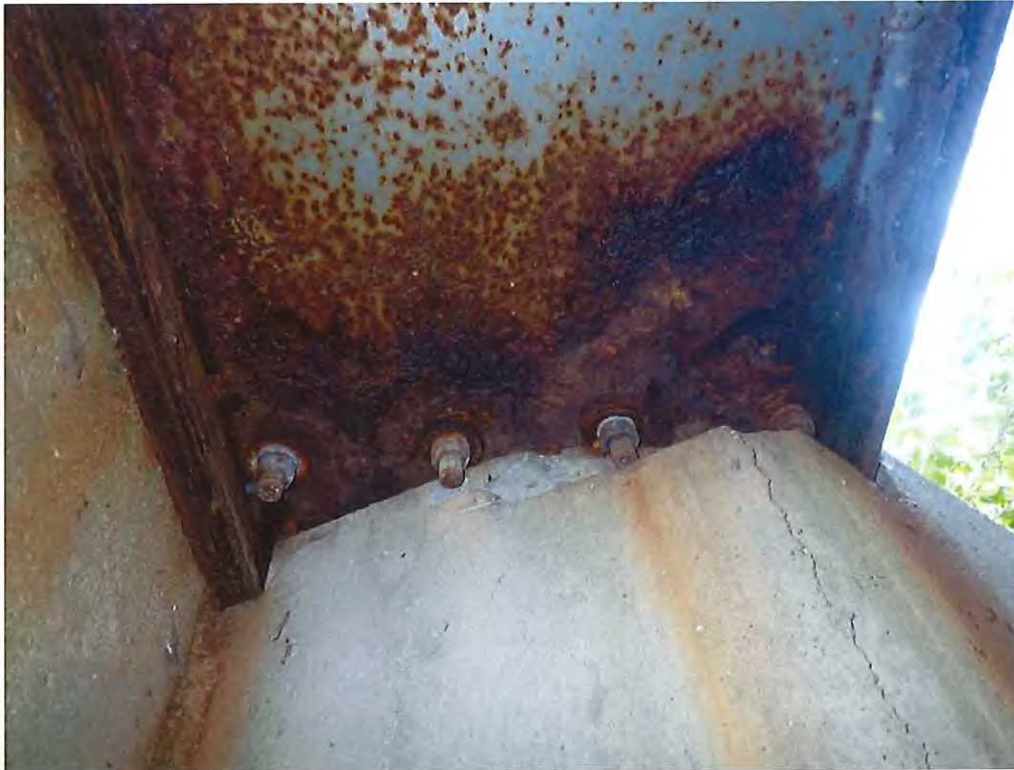
Photo 13: Typical heavy rusting with lamination at the edges of the steel support (below utilities)

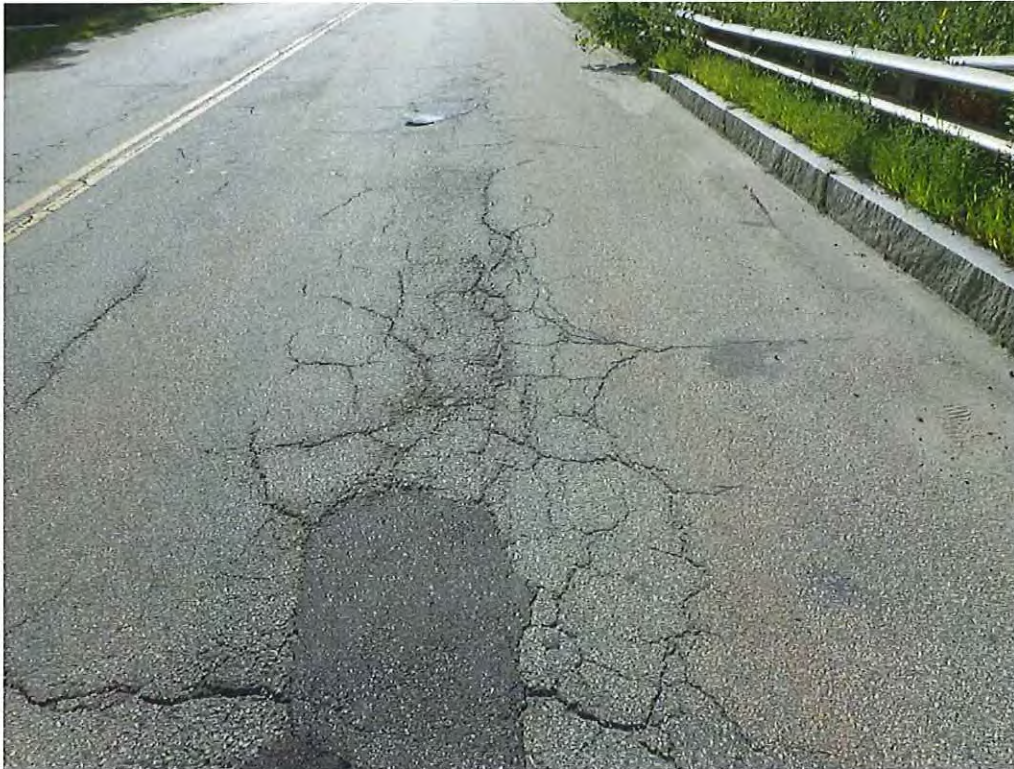
Photo 17: Moderate to heavy map, longitudinal, and transverse cracking in the eastbound roadway at the east approach
