Update to Basis of Design Report

Old Swamp River Dam Removal and Restoration

**Libbey Industrial Parkway
Weymouth, Massachusetts**

Presented to
**Massachusetts Division of Ecological
Restoration (DER)**
251 Causeway Street, Suite 400
Boston, MA 02114

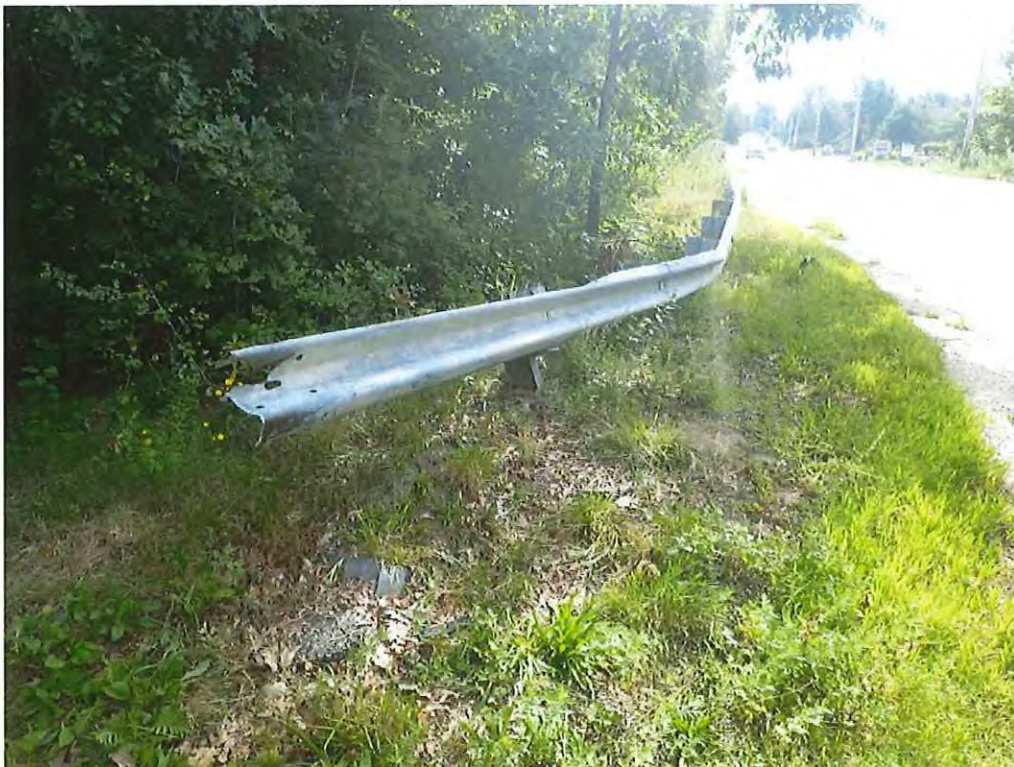
Photo 18: Northwest approach guardrail collision damage has pulled the buried railing out of the ground leaving no end treatment
