Re: Notice of Intent Supplement
104 Kings Cove Beach Road
Weymouth, MA 02191
MassDEP File #081-1278

This supplement has been prepared in response to the Notice of Intent (NOI) application filed by Mr. Gilvan Miranda for the property located at 104 Kings Cove Beach Road, Massachusetts (the “Study Area”). This supplement also responds to the Notice of Violation issued by the Weymouth Conservation Commission on November 5, 2021 regarding construction of a retaining wall within 100 feet of Coastal Beach and potential alteration to Coastal Beach. The retaining wall is actually a concrete footing for a proposed fence that has not yet been installed.

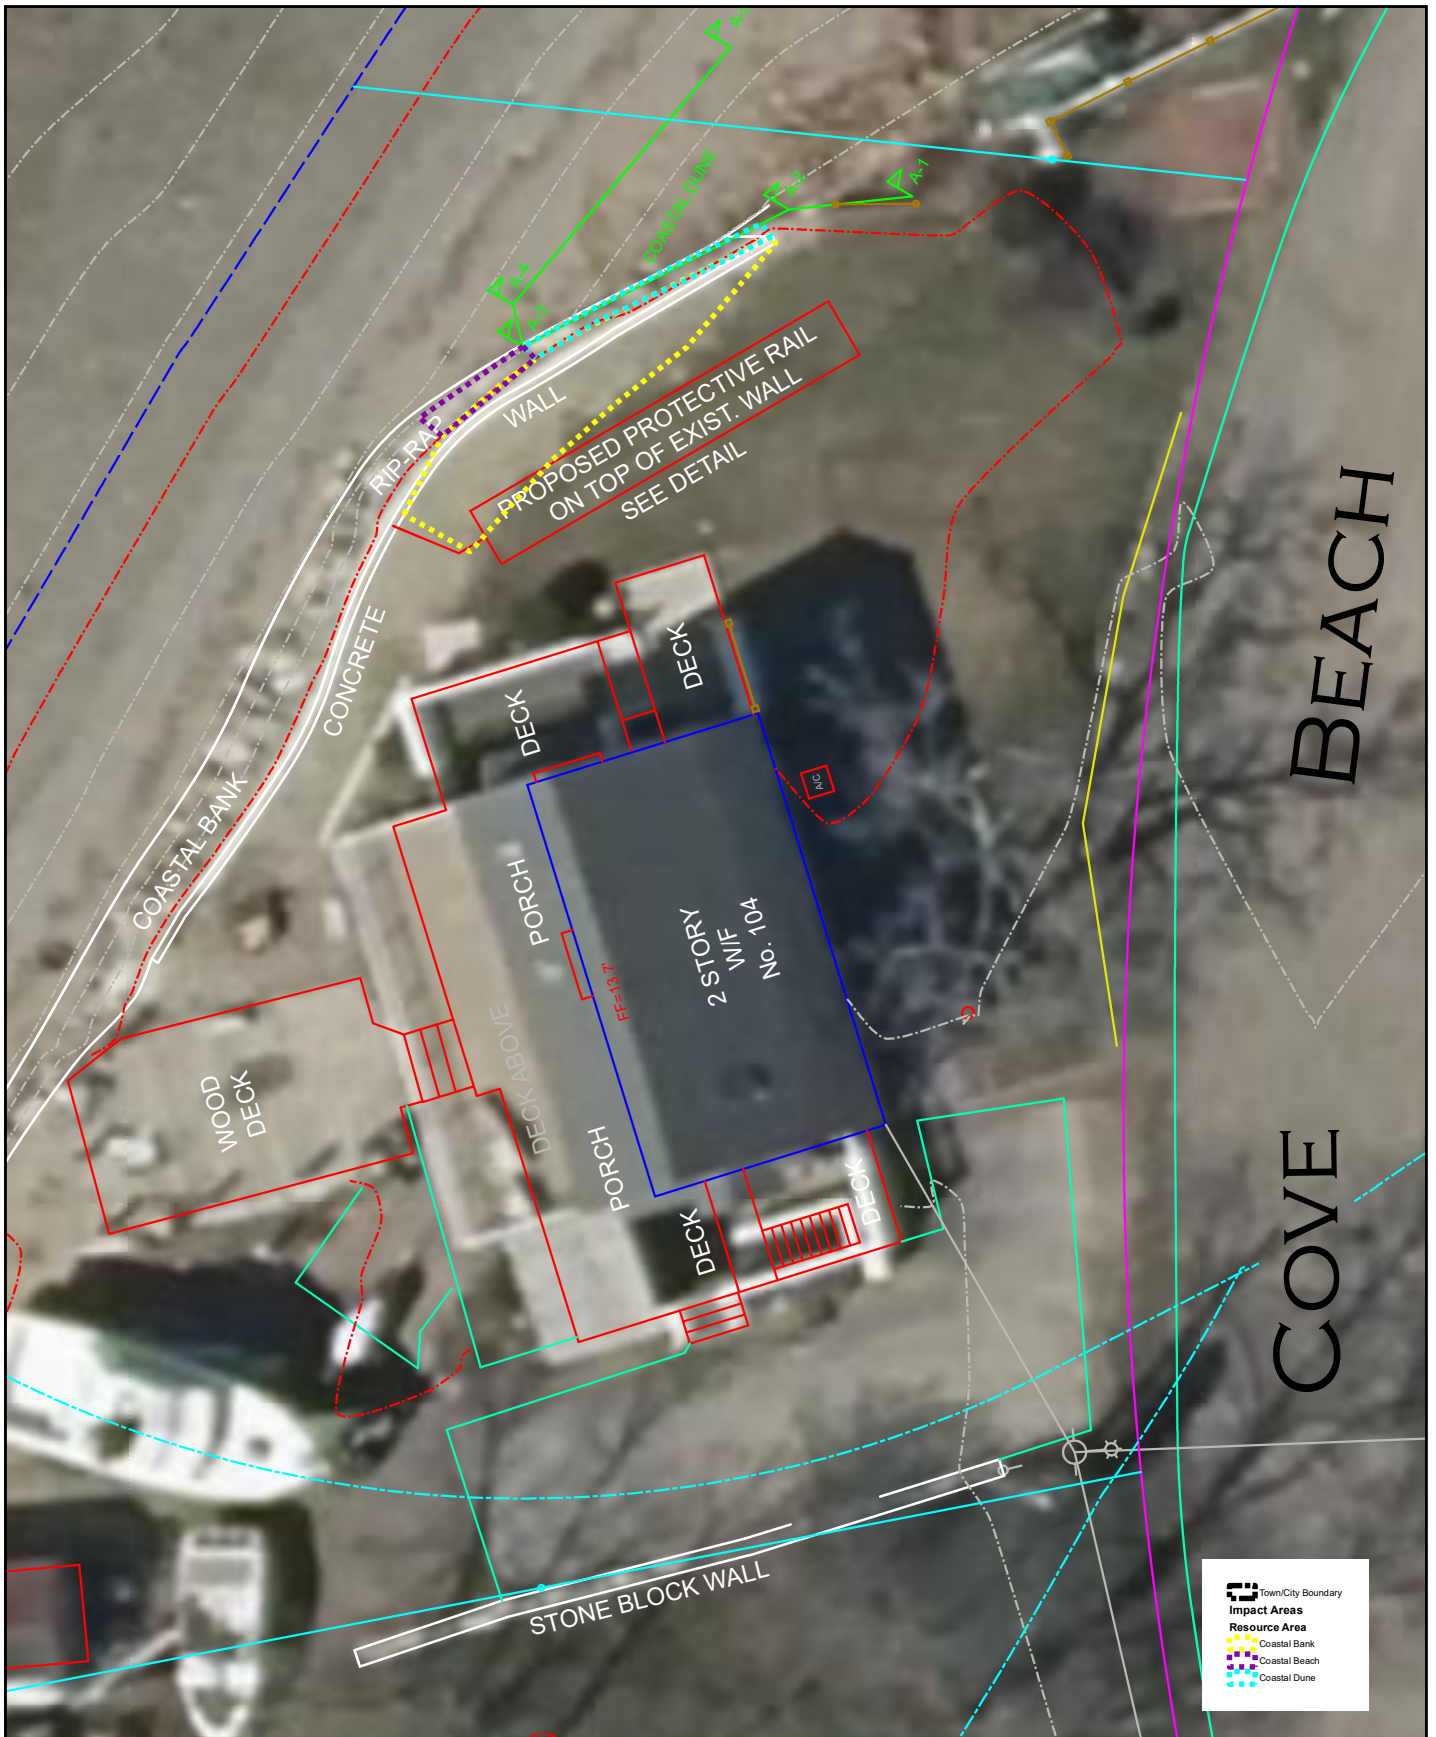
FIGURE 1

2021 Aerial Map
NOI Supplement
104 Kings Cove Beach Road
Weymouth, MA

The imagery prior to and including 2008 was not very useful to discern features and is not further discussed. Figures 1, 2, and 3 show the Study Area on aerial imagery for 2021, 2019, and 2013, respectively. LE compared the imagery from 2013, 2019, and 2021 and prepared an impact assessment graphic (See Figure 4) to demonstrate the limit of impacted resource areas.

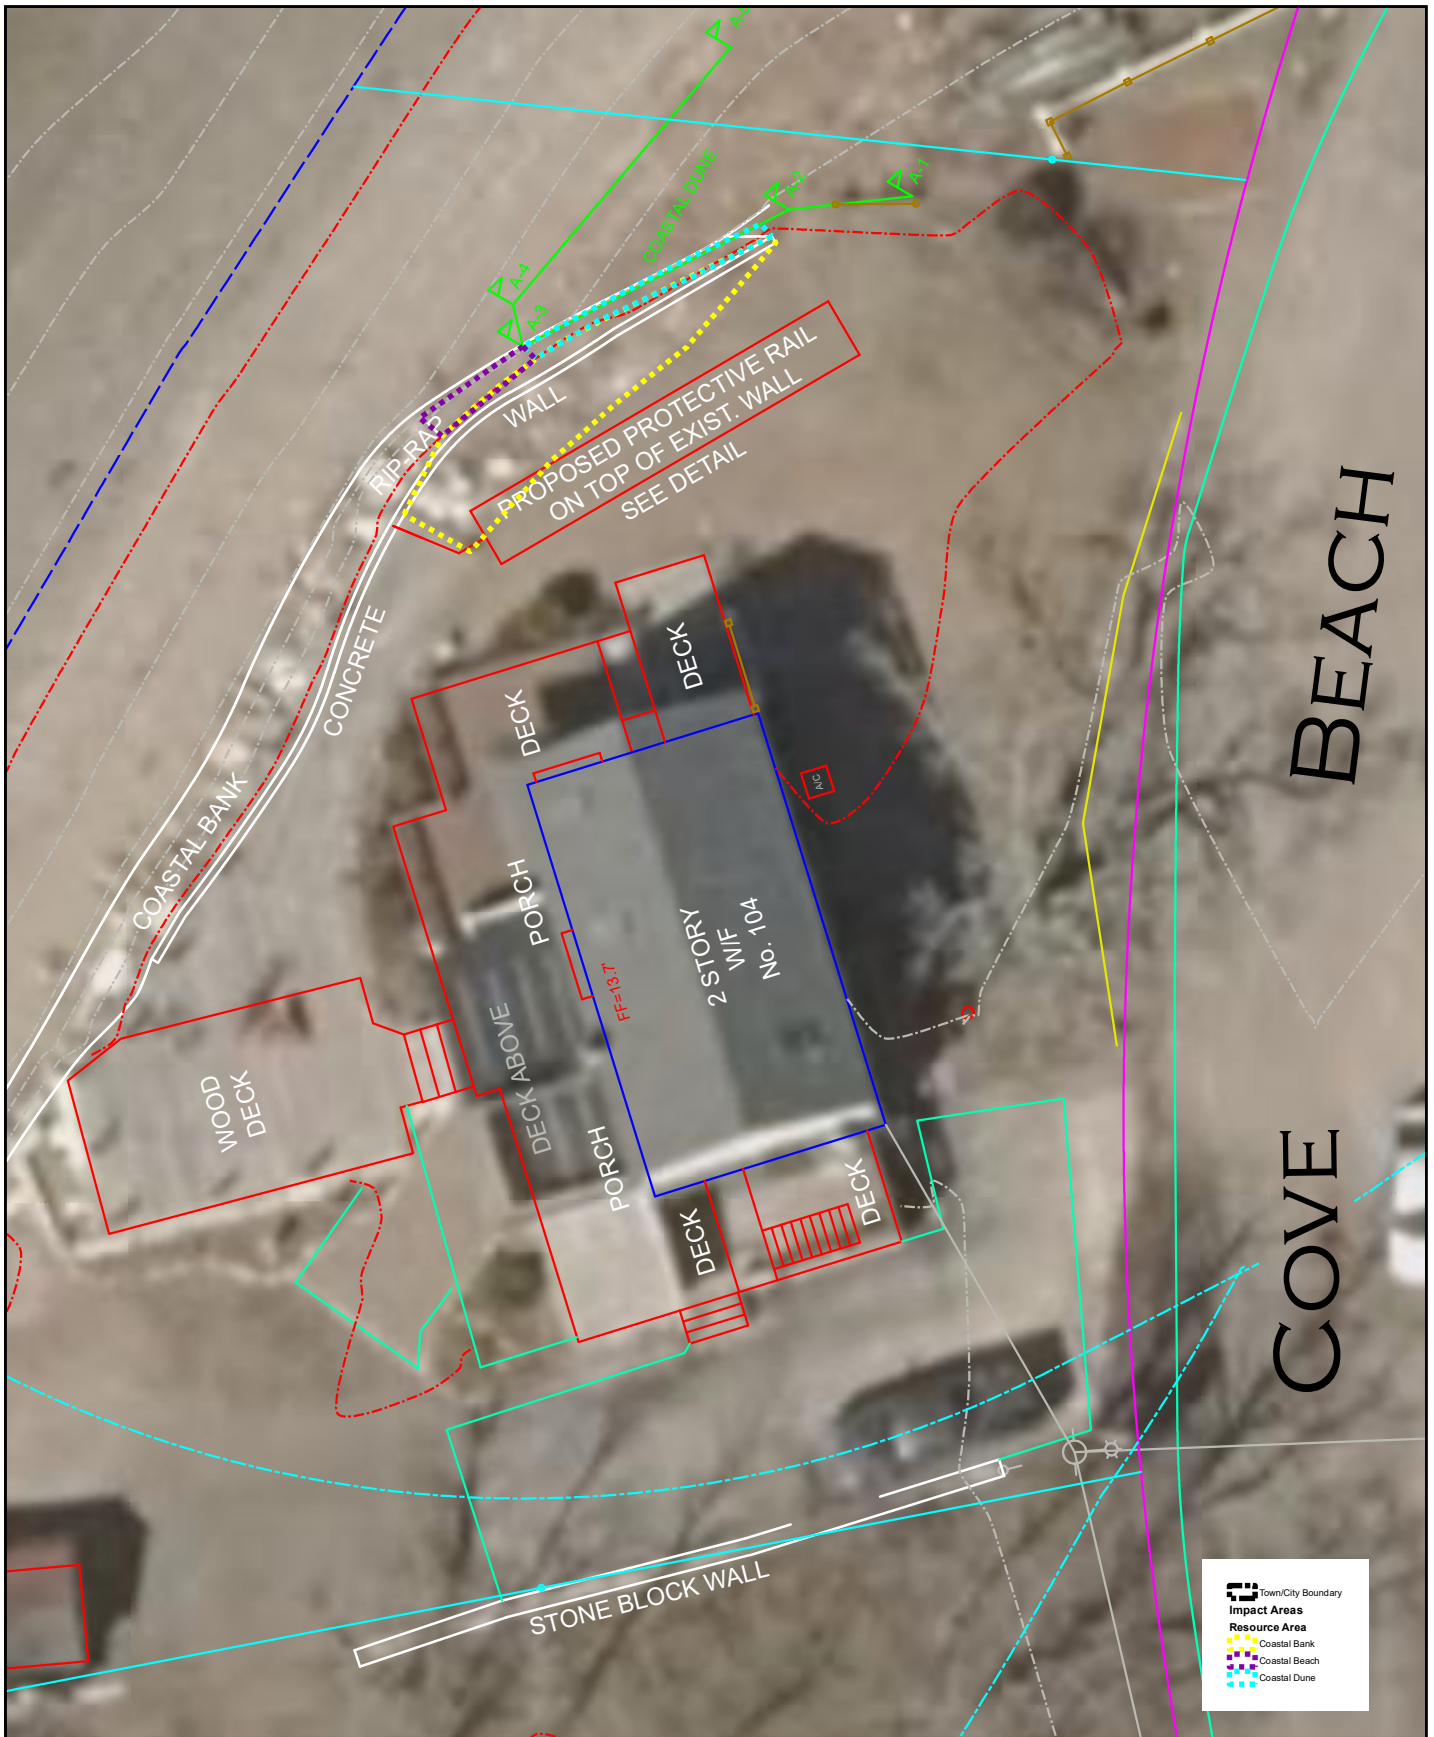
FIGURE 2

2019 Aerial Map
NOI Supplement
104 Kings Cove Beach Road
Weymouth, MA

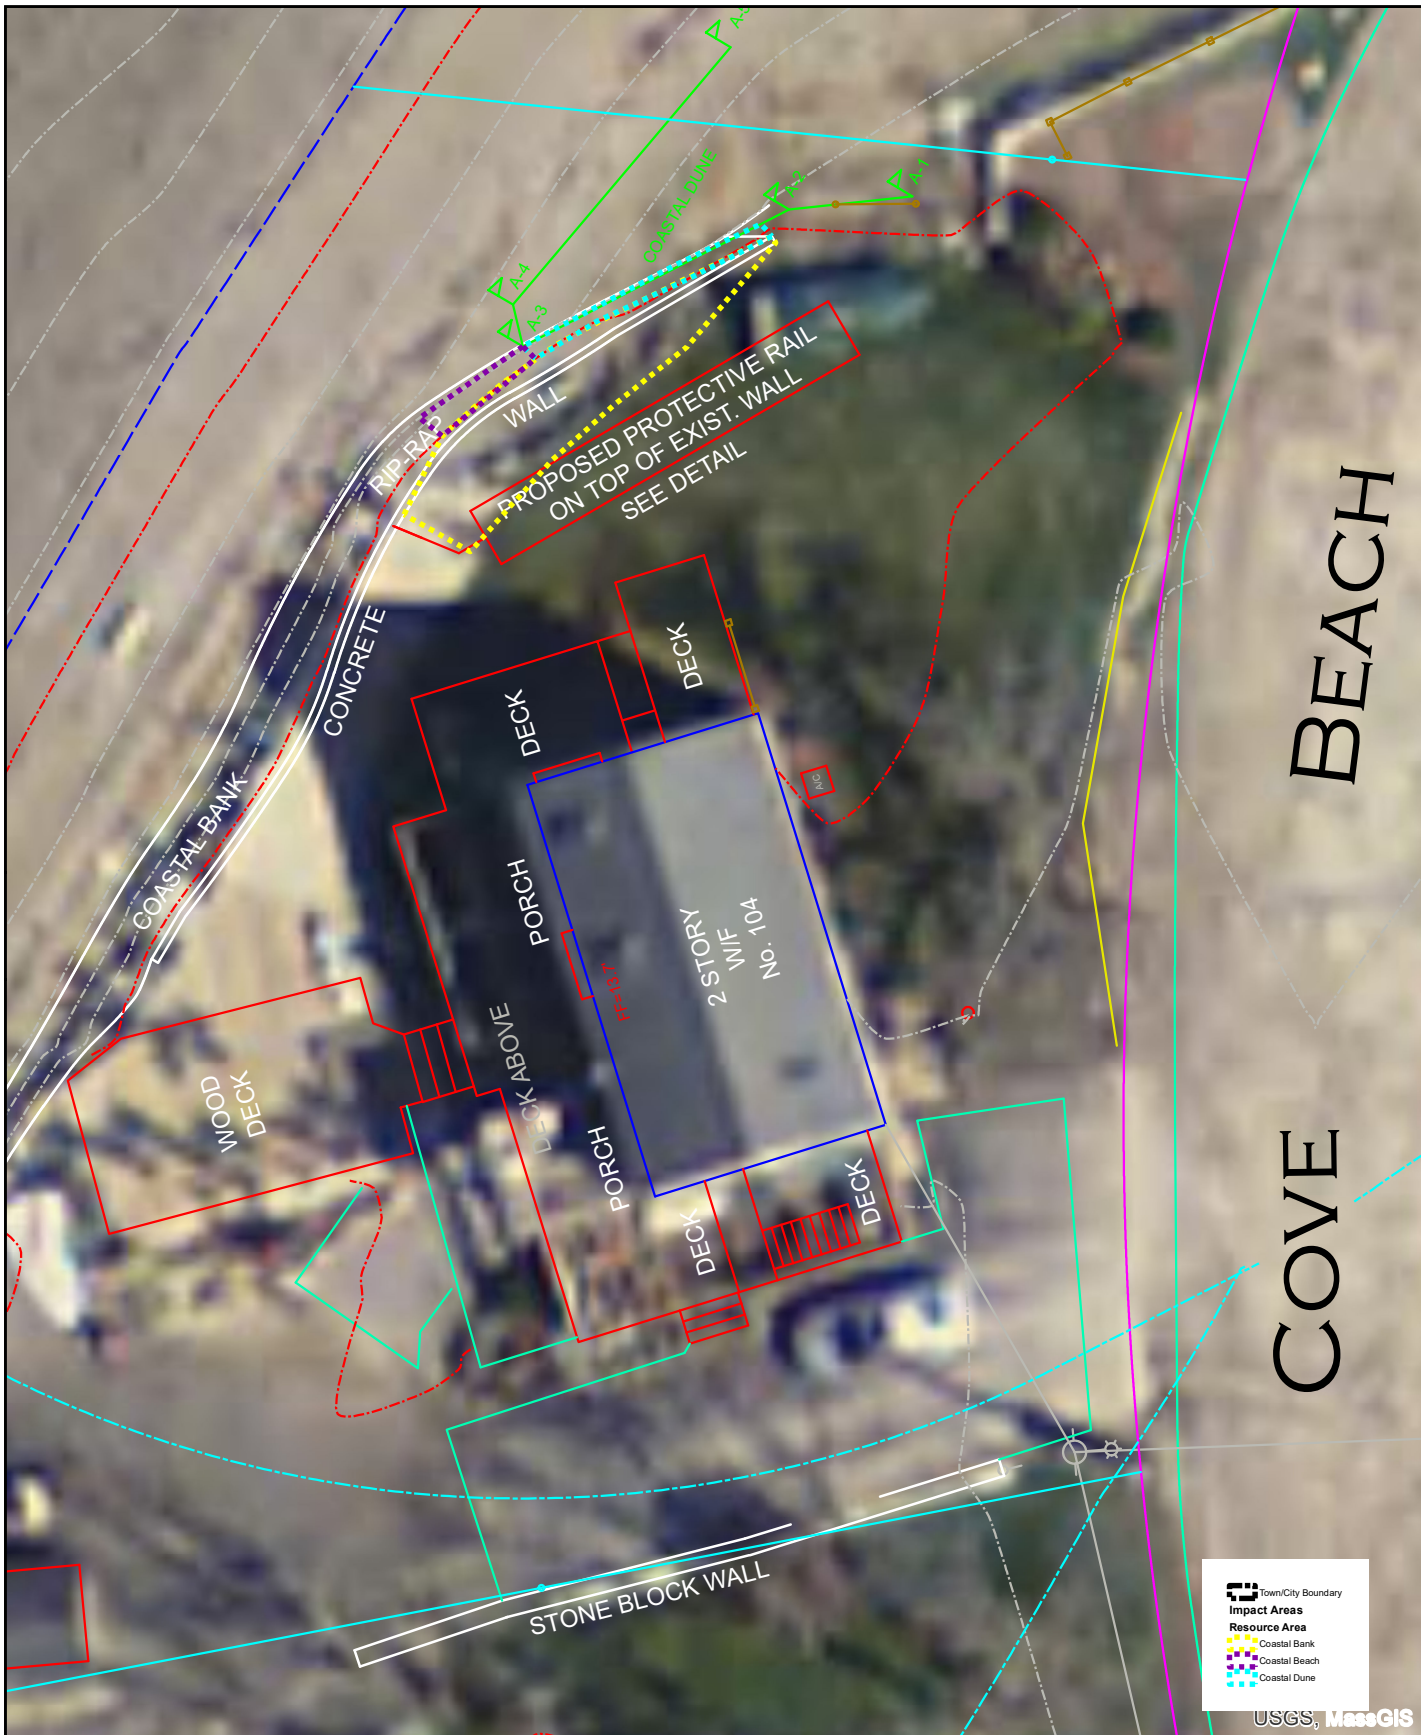
FIGURE 3

2013 Aerial Map
NOI Supplement
104 Kings Cove Beach Road
Weymouth, MA

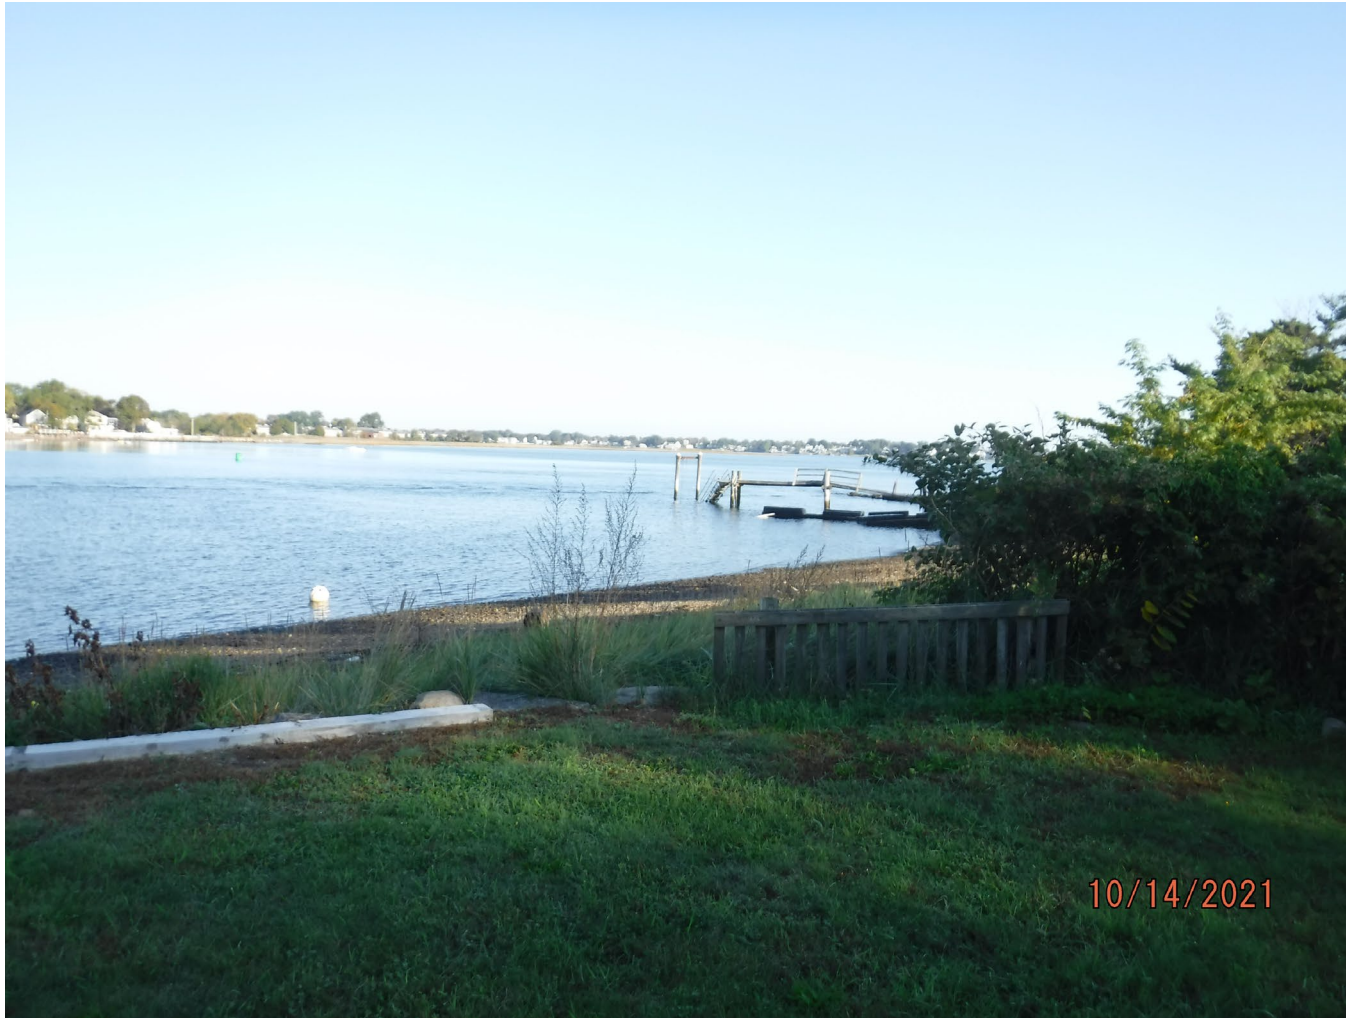
Photograph 1: View of the northern end of the concrete fence foundation, Coastal Dune, wooden fence, and lawn, facing north.

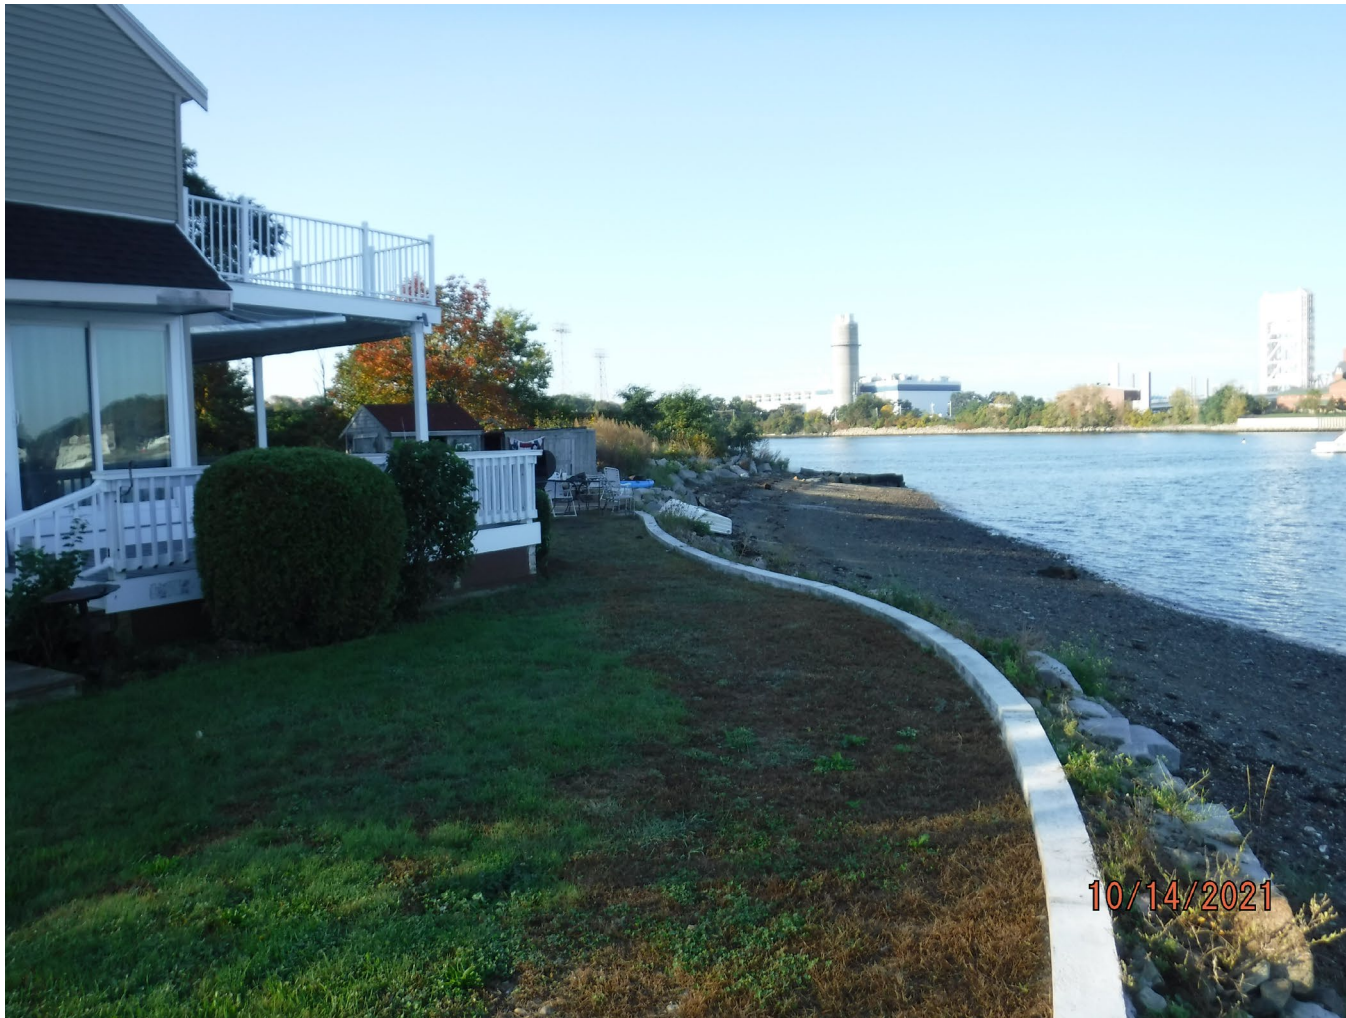
Photograph 2: View of the concrete fence foundation and lawn, facing south.

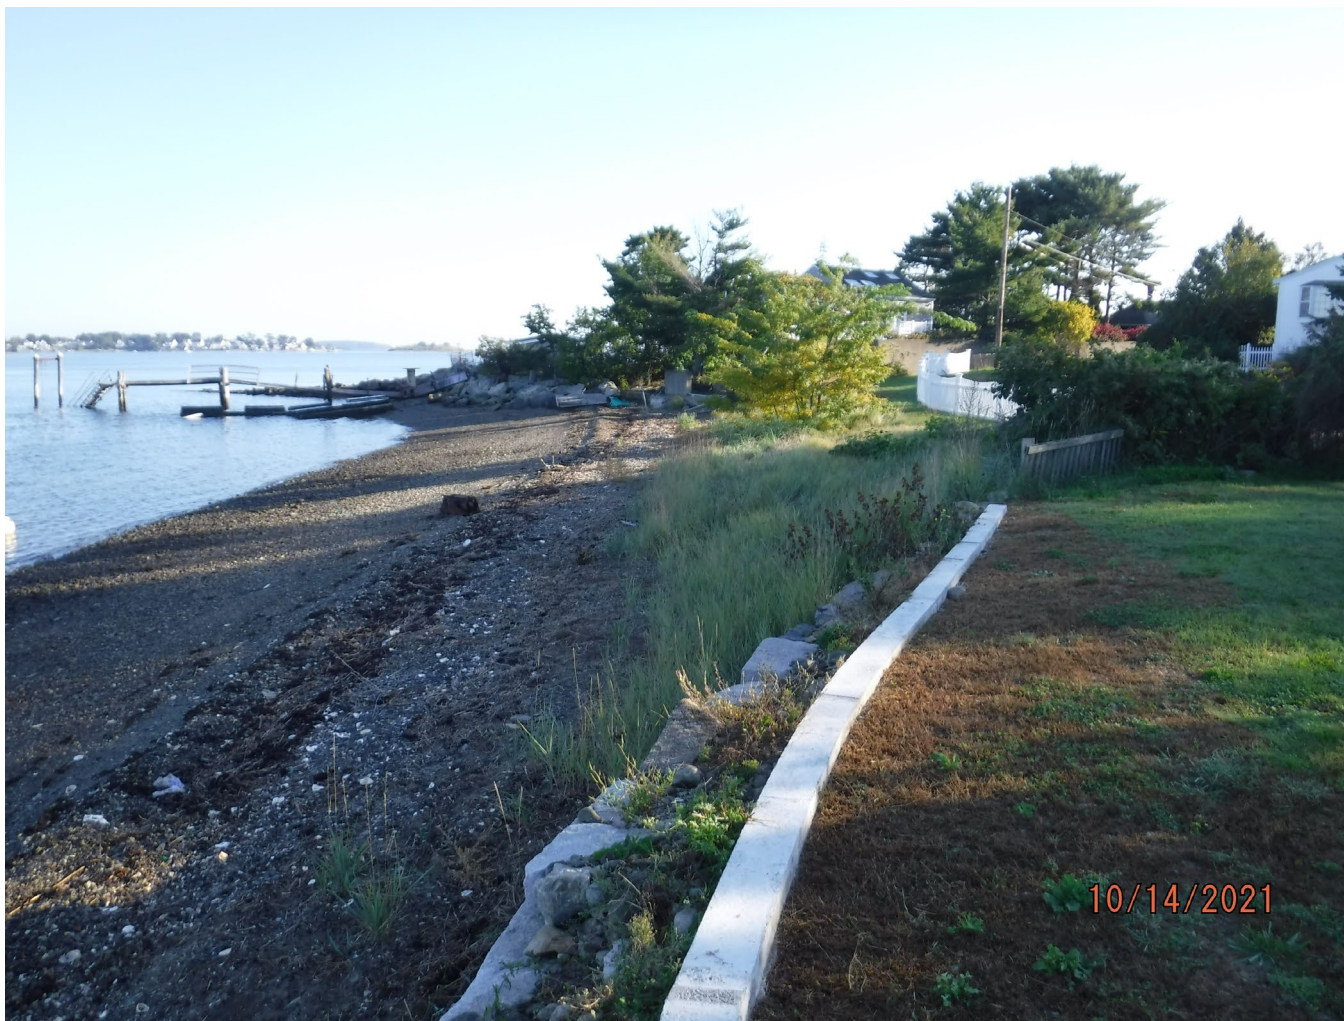
Photograph 3: View of the concrete fence foundation, Coastal Beach, Coastal Dune, and lawn, facing northeast.

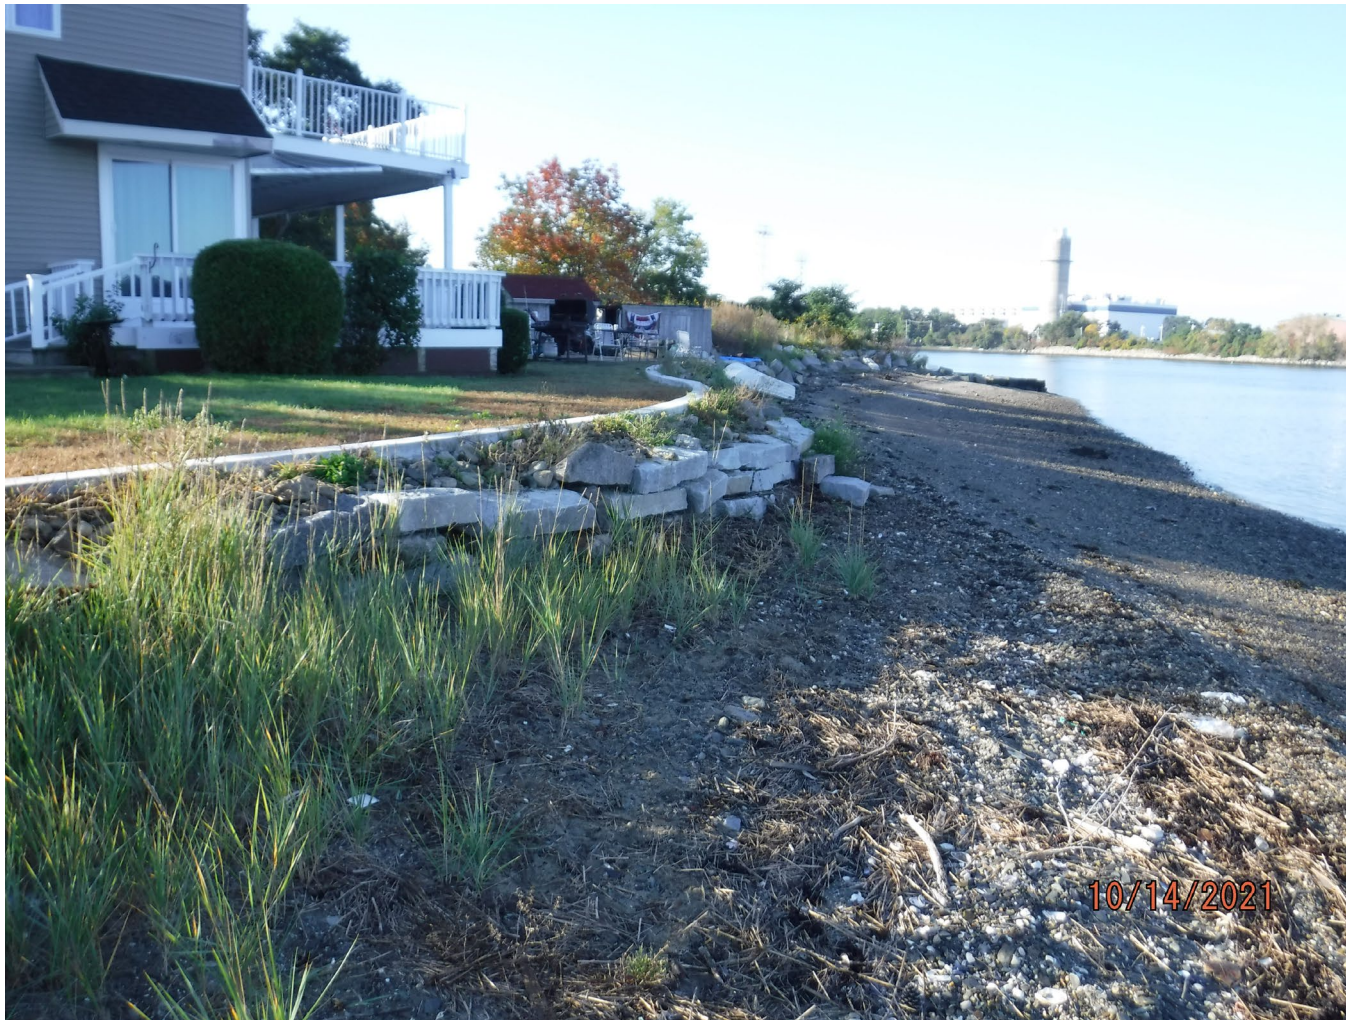
Photograph 4: View of concrete fence foundation, riprap wall, Coastal Beach, and southern end of Coastal Dune, facing south.

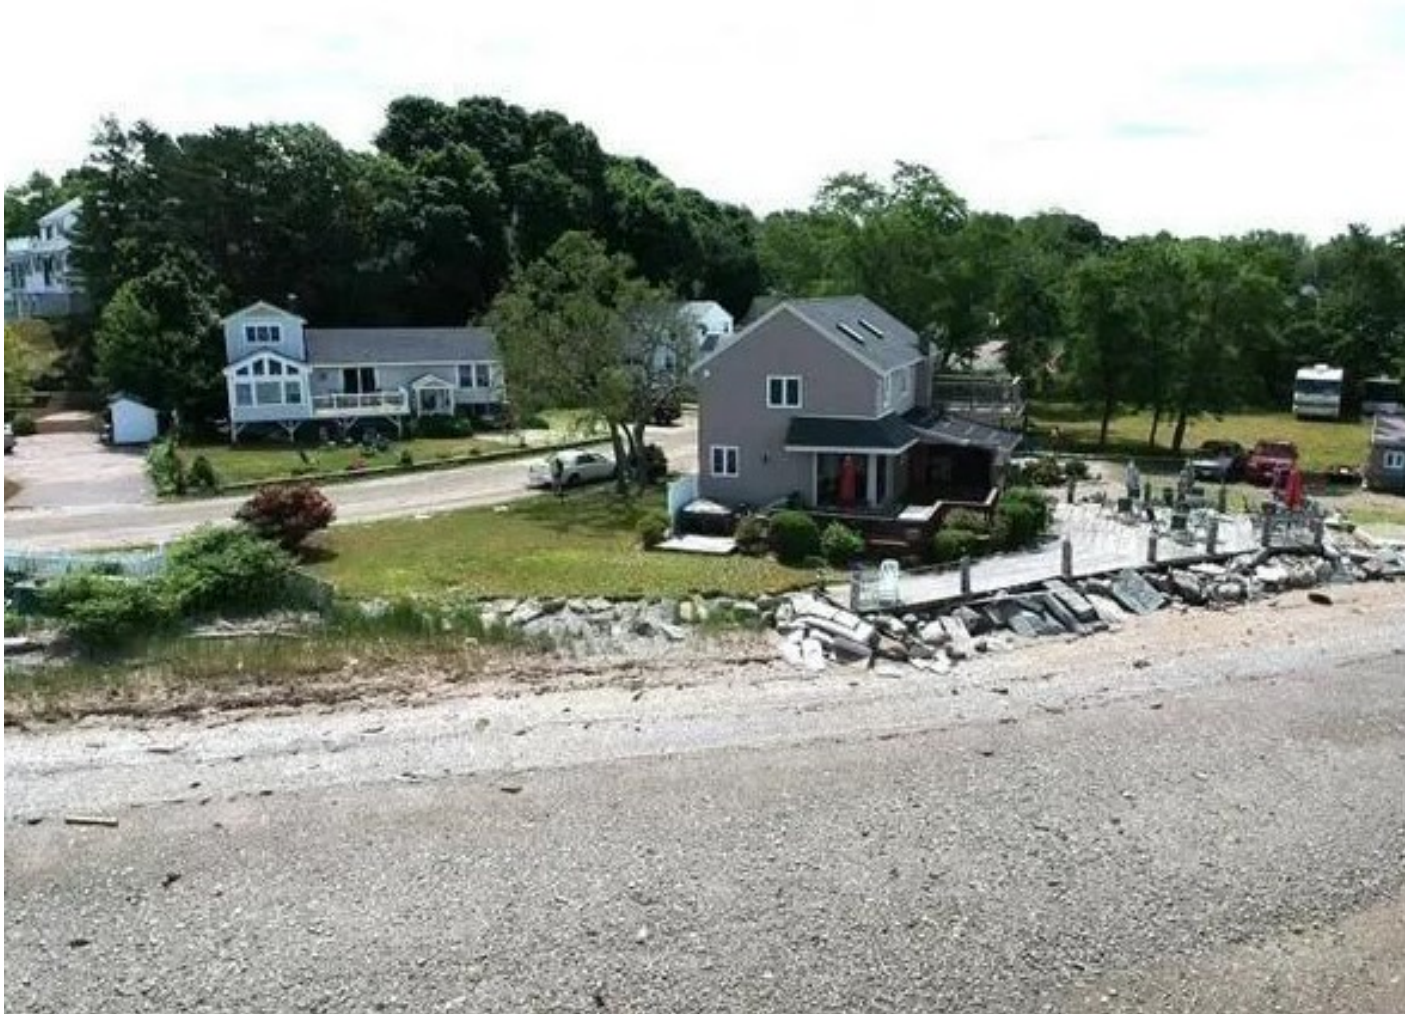
Photograph 5: View of the resource areas prior to construction of fence foundation. Note pre-existing structure (deck) along Coastal Bank.
