**INTERIM REPORT
FOR RESTORATION OF THE WEST COVE
OF WHITMAN'S POND
1999-2000**

WEYMOUTH, MASSACHUSETTS

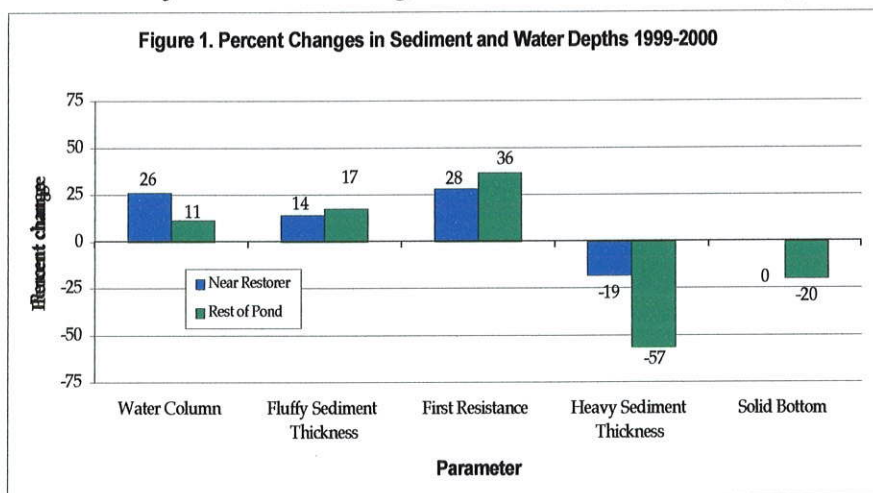
changed over the course of two years we can assume that any changes in water column depth reflect an increase or decrease in sediment depth. Figure 1 summarizes the changes (%) in water depth and several layers of sediments between 1999 and 2000. Water column

depth increased significantly more near the Restorer than in other parts of the pond. This suggests that organic matter in top sediments has been digested by organisms seeded from the Restorer. Furthermore, this finding is supported by the fact that fluffy sediments (top sediments with a high organic matter content) increased significantly less in the area near the Restorer than in other parts of the pond. The reason for fluffy sediment increase throughout the pond is likely to be a result of the time in which samples were taken. Samples in 1999 were taken during September, before most plant dieback, while samples from 2000 were taken in mid-November, after plant dieback. Since decaying plants contribute to fluffy sediment thickness, a lower increase of fluffy sediments near the Restorer suggests that fewer plants are growing near the Restorer than in other parts of the lake. This idea is supported by plant observations presented discussed in Section 5.

The increase in depth of top and mid level sediments and the decrease in depth of heavy bottom sediments raises many questions. It is possible that bottom sediments are becoming loosened and converting into lighter, less packed top sediments. Alternatively, this result could be the result of sampling error. Standard sediment measurements over the course of several years are necessary to discern what might be occurring.

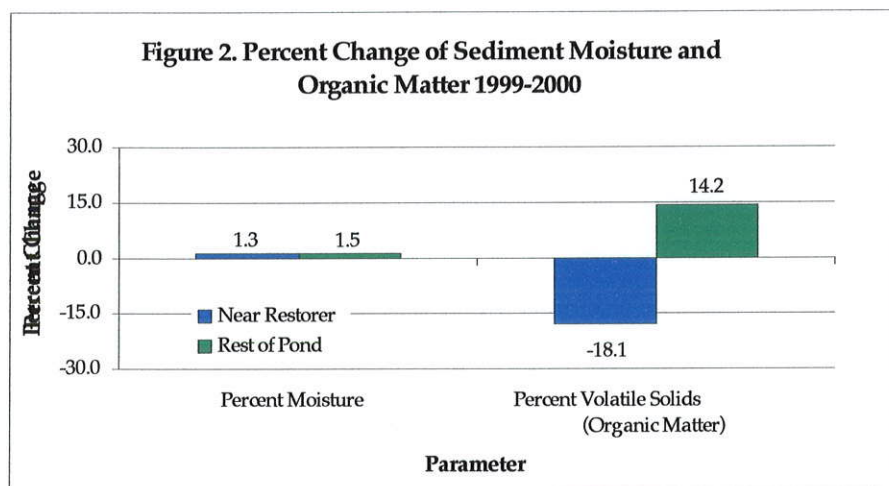
dispersed into the Weymouth pond system. Thus, if the Restorer is operating properly we would assume the percent of organic matter (measured as volatile solids) in top sediments to decrease in areas closer to the

Restorer. Such reductions appear to have occurred between the years of 1999 and 2000 (Figure 2). Increases in organic matter in parts of the pond not near the Restorer may be due to plant diebacks that occur in the fall. Such dieback occurred after the 1999 samples were taken but prior to the 2000 samples. Sources of organic pollution, unknown to the writers, could also be contributing to organic matter build-up throughout the pond. Percent moisture of the two grouped sets of samples changed only slightly and in a very similar way suggesting that data collected during 1999 and 2000 is comparable (Figure 2). However, insufficient data exists to develop a statistically valid statement, and sampling error could have occurred in either 1999 or 2000. More complete standard testing over the course of a longer period of time is necessary to determine whether the reduction in organic matter of top sediments is indeed occurring near the Restorer.

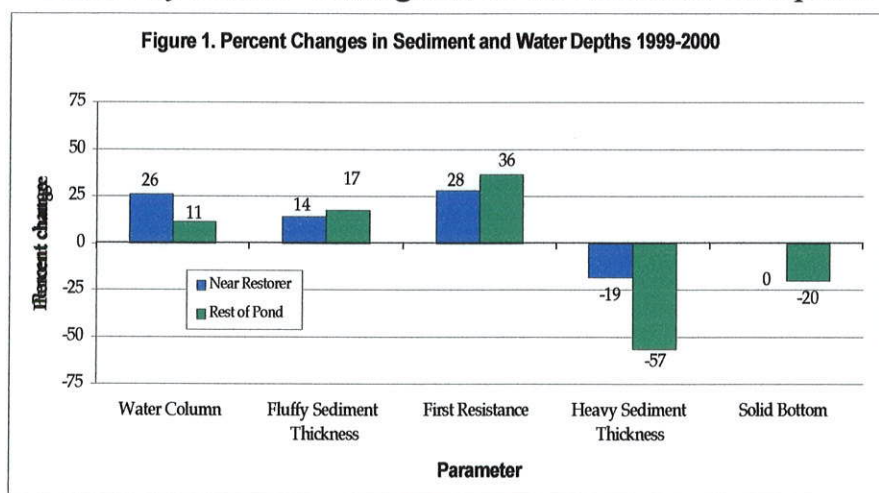
changed over the course of two years we can assume that any changes in water column depth reflect an increase or decrease in sediment depth. Figure 1 summarizes the changes (%) in water depth and several layers of sediments between 1999 and 2000. Water column

depth increased significantly more near the Restorer than in other parts of the pond. This suggests that organic matter in top sediments has been digested by organisms seeded from the Restorer. Furthermore, this finding is supported by the fact that fluffy sediments (top sediments with a high organic matter content) increased significantly less in the area near the Restorer than in other parts of the pond. The reason for fluffy sediment increase throughout the pond is likely to be a result of the time in which samples were taken. Samples in 1999 were taken during September, before most plant dieback, while samples from 2000 were taken in mid-November, after plant dieback. Since decaying plants contribute to fluffy sediment thickness, a lower increase of fluffy sediments near the Restorer suggests that fewer plants are growing near the Restorer than in other parts of the lake. This idea is supported by plant observations presented discussed in Section 5.

The increase in depth of top and mid level sediments and the decrease in depth of heavy bottom sediments raises many questions. It is possible that bottom sediments are becoming loosened and converting into lighter, less packed top sediments. Alternatively, this result could be the result of sampling error. Standard sediment measurements over the course of several years are necessary to discern what might be occurring.

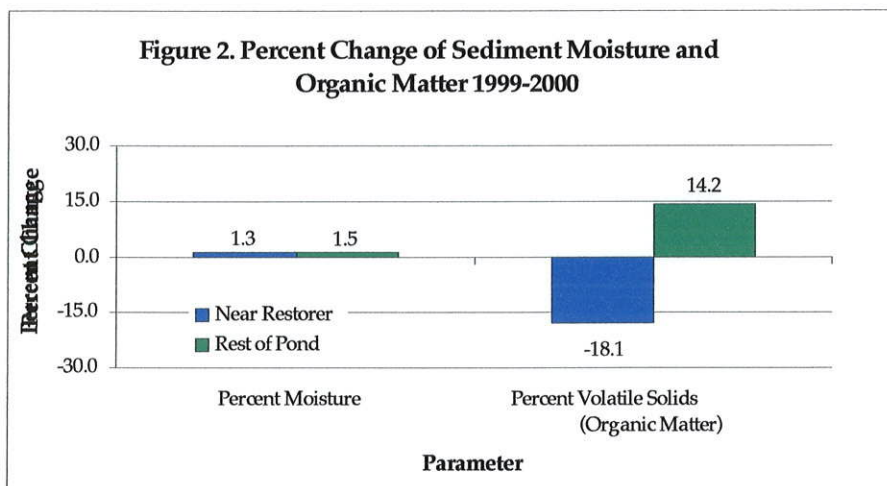
dispersed into the Weymouth pond system. Thus, if the Restorer is operating properly we would assume the percent of organic matter (measured as volatile solids) in top sediments to decrease in areas closer to the

Restorer. Such reductions appear to have occurred between the years of 1999 and 2000 (Figure 2). Increases in organic matter in parts of the pond not near the Restorer may be due to plant diebacks that occur in the fall. Such dieback occurred after the 1999 samples were taken but prior to the 2000 samples. Sources of organic pollution, unknown to the writers, could also be contributing to organic matter build-up throughout the pond. Percent moisture of the two grouped sets of samples changed only slightly and in a very similar way suggesting that data collected during 1999 and 2000 is comparable (Figure 2). However, insufficient data exists to develop a statistically valid statement, and sampling error could have occurred in either 1999 or 2000. More complete standard testing over the course of a longer period of time is necessary to determine whether the reduction in organic matter of top sediments is indeed occurring near the Restorer.
