ROOT CAUSE FAILURE ANALYSIS INVESTIGATION REPORT

# Weymouth Compressor Station September 11, 2020 Closure Seal Failure

**Algonquin Gas Transmission, LLC**  
**Subsidiary of Enbridge Inc.**

**Report No.:** 10263555-1, Rev. 0

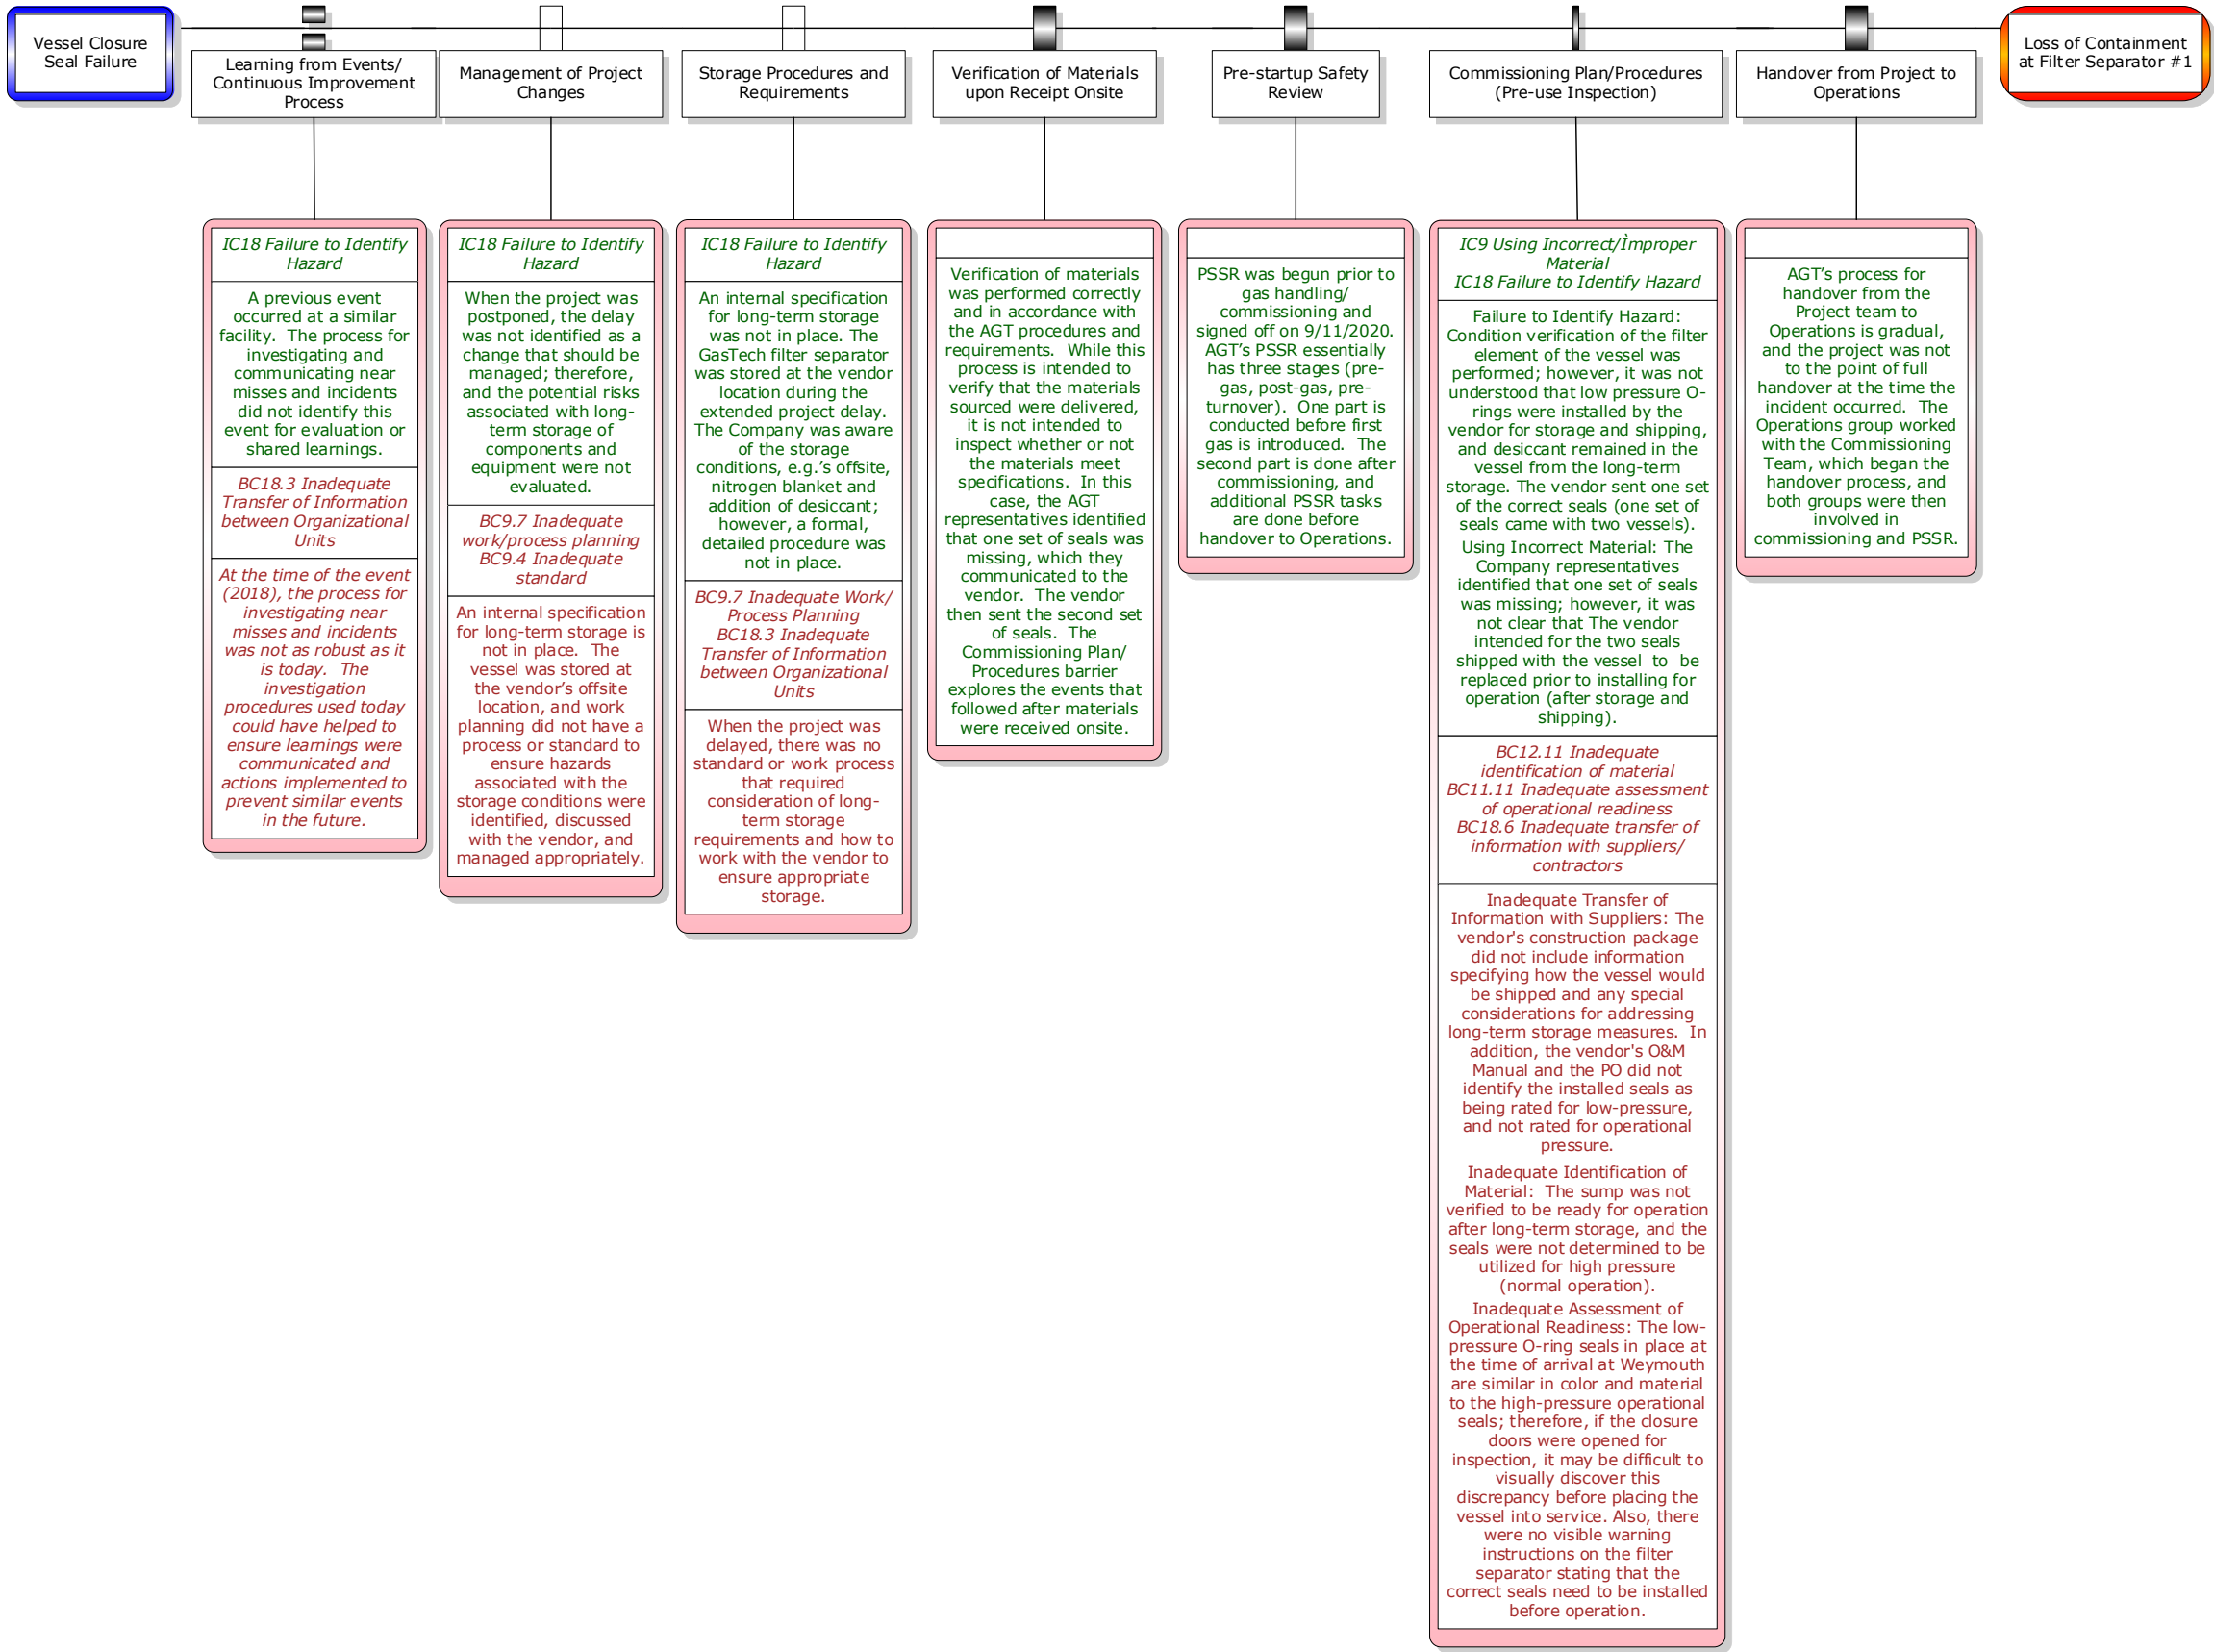
### **BSCAT Diagram**

The complete BSCAT™ diagram, which can be found in Appendix A, includes the full causation for each barrier that contributed to the event.
