BRICK GRILL BASEMENT

MORANTE INSURANCE/BARBER SHOP BASEMENT

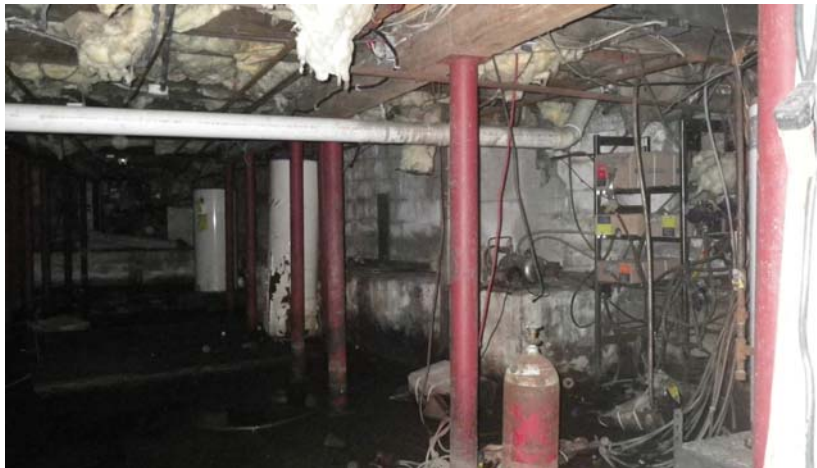
Brick Grill Basement B2 - looking along Smelt culvert wall.

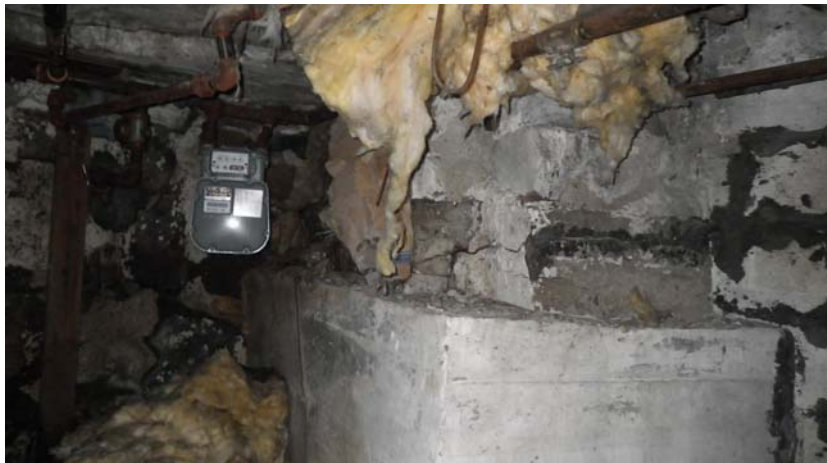
Brick Grill Basement B6 - looking at NW corner at Commercial Street.

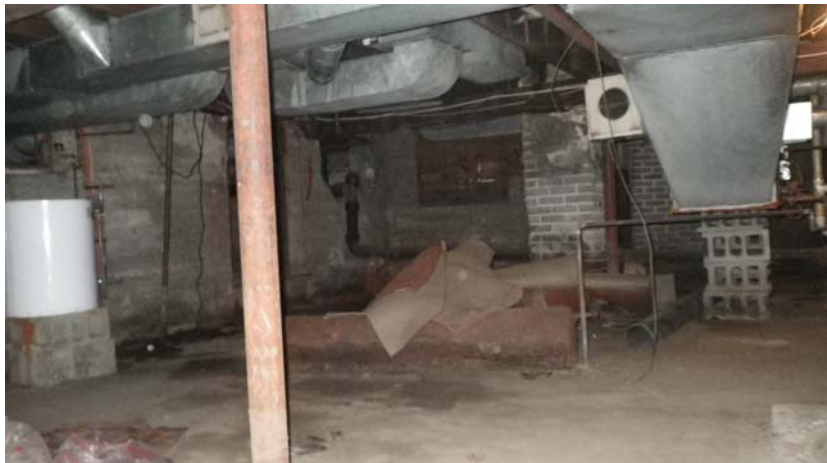
Morante Insurance/Barber Shop Basement M3 - looking east.

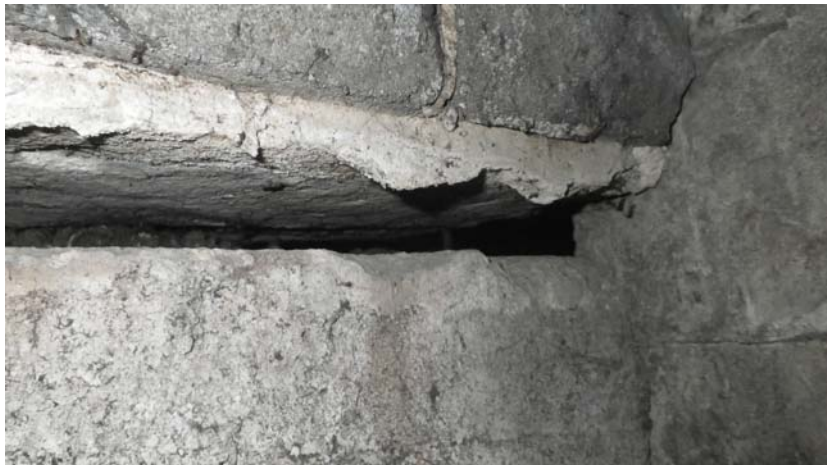
Morante Insurance/Barber Shop Basement M6 - view showing significant settlement of basement wall and concrete cap.

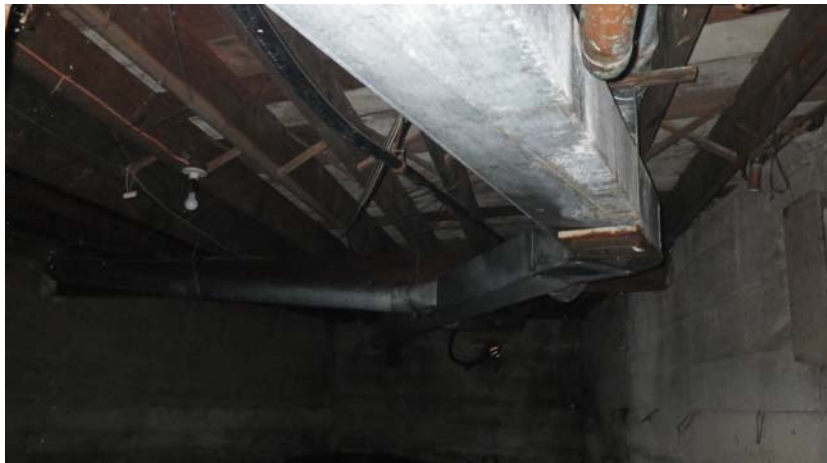
Morante Insurance/Barber Shop Basement M9 - view looking west.

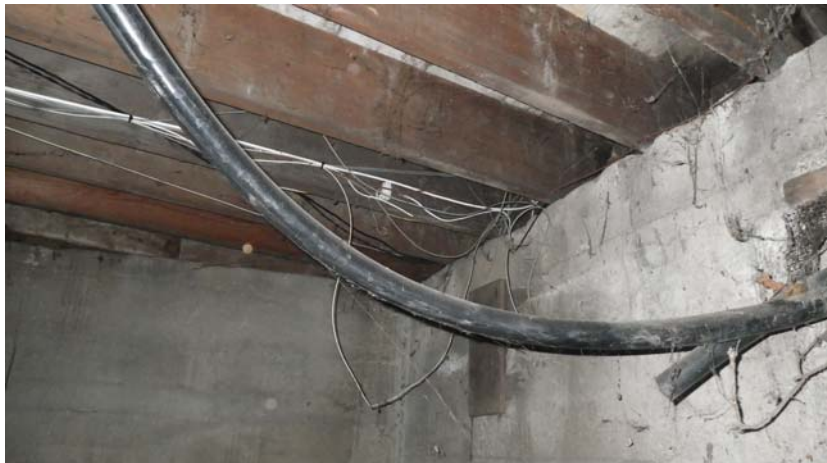
Morante Insurance/Barber Shop Basement M12 - another view in SE corner showing framing.

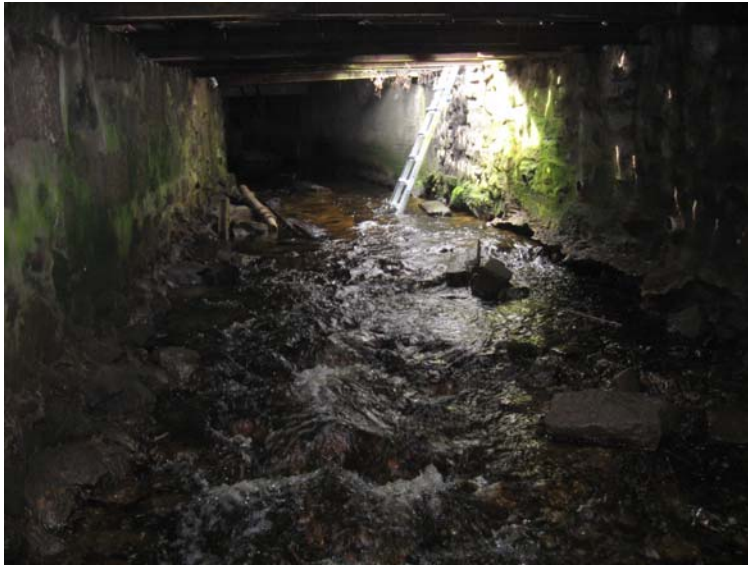
Smelt Brook 1 - looking toward Commercial Street.

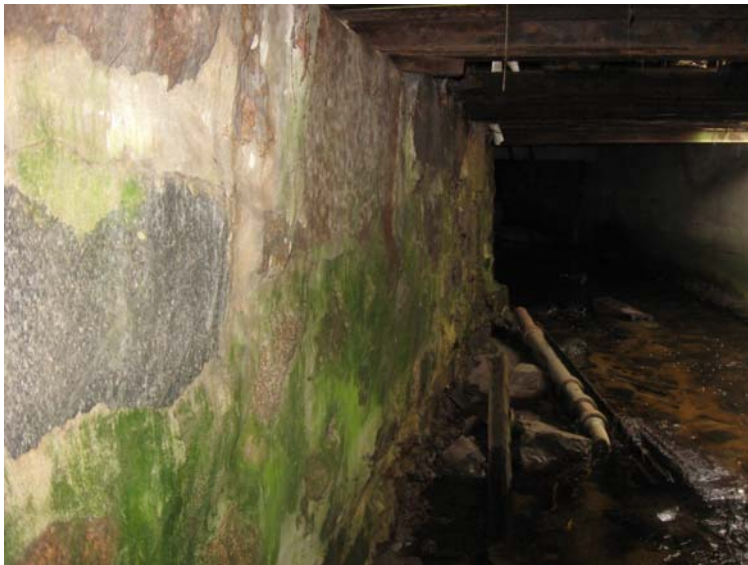
Smelt Brook 2 - looking toward Commercial Street at culvert's south stone wall.

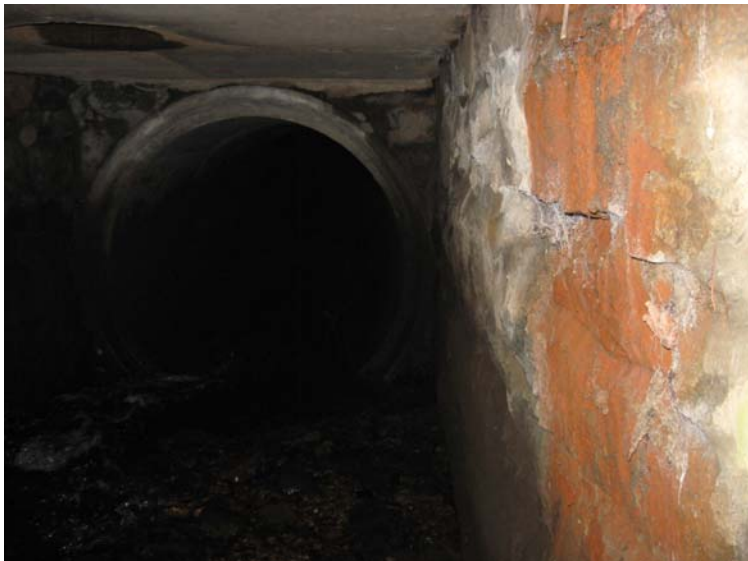
Smelt Brook 3 - looking east at 72 inch pipe beneath concrete slab.

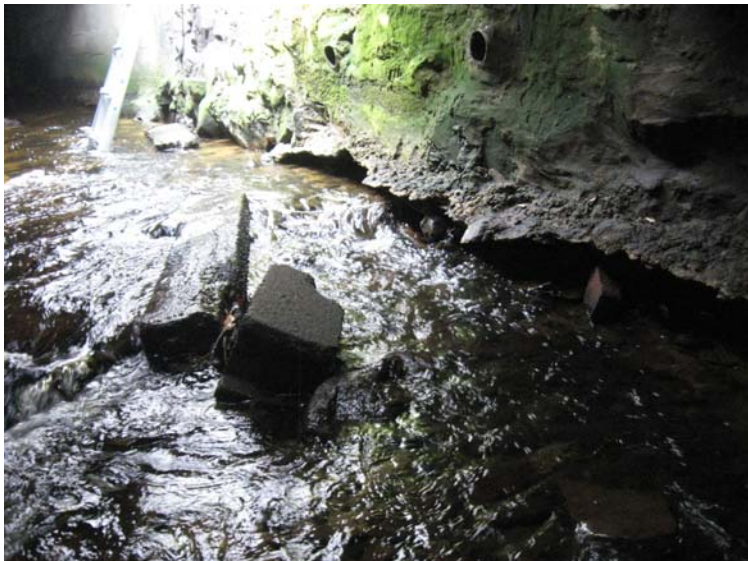
Smelt Brook 6 - another view along north wall.

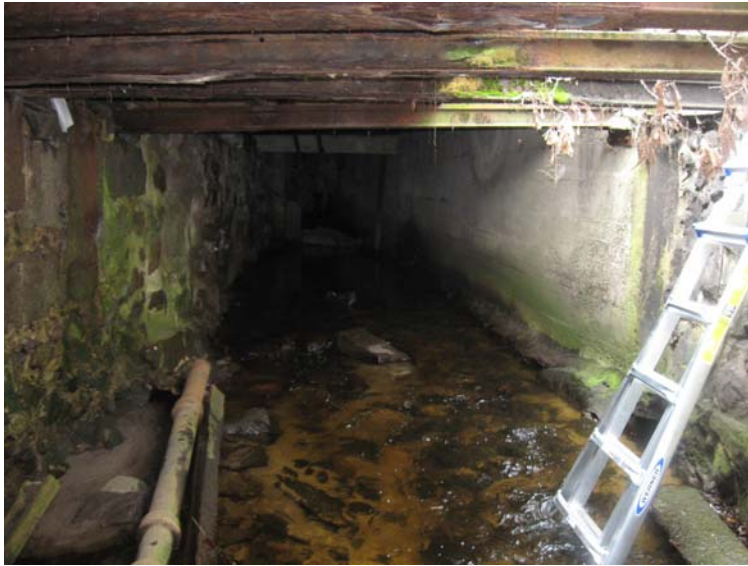
Smelt Brook 7 - looking toward Commercial Street below timber decking.

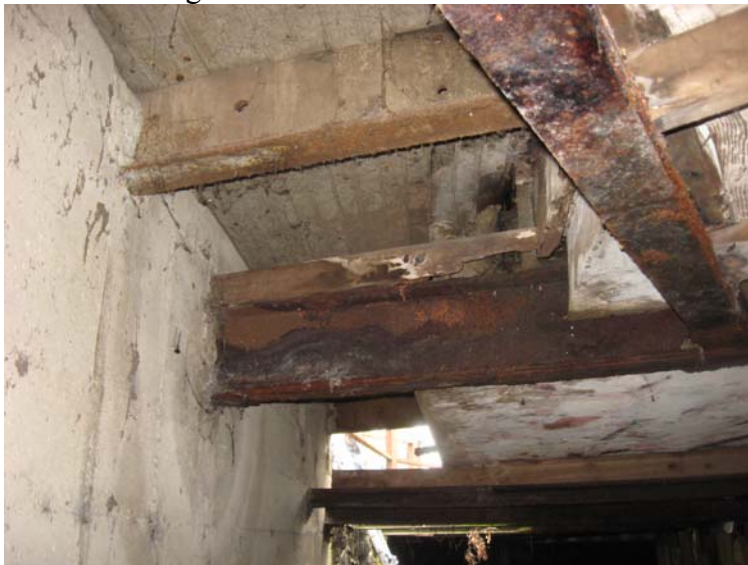
Smelt Brook 8 - looking away from Commercial Street at Morante Insurance Building floor framing.

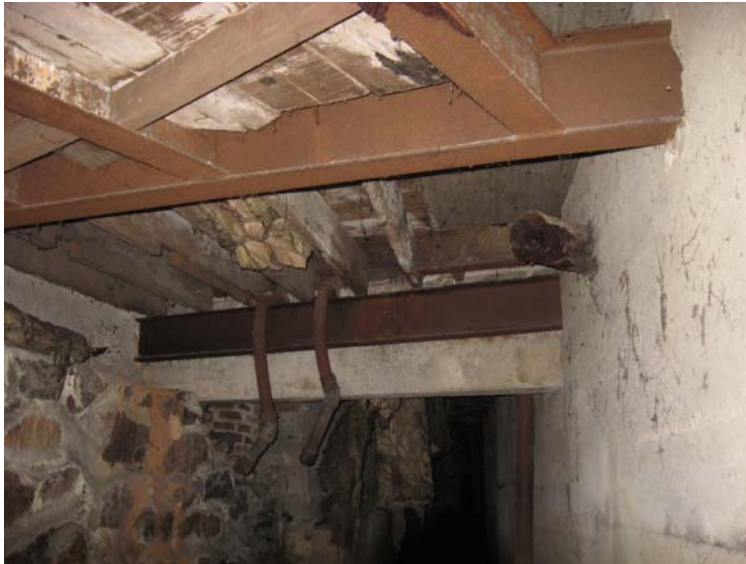
Smelt Brook 10 - another view looking toward Commercial Street of floor framing above culvert.

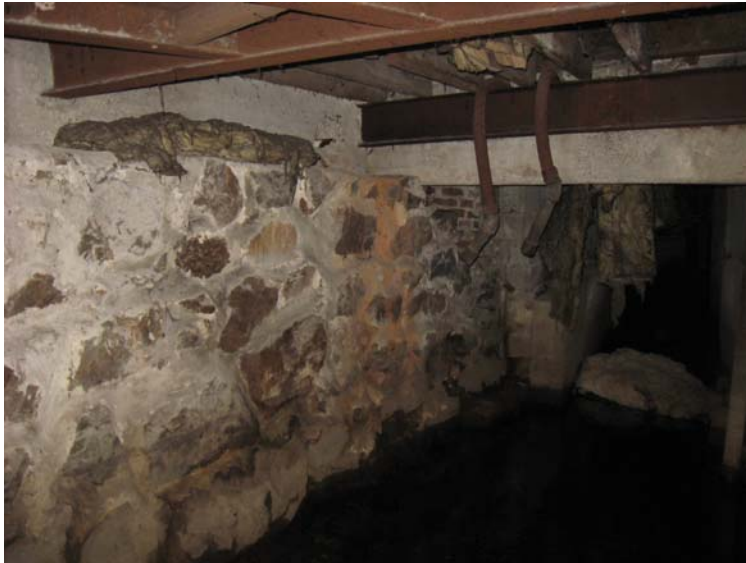
Smelt Brook 11 - view looking at additional steel floor framing.

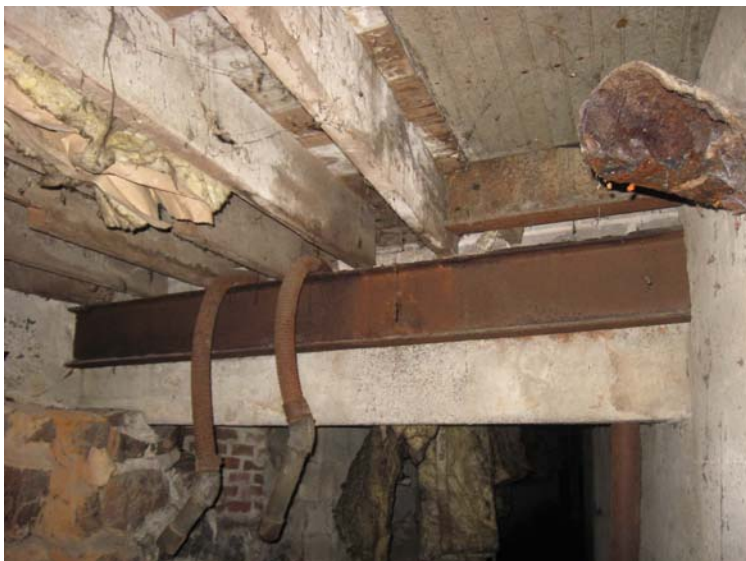
Smelt Brook 12 - view looking toward Commercial Street at framing above culvert.

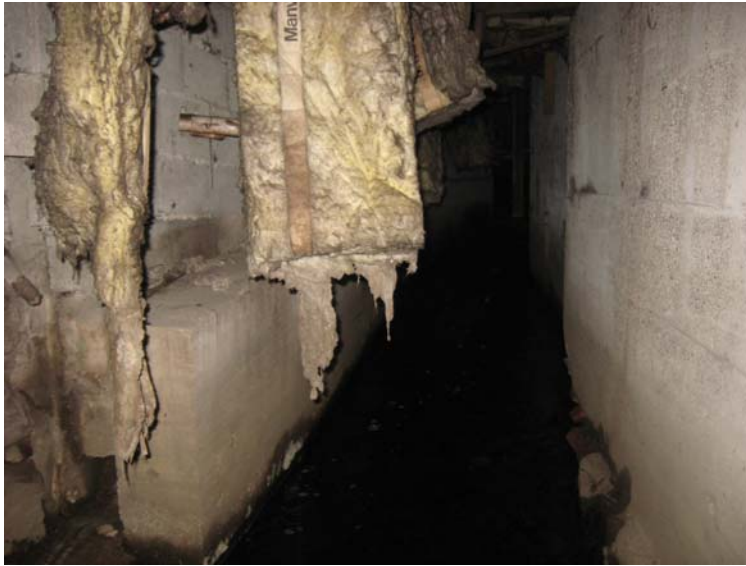
Smelt Brook 13 - looking toward Commercial Street at narrow section of culvert below building.

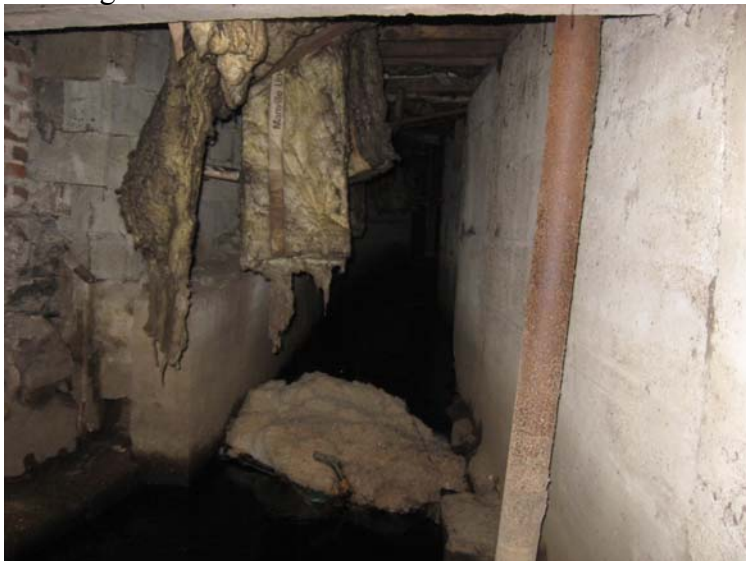
Smelt Brook 15 - another view towards Commercial Street at narrow culvert section.

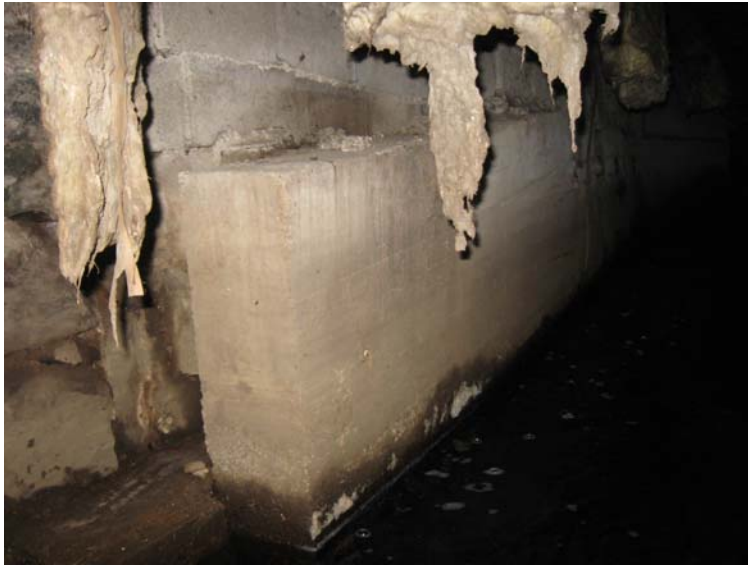
Smelt Brook 16 - view of southern culvert wall sections.

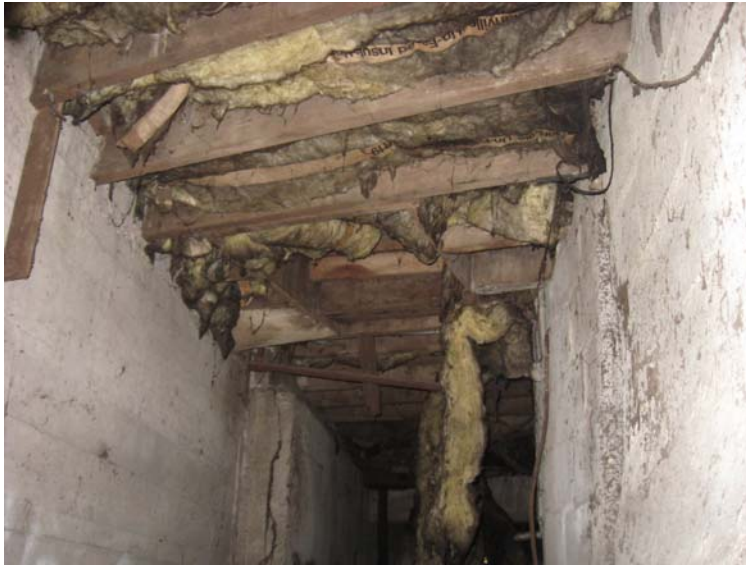
Smelt Brook 19 - looking away from Commercial Street at floor framing above.

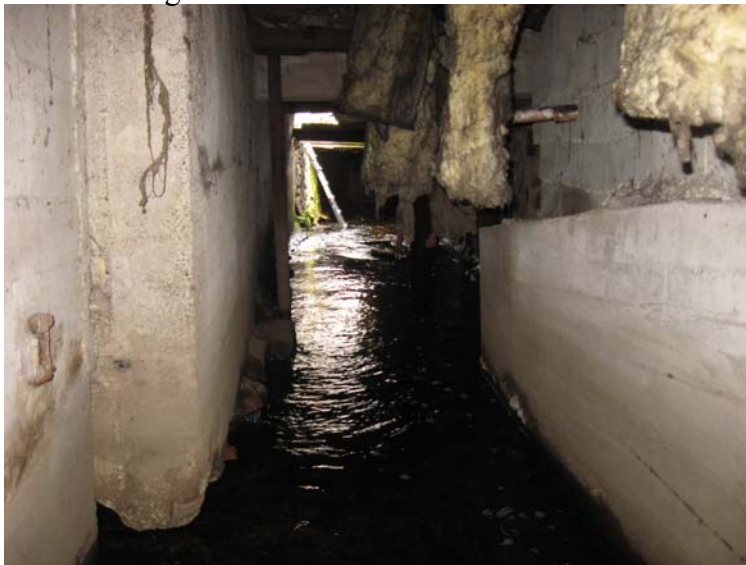
Smelt Brook 20 - view looking away from Commercial Street.

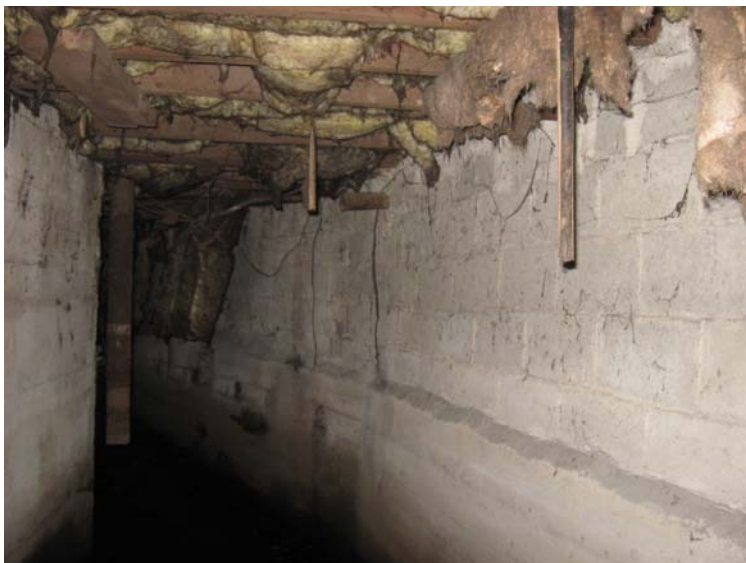
Smelt Brook 21 - another view looking away from Commercial Street at floor framing.

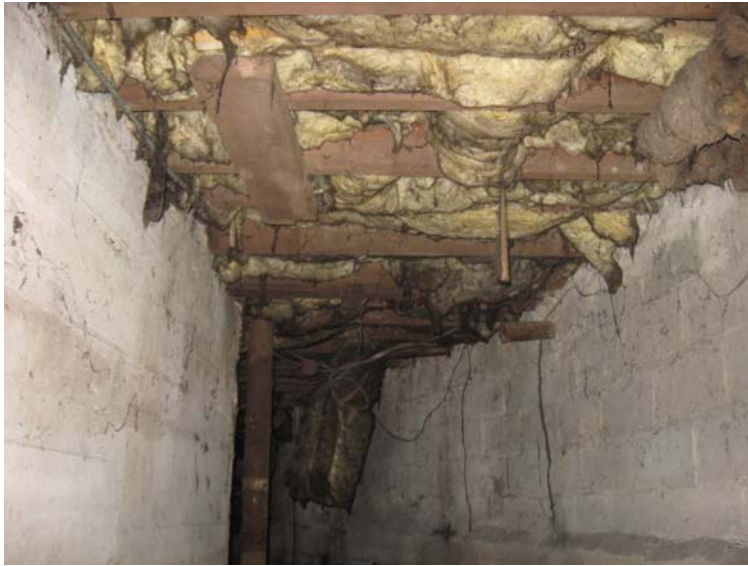
Smelt Brook 22 - another view of floor framing looking away from Commercial Street.

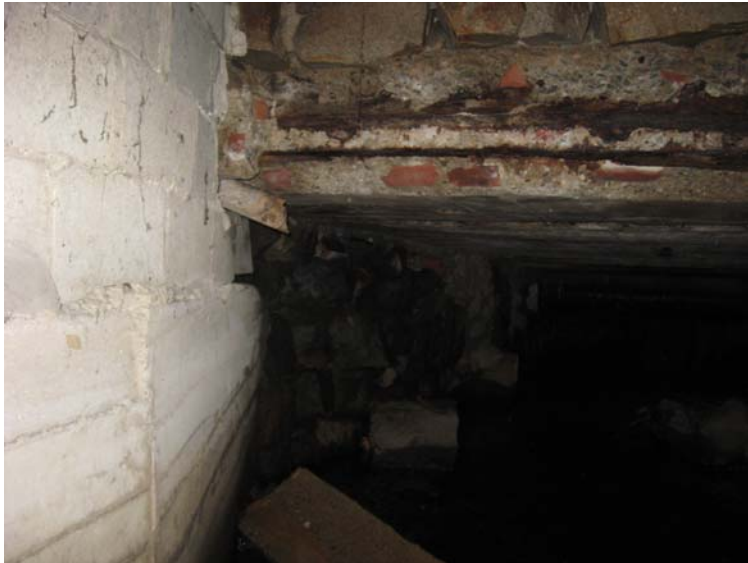
Smelt Brook 23 - looking at the edge of Commercial Street.

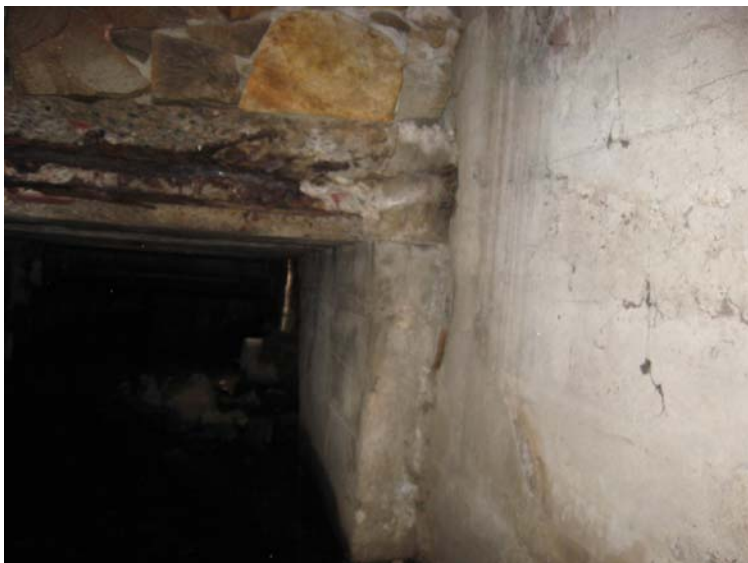
Smelt Brook 24 - looking at the edge of Commercial Street.

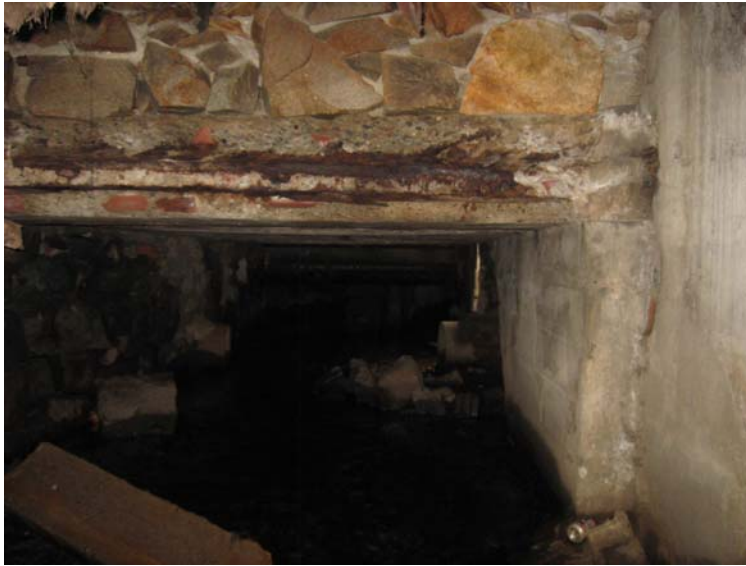
Smelt Brook 25 - view looking at edge of Commercial Street.

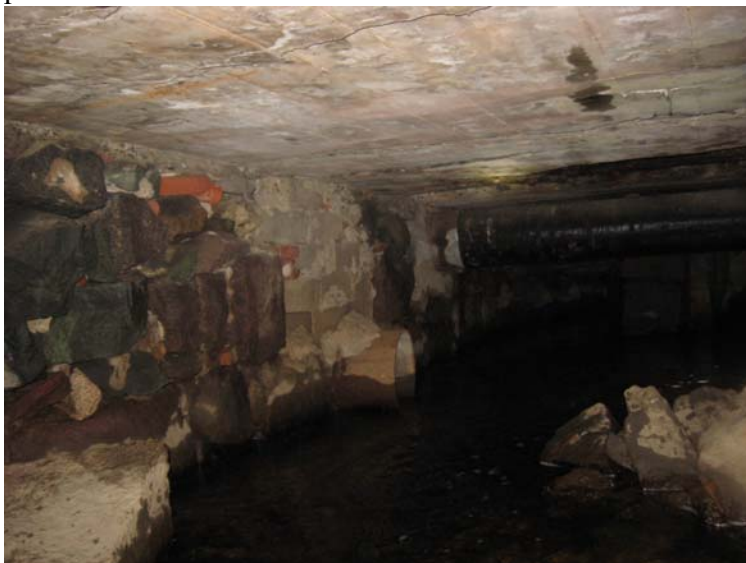
Smelt Brook 33 - view below Commercial Street.

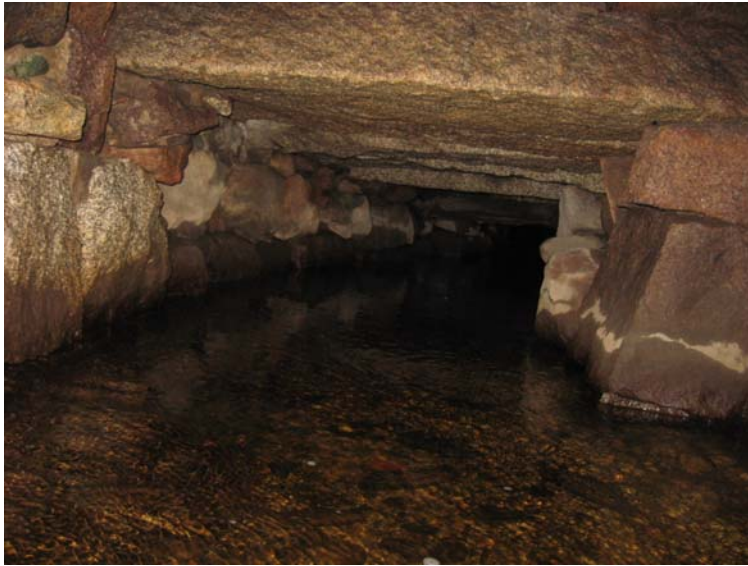
Smelt Brook 34 - view below Commercial Street along south side.

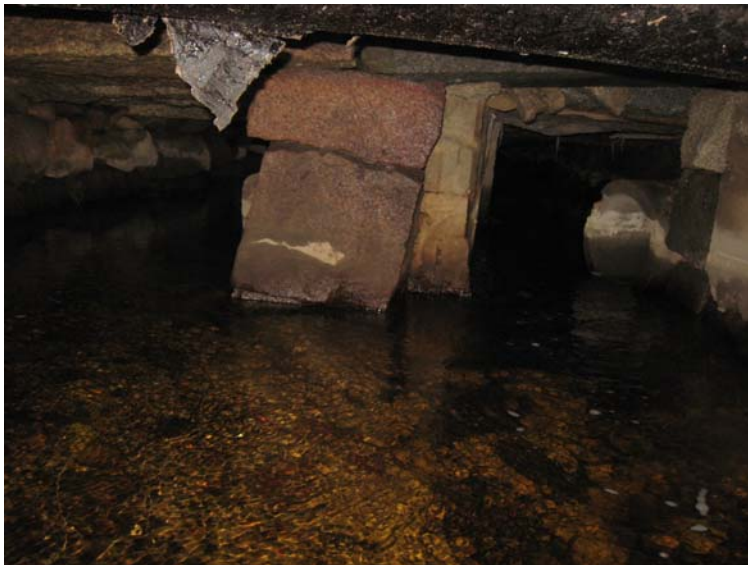
Smelt Brook 35 - view below Commercial Street at center pier.

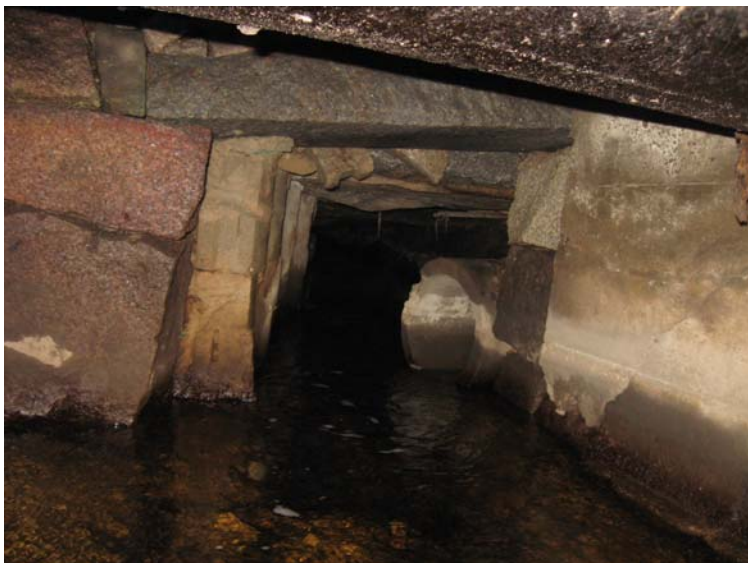
Smelt Brook 36 - view below Commercial Street along north side.

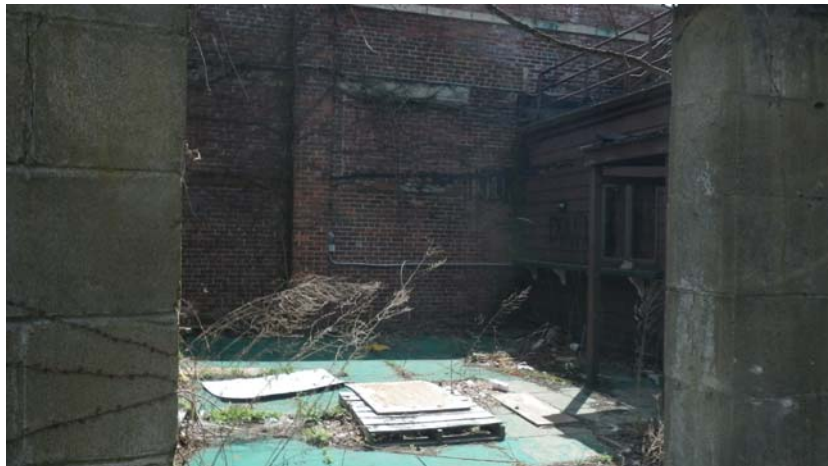
Brick Grill Exterior E2 - view at rear patio.

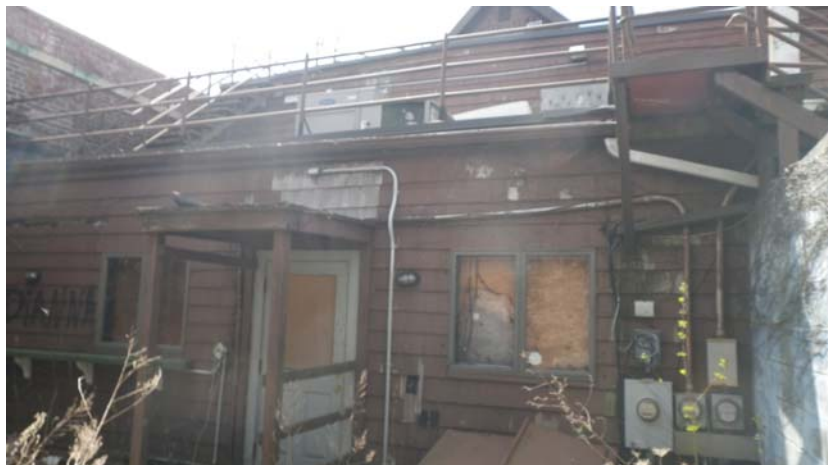
Brick Grill Exterior E3 - from patio looking west.

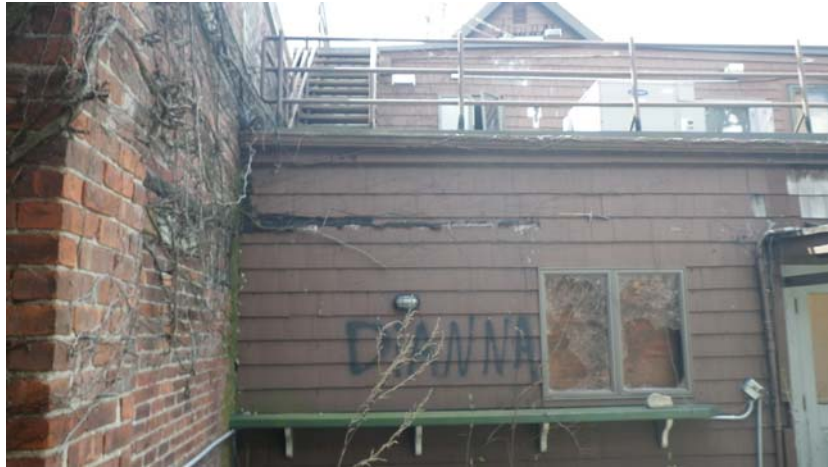
Brick Grill Exterior E4 - from patio looking west.

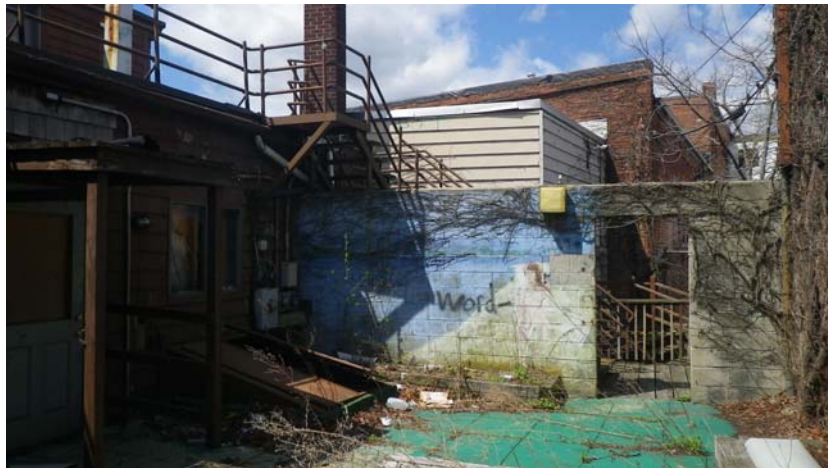
Brick Grill Exterior E5 - from patio looking north.

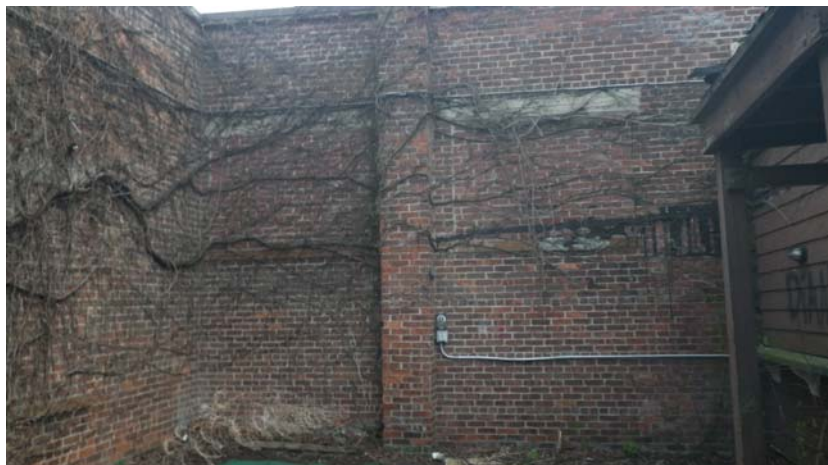
Brick Grill Exterior E6 - from patio looking south at Chair Fair Building.

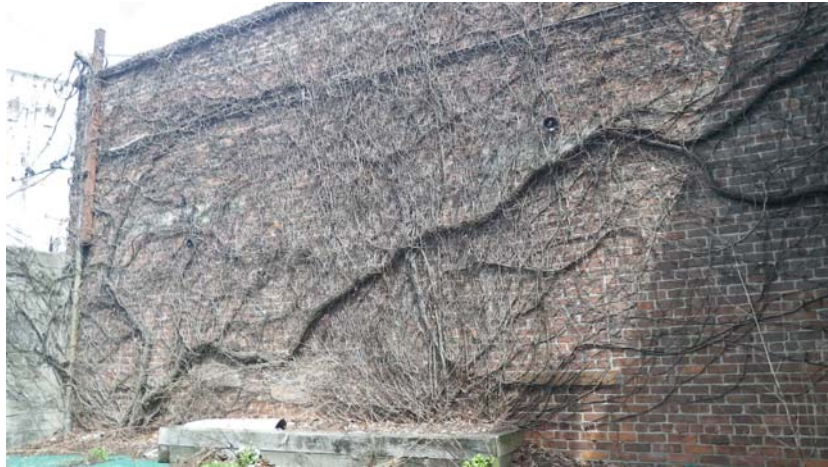
Brick Grill Exterior E7 - from patio looking at Chair Fair Building.

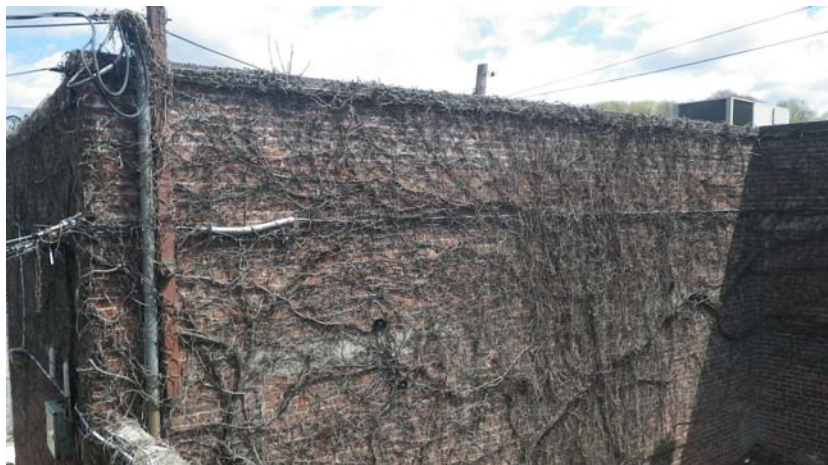
Brick Grill Exterior E9 - looking east at Chair Fair Building.

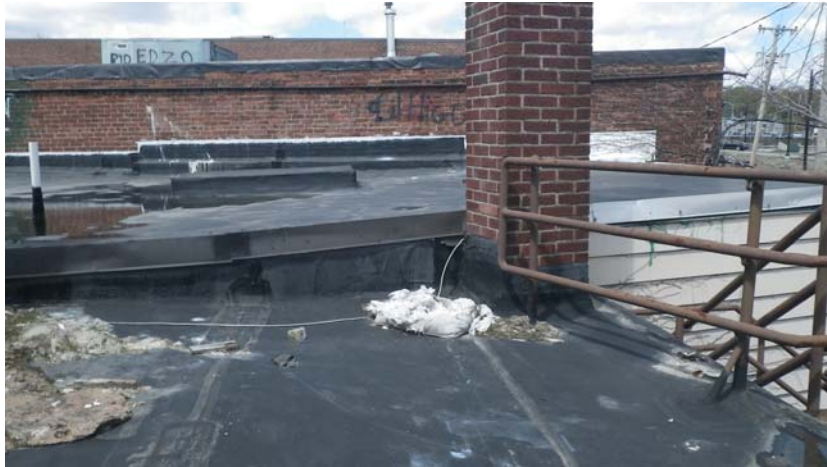
Brick Grill Exterior E10 - roof view looking north over Morante Insurance Building.

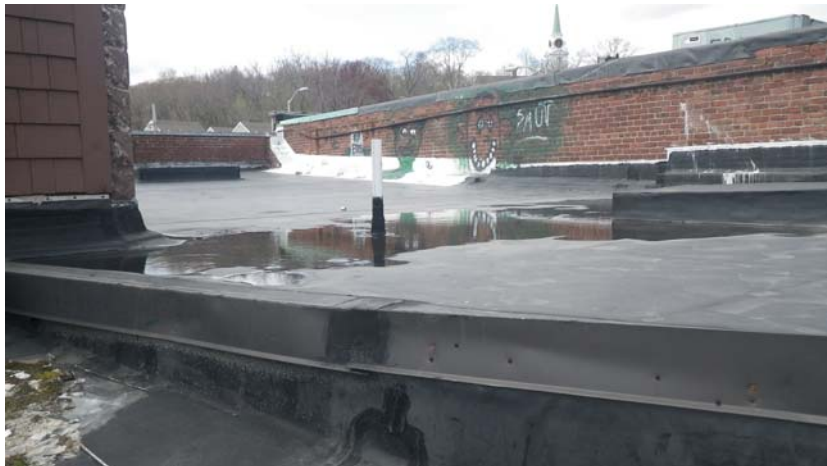
Brick Grill Exterior E11 - looking NW over Morante Insurance Barber Shop.

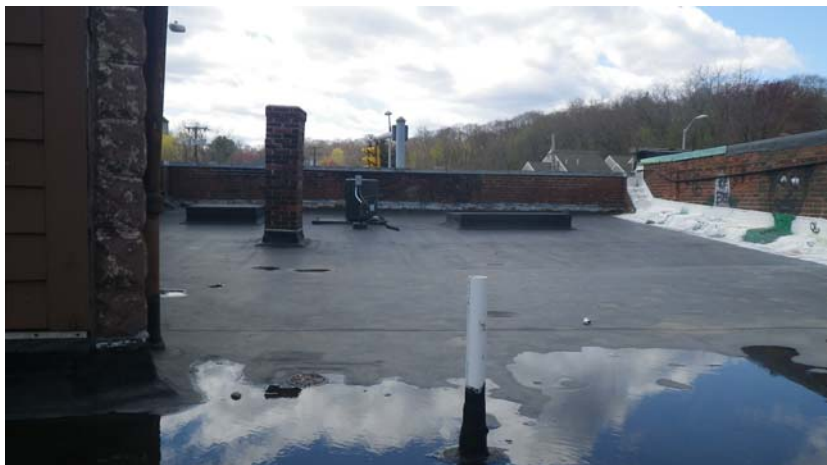
Brick Grill Exterior E12 - looking towards Commercial Street over Morante Insurance Barber Shop.

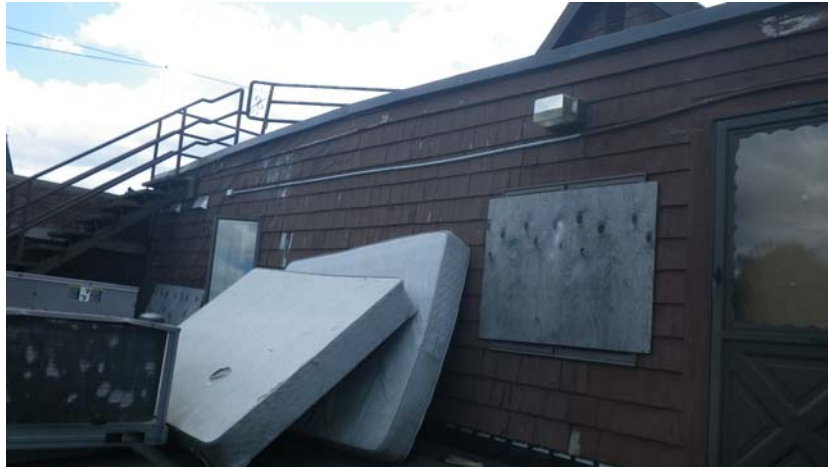
Brick Grill Exterior E13 - looking toward Commercial Street over 1 story section.

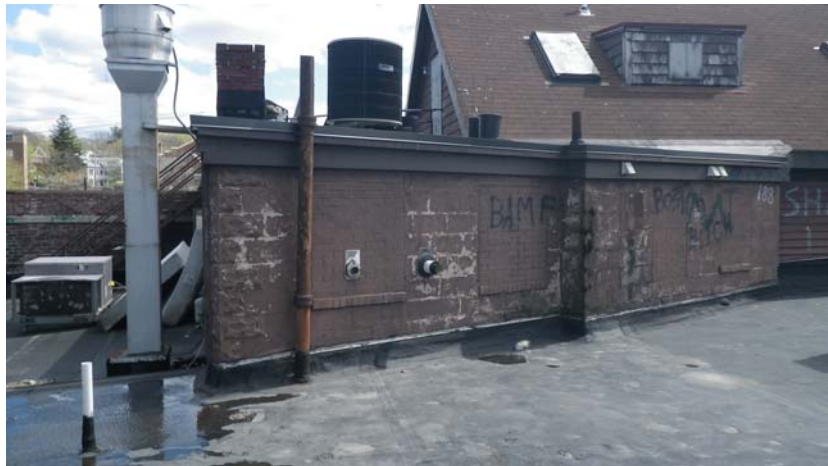
Brick Grill Exterior E14 - looking south from Morante Insurance at Brick Grill.

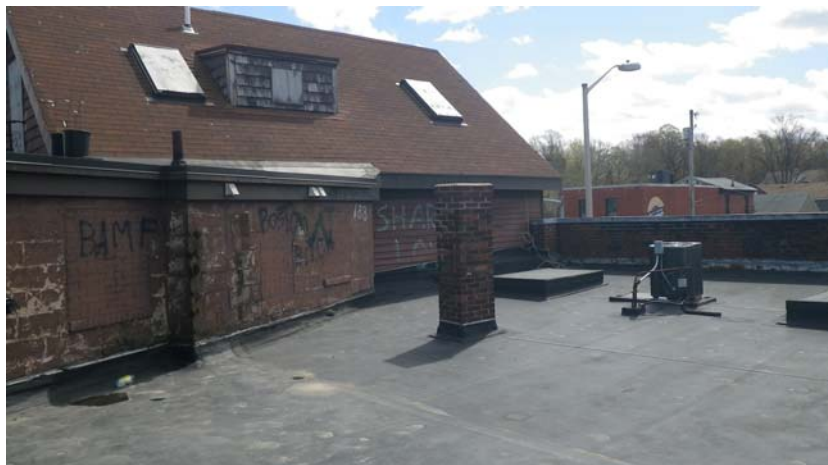
Brick Grill Exterior E15 - looking west from Morante Insurance at Brick Grill.

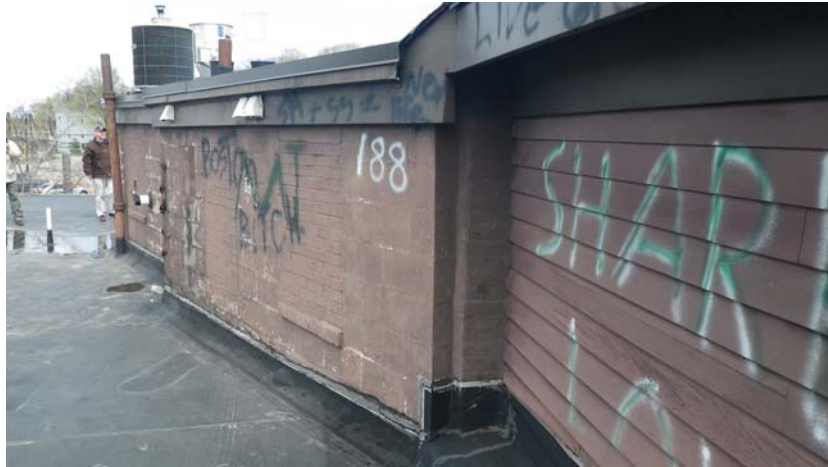
Brick Grill Exterior E16 - looking east along side of Brick Grill.
